Dam Inspection Report

Pefferlaw Dam

Town of Georgina
Regional Municipality of York

December 2019

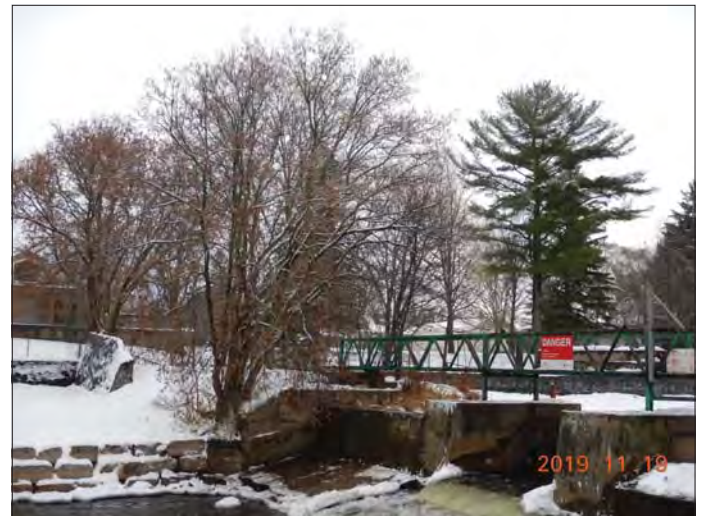
Photo 2701 - Sept 19, 2019
Pefferlaw Dam
Large Tree on Crest of Left (West) Earth Embankment

There are a number of large trees growing on the embankment and immediately adjacent to the concrete structures. The root systems from these trees have the potential to cause damage to the concrete sections of the dam and encourage piping through the earth sections of the dam. Additionally, if one of the large trees were to fall and pull up the root ball, the ability of the earth embankment to retain the head pond may be compromised.

Recommendation	Description of Deficiency	Priority	Estimated Cost	Additional Comments
1. Remove the trees from the earth embankment and from adjacent to concrete or masonry structures and remediate the voids left by the root systems.	There are a significant number of large trees located on the earth embankment sections.	Medium	\$15,000	The cost estimate assumes that a contractor would be hired to remove the trees, remediate the root systems and restore the earth embankment. Cost savings may be realized if the LSRCA is able to complete this work using internal resources.

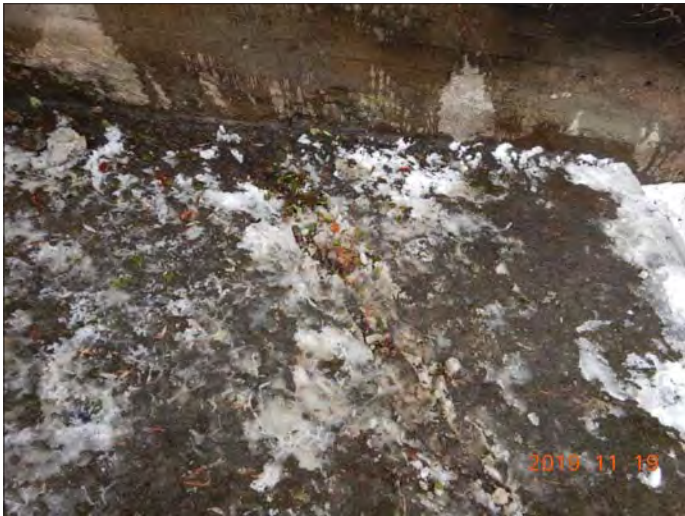
Photo 2760 - Sept 19, 2019
 Pepperlaw Dam
 Gap Between Left (West) Weir and Left (West) Apron

Left (West) Weir – Inspection of the left (west) weir was limited as it was partially snow covered during the inspection. There is a large gap (25 mm) at the construction joint where the flat section of the weir crest meets the sloping section of the weir crest. There is also a wide crack located approximately 200 mm downstream of the construction joint. There is a 600 mm wide strip along the sloping section of the weir that is delaminated in the area that was exposed by Wills' snow removal. The flat section of the weir crest contains a number of square holes for the installation of the flashboard posts. There appears to be a construction joint approximately 60 mm below the downstream weir crest on the downstream face of the weir. The downstream face of the weir is in good condition, however, there is a 30 mm gap at the interface of the weir and the apron. Video from the underwater inspection did not identify any undercutting of the upstream side of the weir.

2. Undertake a concrete condition assessment for the dam, including concrete coring and detailed surface mapping, and based on the results of the concrete condition assessment prepare a detailed rehabilitation design for the concrete components of the structure.	The condition of the concrete is poor in a number of locations.	High	\$40,000*	<p>The cost estimate provided is the cost of the concrete condition assessment and detailed rehabilitation design. The cost of completing the concrete rehabilitation could be in the range of \$100,000 to \$150,000, to be confirmed as part of the detailed rehabilitation design project.</p> <p>This work should be completed by a professional consulting engineer.</p>

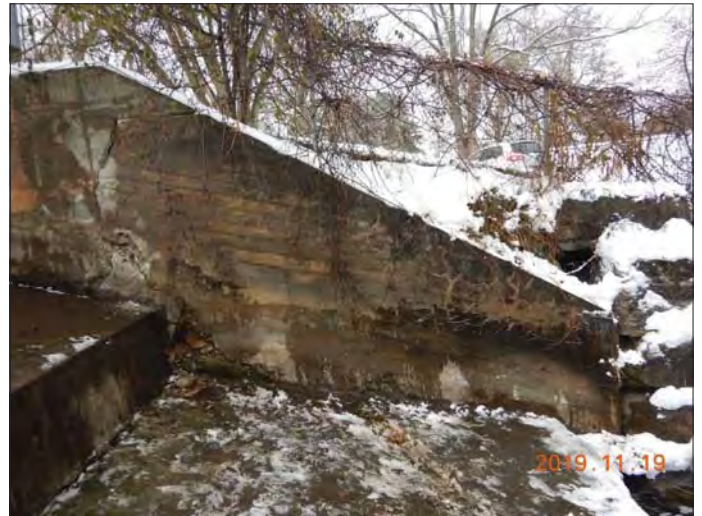
Lake Simcoe Region
conservation authority
Photo 2762 - Sept 19, 2019
Pefferlaw Dam
Crack in Left (West) Apron at Downstream End

Left (West) Apron – The left (west) apron was cleared of snow to facilitate the inspection. The entire surface of the apron is severely eroded on the face (100%). There is a wide crack at the downstream left side of the apron. The cracked area is

approximately 1600 mm by 2300 mm. The downstream edge of the apron is approximately 800 mm high. Video from the underwater inspection identified the possibility of some cracks with efflorescence and some minor spalls. There was also one location that appeared to show some minor undercutting of the apron.

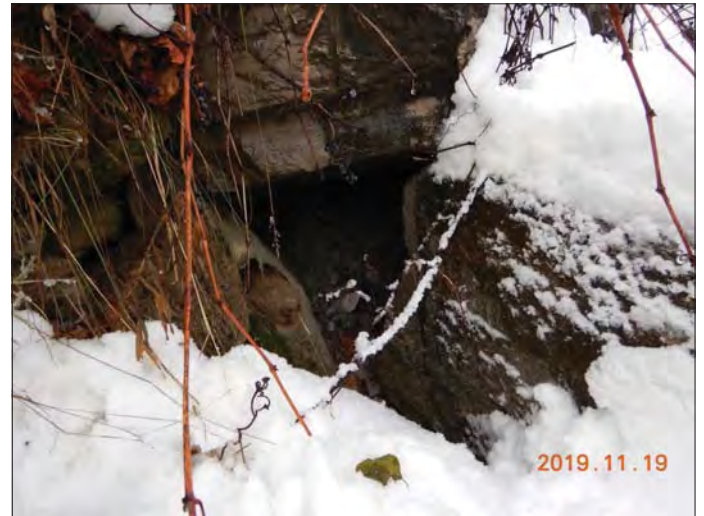
Photo 2771 - Sept 19, 2019
 Pefferlaw Dam
 Void Below Armour Stone Wall, Left (West) Side

7. Repair the erosion behind the downstream left (west) and right (east) armour stone retaining walls.	There is erosion behind the armour stone retaining walls.	High	\$25,000	The scope of the erosion repair is difficult to determine due to the presence of snow on the ground during the dam inspection. The cost estimate assumes that the LSRCA will retain a contractor to complete the work.

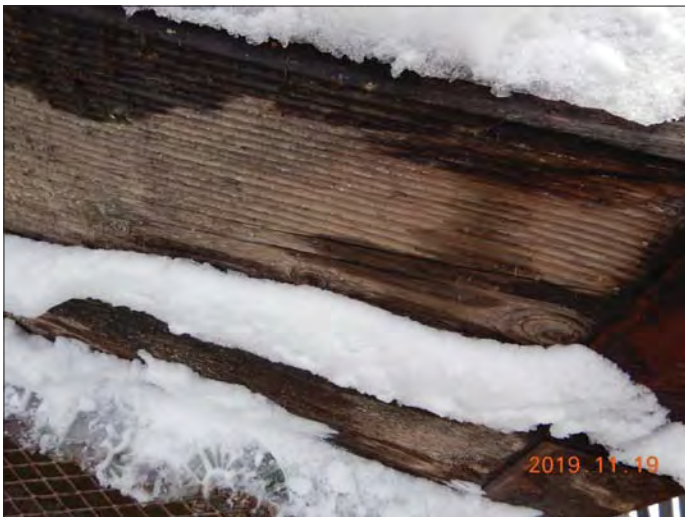
Lake Simcoe Region
conservation authority
 Photo 2798 - Sept 19, 2019
Pefferlaw Dam
 Stoplog Condition

Recommendation	Description of Deficiency	Priority	Estimated Cost	Additional Comments
5. Replace the flashboards and flashboard posts, as planned. Note: Future replacement of the stoplogs may be required.	The flashboards and flashboard posts are in poor condition and the LSRCA is already planning to replace them. The stoplogs may require replacement in 2 to 5 years.	High	\$8,000	The cost estimate assumes that the LSRCA will outsource the fabrication of the flashboard posts and will fabricate the flashboards using internal resources.

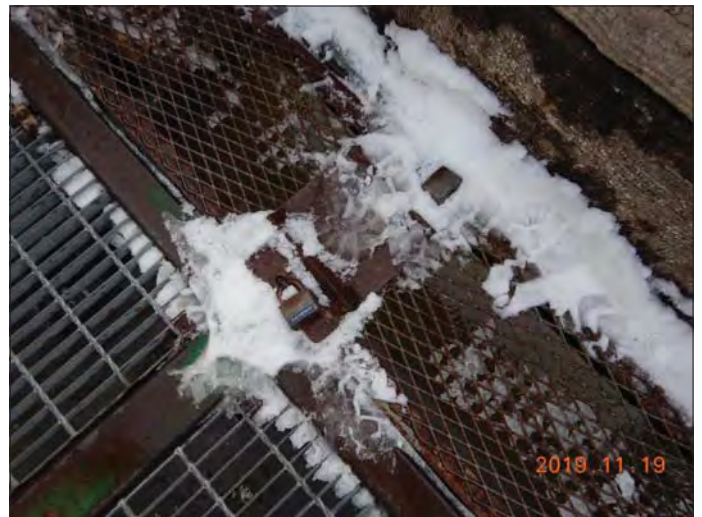
Lake Simcoe Region
conservation authority
 Photo 2799 - Sept 19, 2019
Pefferlaw Dam
 Stoplog Condition

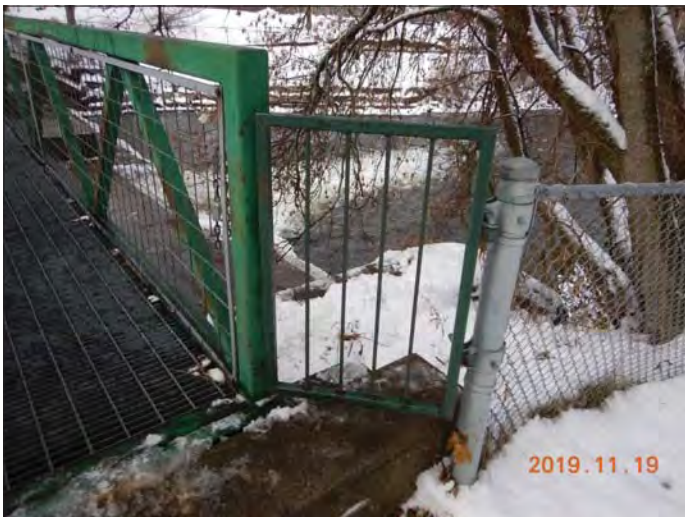
Lake Simcoe Region
conservation authority
 Photo 3916 - Sept 19, 2019
Pefferlaw Dam
 Cracks in Vertical HSS Sections of the Truss Bridge

Truss Bridge – The east and west pedestrian spans are in fair condition, with coating failure and minor corrosion throughout.

3. Undertake a structural evaluation of the truss bridge within one (1) year and develop a detailed repair or replacement design for the truss bridge and dam deck. Depending on the results of the structural evaluation, temporary repairs, the removal of the stoplogs stored on the deck or temporary suspension of dam operations may be required.	The steel truss is in poor condition with failure of the coating and cracking and bowing of the structural steel members.	Immediate	\$5,000*	<p>The cost estimate provided is the cost for the structural evaluation only. The cost for the detailed design for the repair or replacement will depend on the results of the structural evaluation and on the structure type but would likely be in the range of \$30,000 to \$60,000.</p> <p>This work should be completed by a professional consulting engineer.</p> <p>As an alternate to undertaking Recommendation 3, the LSRCA could stop operating the dam, remove the stoplogs stored on the dam and eliminate public access across the dam. However, this is only seen as a short term solution and a permanent solution, such as repair, replacement or dam decommissioning will ultimately be required in order to ensure public and operator safety.</p>

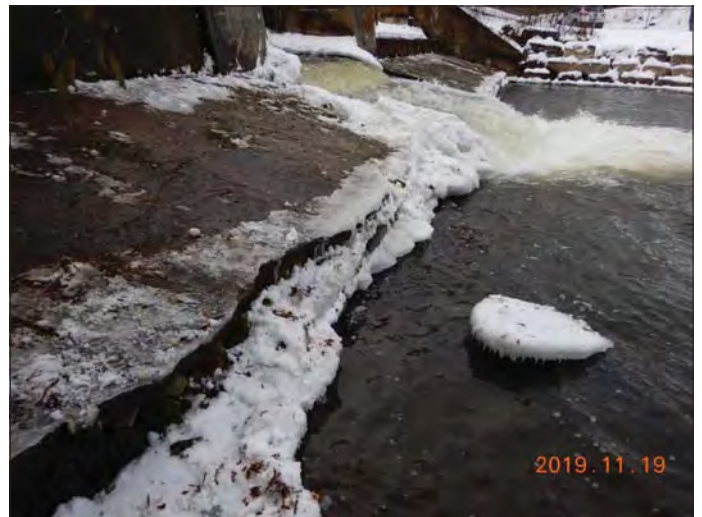
Undercutting in Right (East) Apron
