## **Structural Design Memorandum**

### **Pefferlaw Dam**

**Town of Georgina  
Regional Municipality of York**

**D.M. Wills Project Number 19-5381**

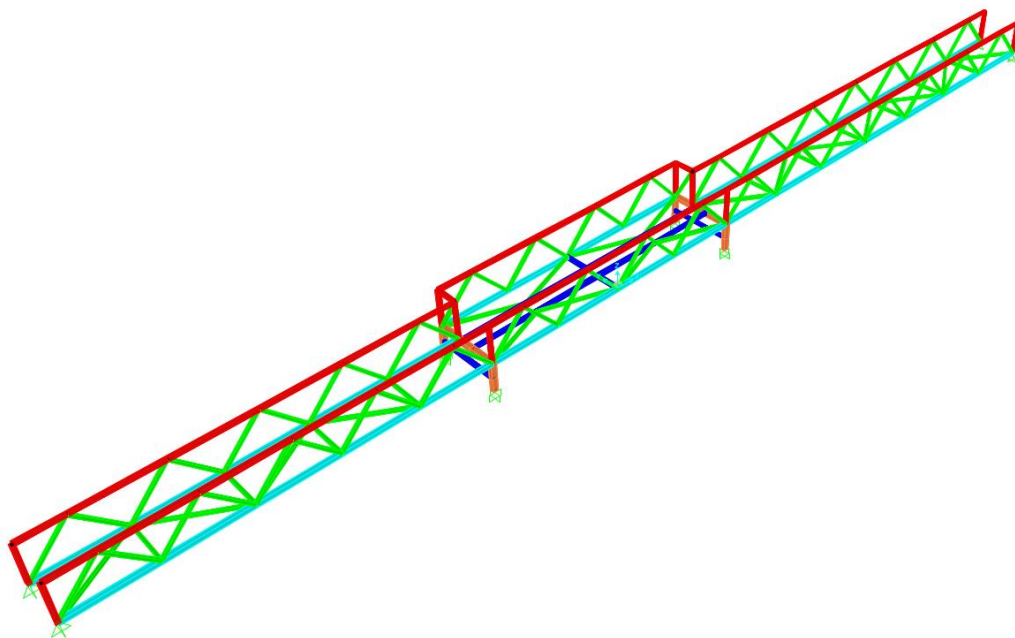
**Figure 1 – Pefferlaw Dam Access Bridge SAP2000 Model**

The evaluation included creation of a model of the existing operational truss in SAP2000 as shown in **Figure 1**, including member dimensions from the design drawings that were verified onsite, and design strengths from the drawings. Various loading scenarios were applied to determine the demand on the elements of the operational truss to determine if elements of the truss are overstressed.

It was determined through the evaluation that the effect of the storing of stoplogs is less than the effect of the specified pedestrian live load. Furthermore, it was determined that the cracking at the end vertical HSS of the middle truss section are not due to overstressing. The operational span truss was found to be capable of carrying the above mentioned loads, and the anchorage at the pier posts were determined to be adequate.

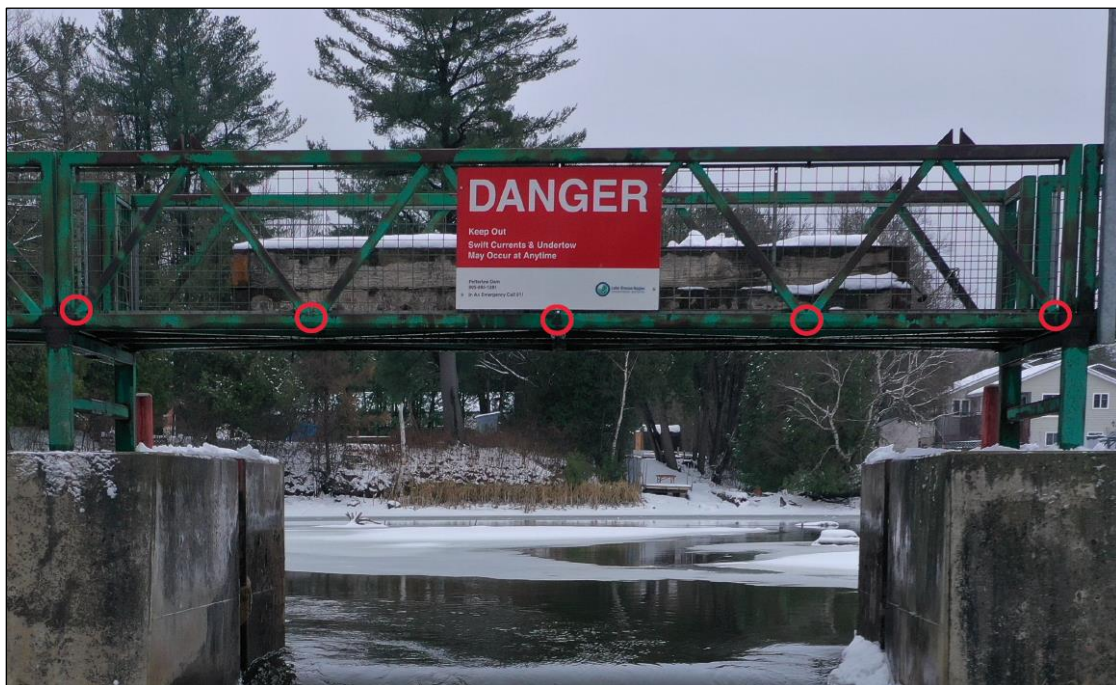
**Figure 2 – Fall Arrest Anchor Possible Locations**

It was determined through the evaluation that the top chord of the truss has inadequate capacity to be used as a fall arrest anchor. The operation span truss was found to be capable of carrying the fall arrest load if the anchor was located on the bottom chord at the convergence of diagonals and at the end posts. All fall arrest systems and anchorage should be verified to be in compliance with O. Reg. 213/91, s.16.

The existing fall arrest system does not span the operational span of the truss. However, the existing system on the western span, comprised of a steel cable passing through eyelets welded to L-shaped HSS members which are fastened to the underside of the approach truss, should be assessed and if suitable can be extended over the operational span. Preferably new supports erected on top of the concrete piers would remove the fall arrest system from the truss altogether. This approach to the extension of the existing fall arrest system separates the operational span truss from the fall arrest system, which is preferred when considering future maintenance or replacement of either element.

- Repair cracks at the operation span truss end vertical HSS.
- Repair concrete and repair the bearing seat at the west abutment.
- Recoat structural steel.
- Review current fall arrest anchorage practices and modify as necessary.

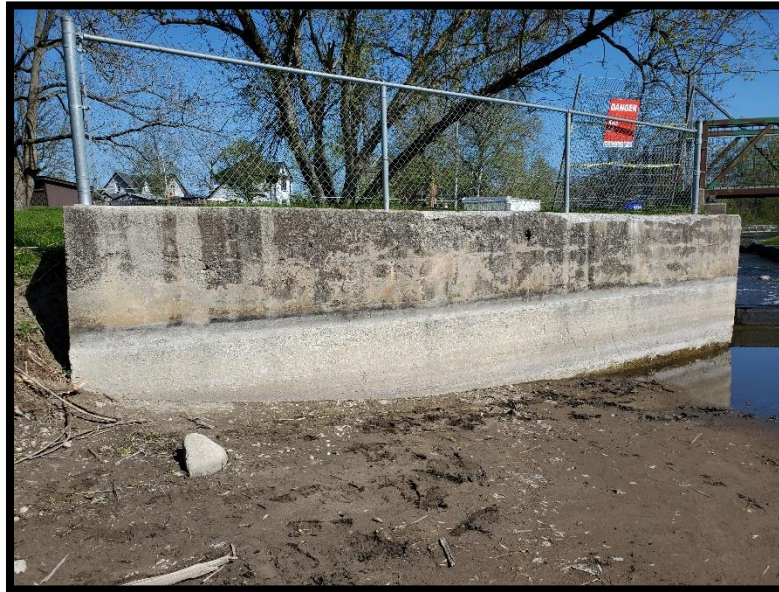
**Photo 3 – Upstream West Retaining Wall, Spalling at Top Edge**

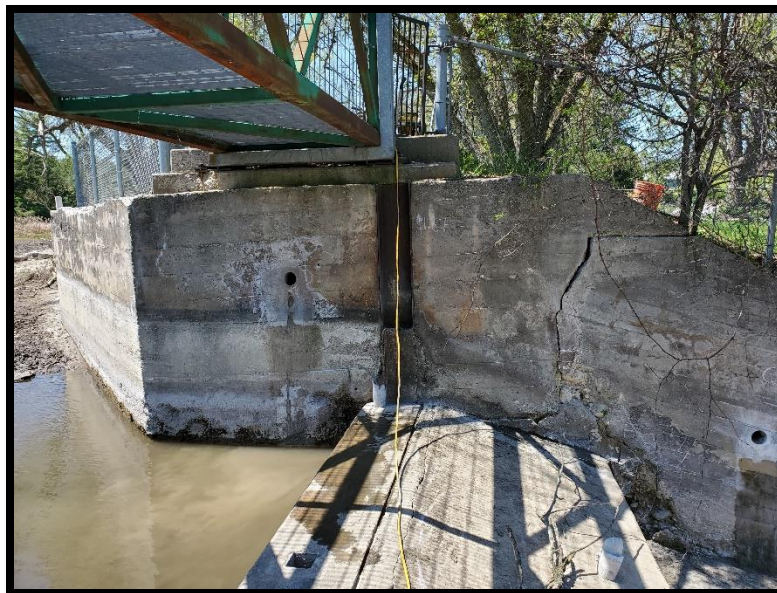
**Photo 4 – West Abutment, Erosion at Waterline and Wide Vertical Cracking**

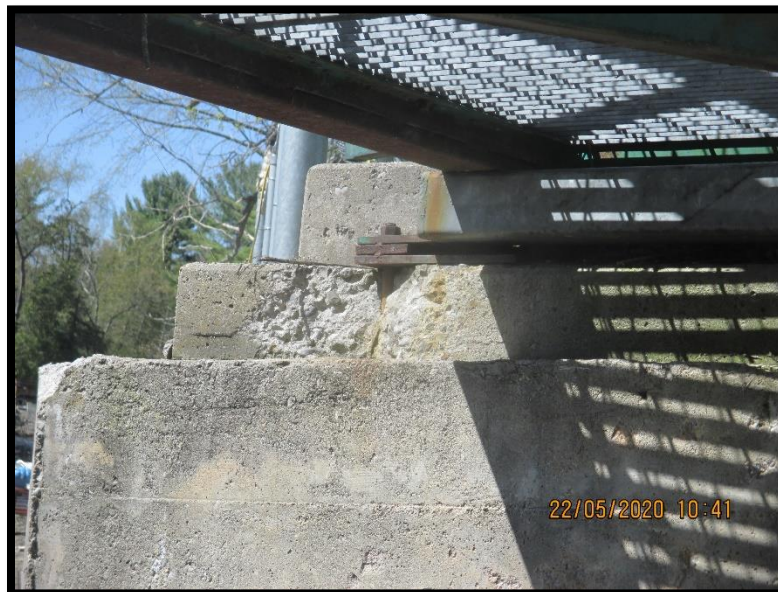
**Photo 5 – West Abutment, Spalling Under Southwest Bearing**

\* Requires localized concrete repair under bearing at southwest edge of west abutment

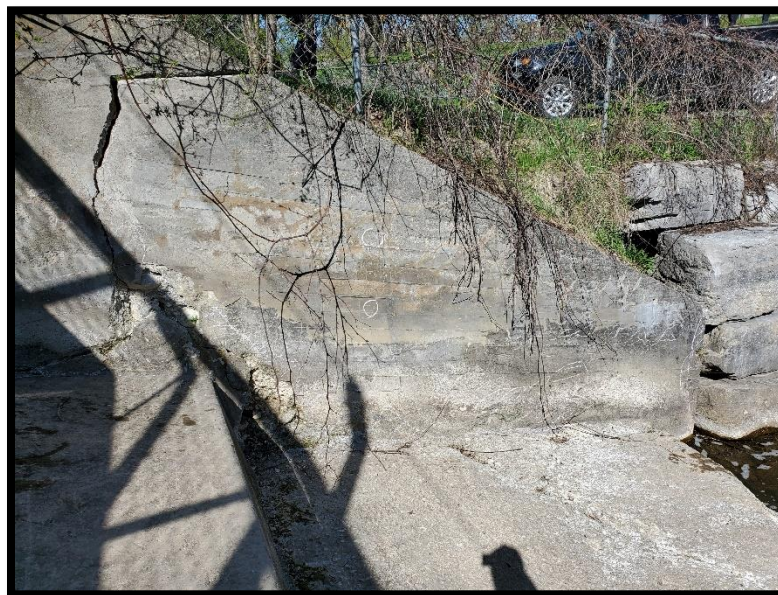
**Photo 6 – Downstream Retaining Wall at West Abutment, Wide Vertical Crack and Spalling at Weir**

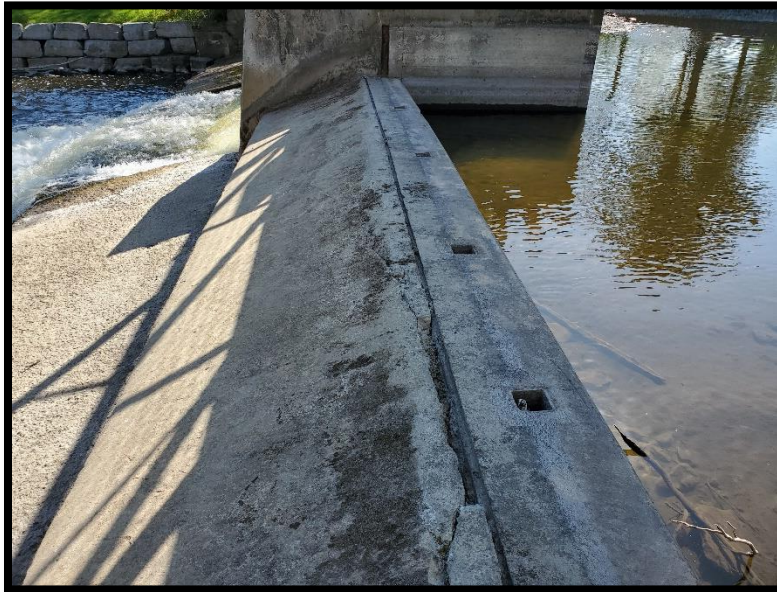
**Photo 7 – West Overflow Weir, Wide Crack along Weir**

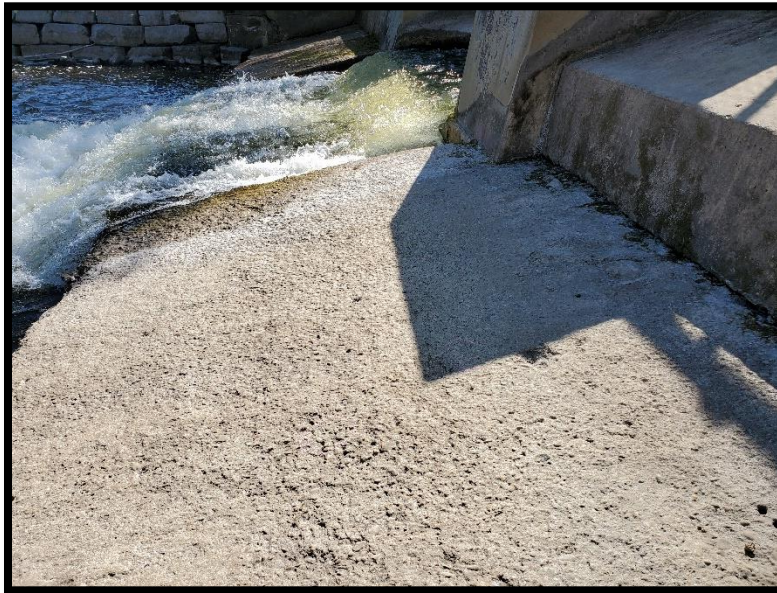
**Photo 8 – West Overflow Weir Concrete Apron, Severe Scaling (Typ.)**

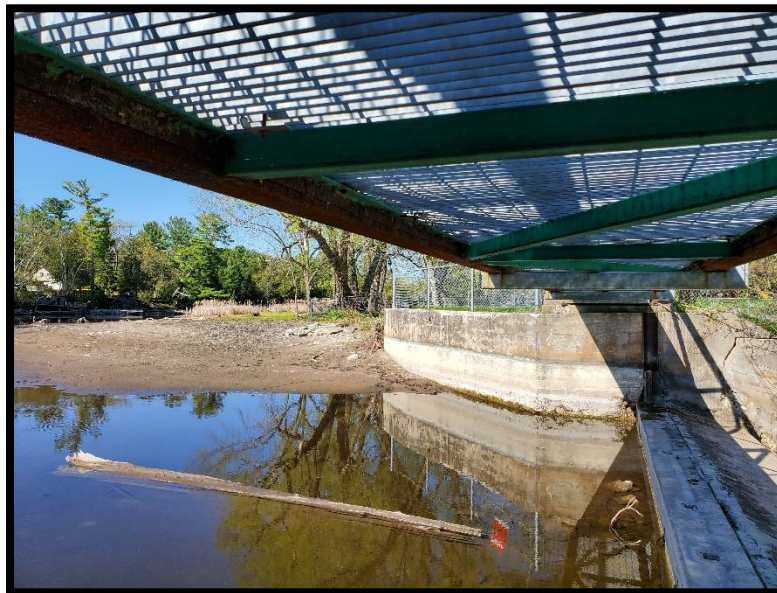
**Photo 10 – Underside of West Span of Pedestrian Bridge, Failed Protective Coating and Moderate Corrosion of Longitudinal HSS (Typ.)**

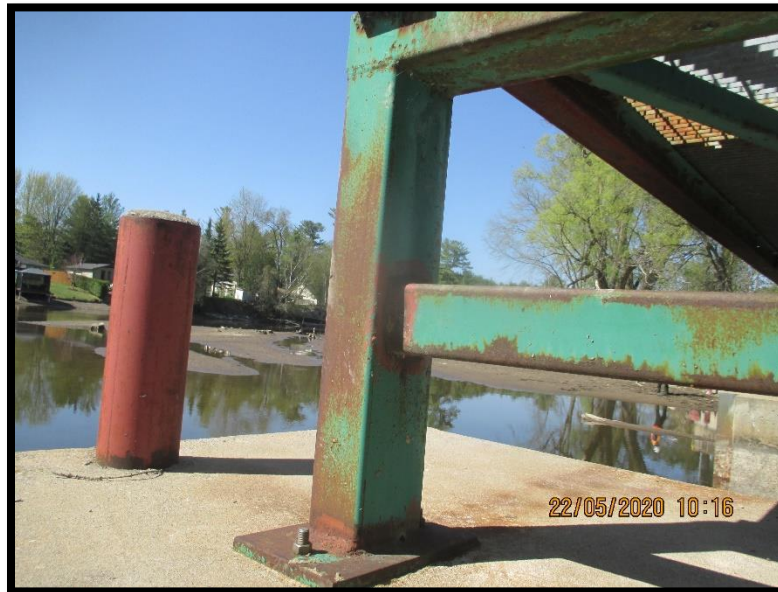
**Photo 11 – HSS Support at West Pier, Loss of Protective Coating and Light Corrosion (Typ.)**

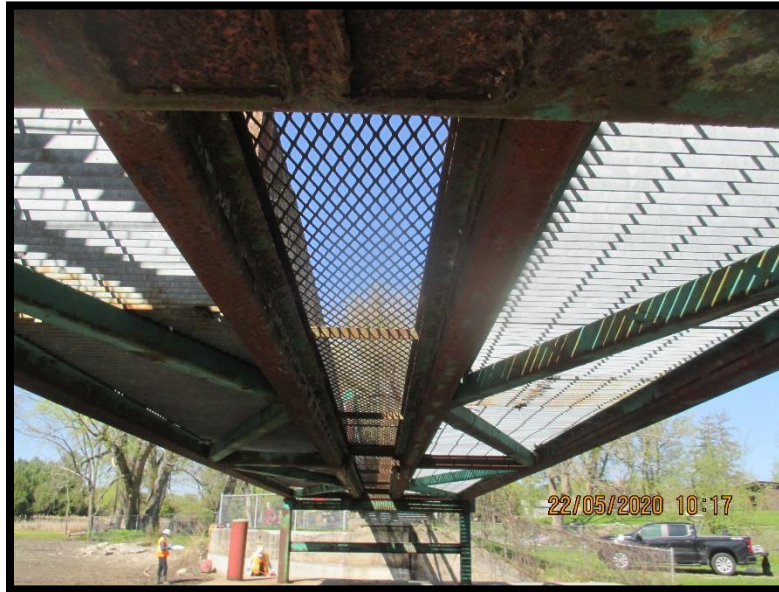
**Photo 13 – Underside of Pedestrian Bridge over Operational Span, Failing Protective Coating and Moderate Corrosion of Longitudinal HSS (Typ.)**

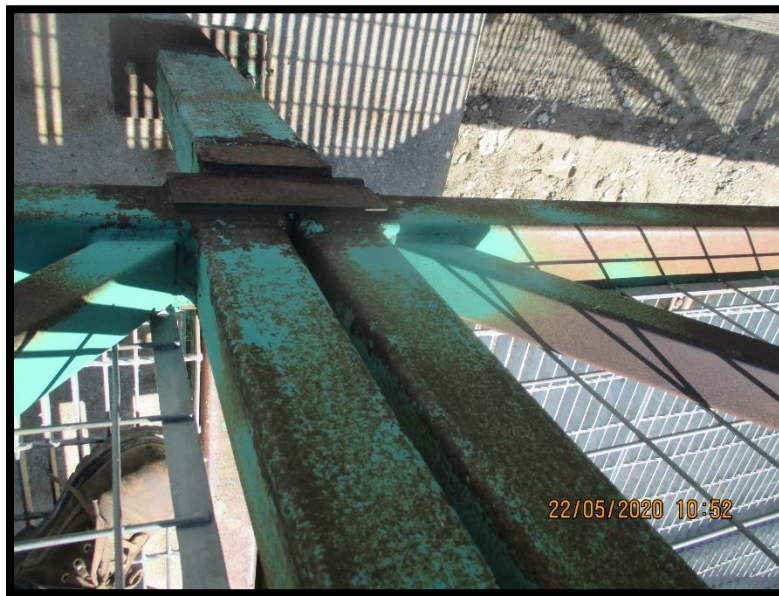
**Photo 14 – Joint Between Operational and East Span, Loss of Protective Coating and Light to Moderate Corrosion (Typ.)**

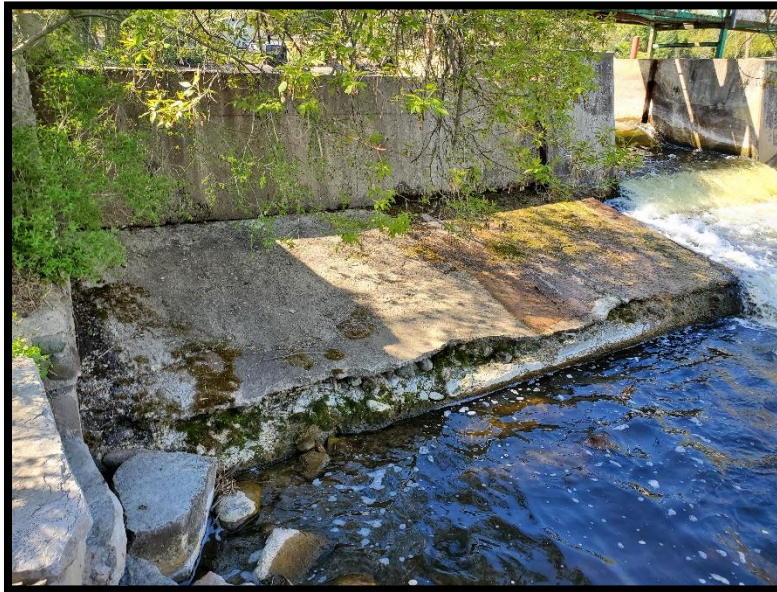
**Photo 17 – East Concrete Apron, Severe Spalling and Undermining (Typ.)**

face, partial or complete refacing of the concrete element should be considered. Complete replacement of the east abutment retaining wall is recommended, and partial replacement or grouting below the east apron slab will be required.

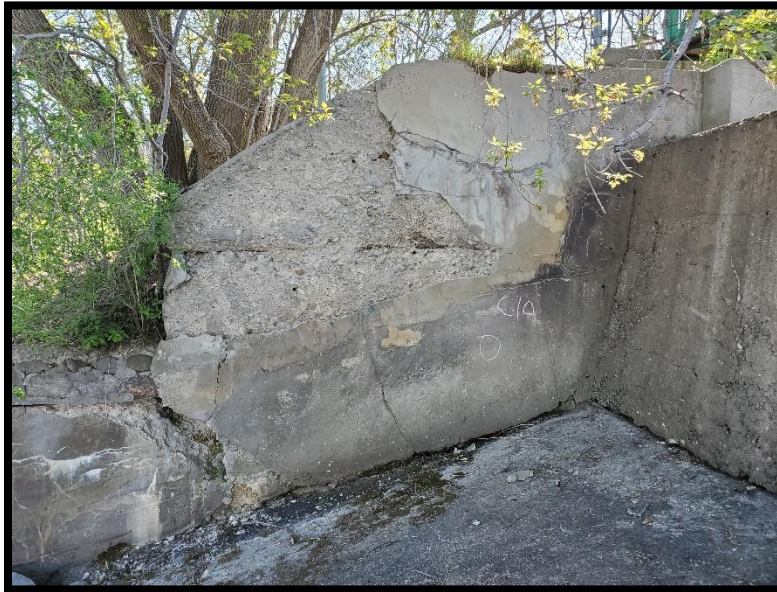
**Photo 19 – Downstream East Retaining Wall, Severe Spalling, Disintegration, and Delamination with Wide Cracks (Typ.)**

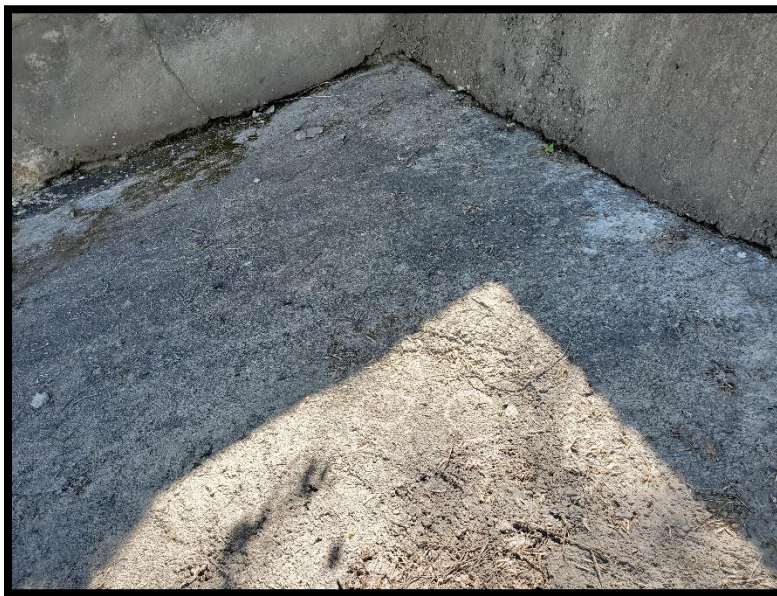
**Photo 20 – East Concrete Apron, Medium Scaling (Typ.)**

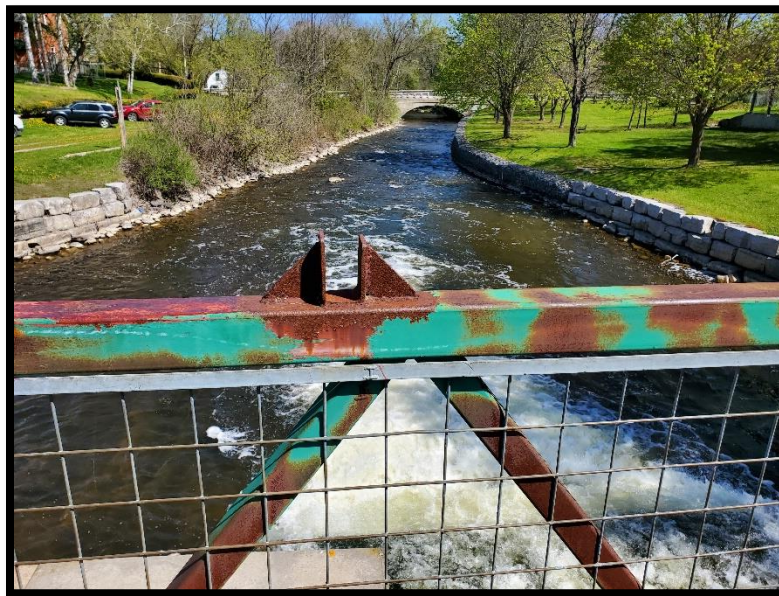
**Photo 22 – Winch Anchorage on Truss HSS, Moderate Corrosion (Typ.)**

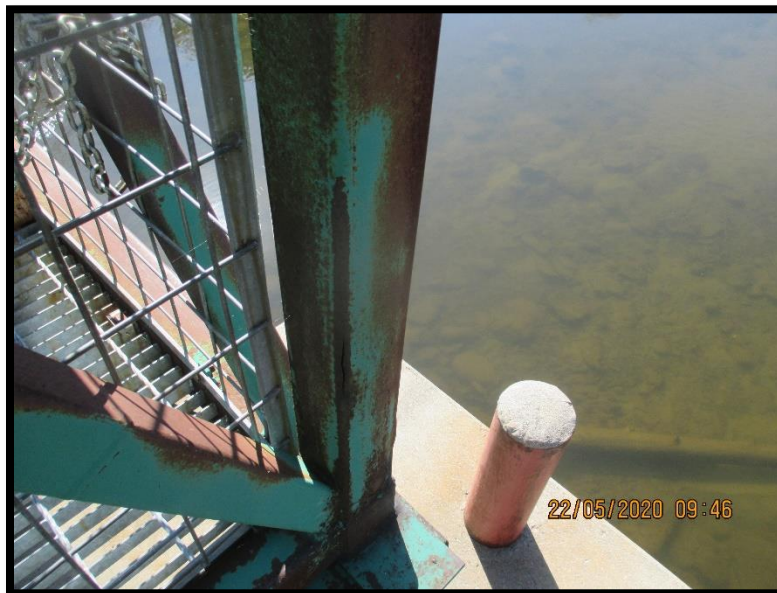
**Photo 24 – Vertical HSS at Operational Span, Wide Cracks in Steel (2)**

- Weld Crack Repair of the Operational Span

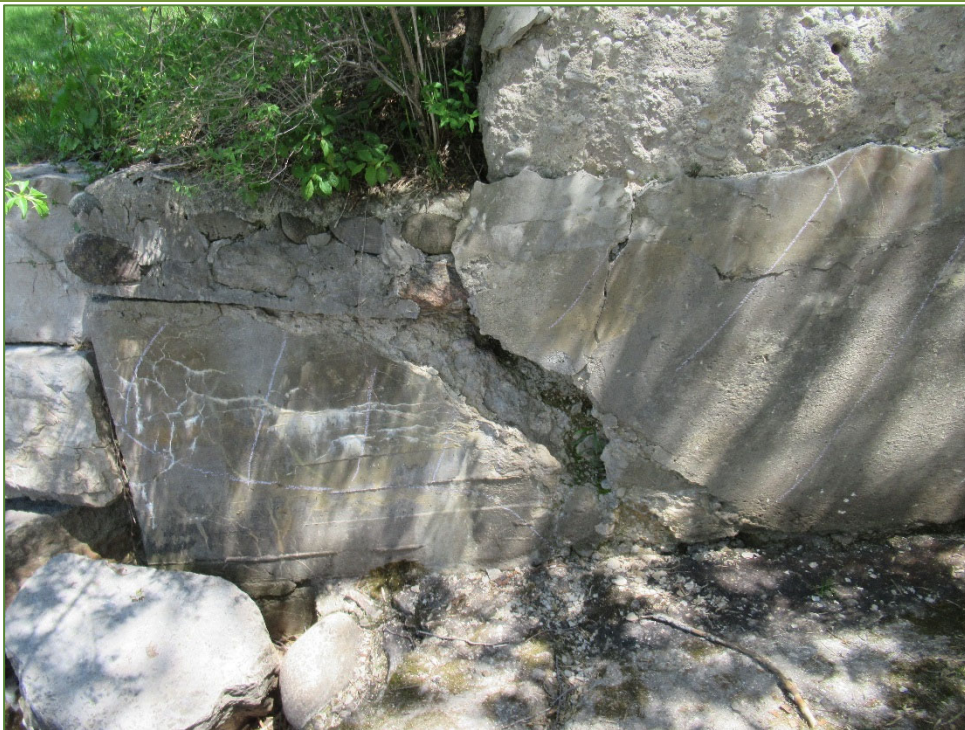
**Photo P5 East Abutment and Retaining Wall** (fair to poor condition – cracks, spall, delamination and light to severe scaling)

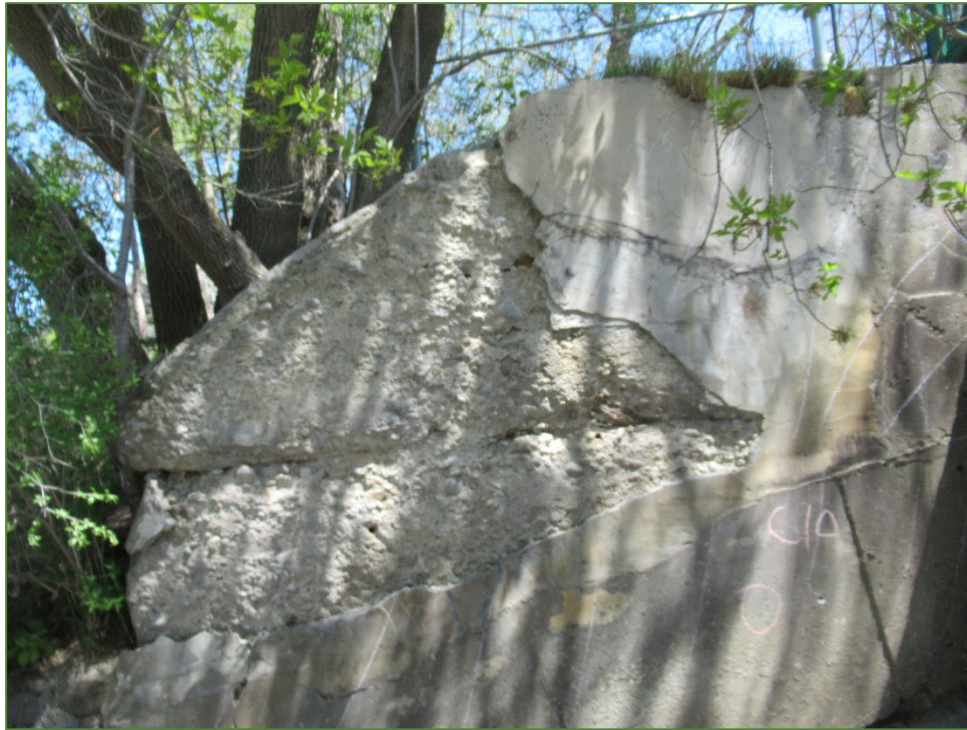
**Photo P6 East Abutment and Retaining Wall** (cracks, spall, delamination and light to severe scaling)

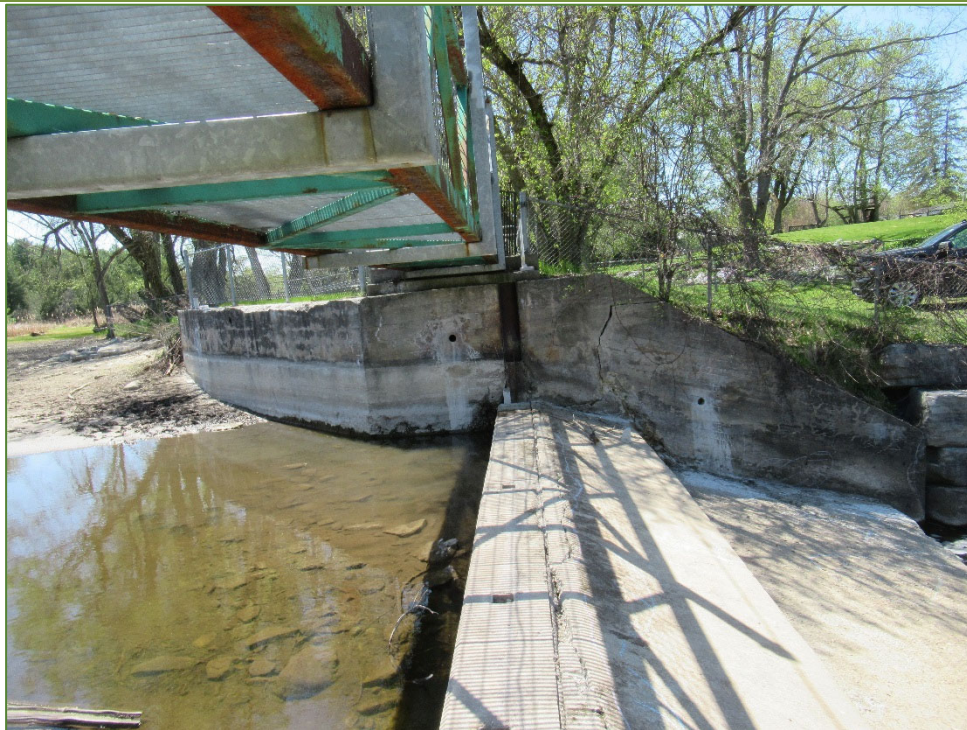
**Photo P7 East Abutment and Retaining Wall** (cracks, delamination and severe scaling)

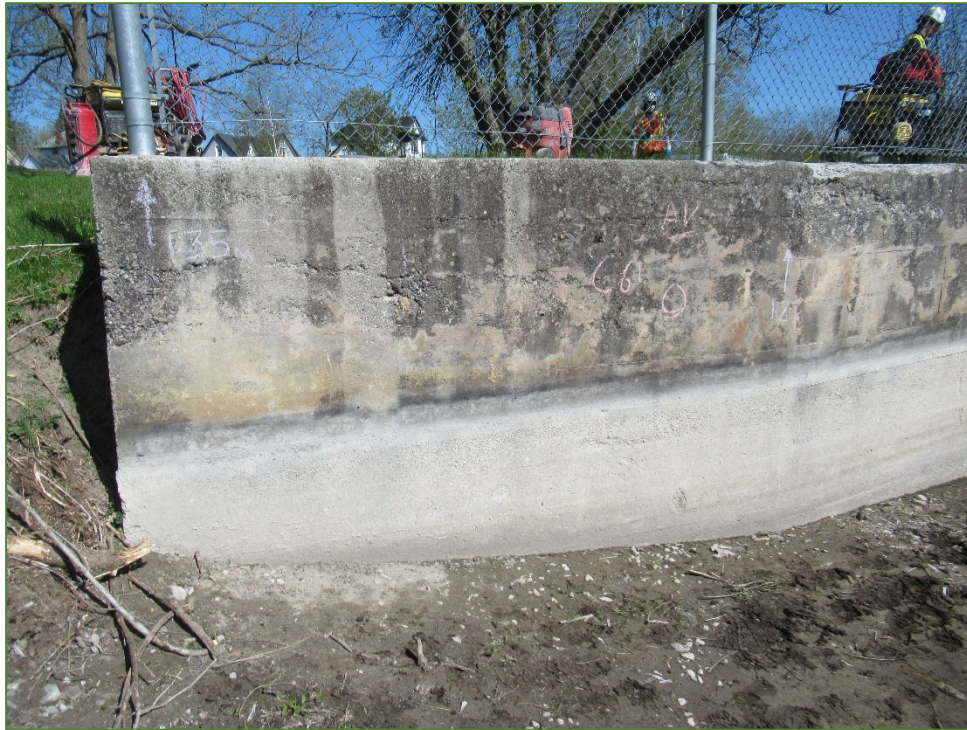
**Photo P8 West Abutment and Retaining Wall** (fair condition – cracks, spall, delamination, light to medium scaling and staining) note undermining, and alkali aggregate reaction on the surface

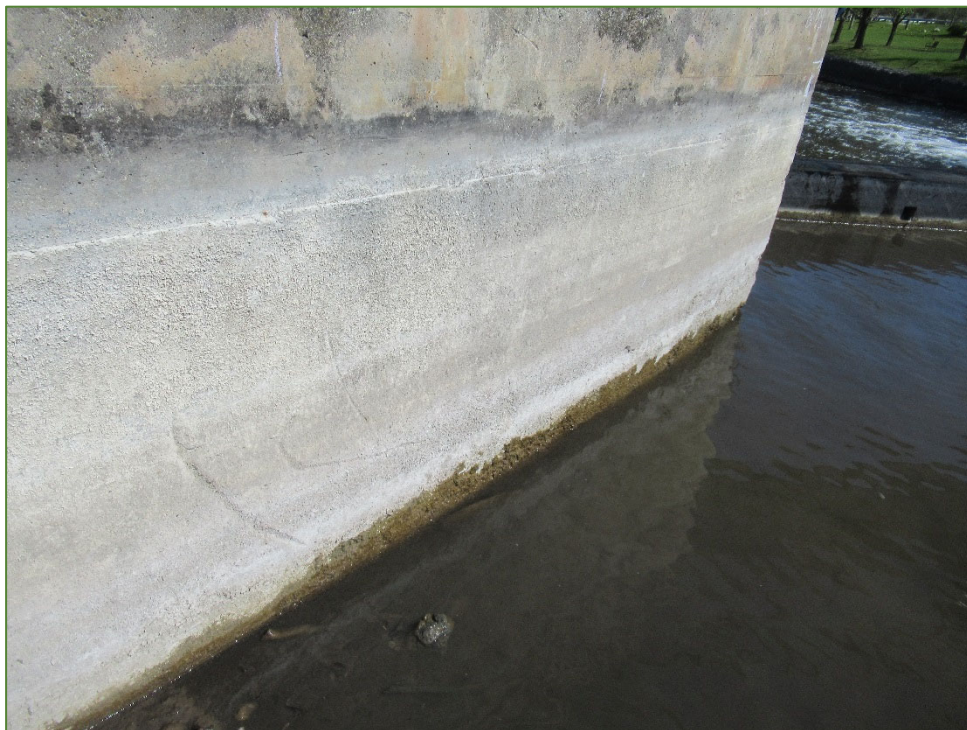
**Photo P9 West Abutment and Retaining Wall** (cracks, spall and light to medium scaling)

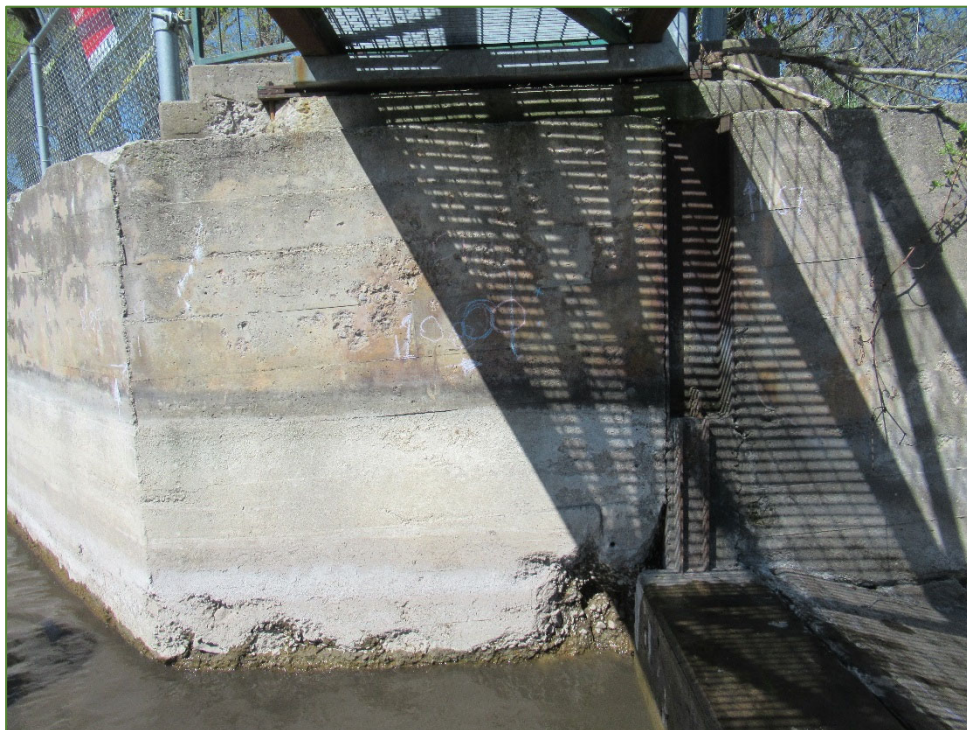
**Photo P12 West Abutment and Retaining Wall** (cracks, spall, light to severe scaling and staining) note undermining

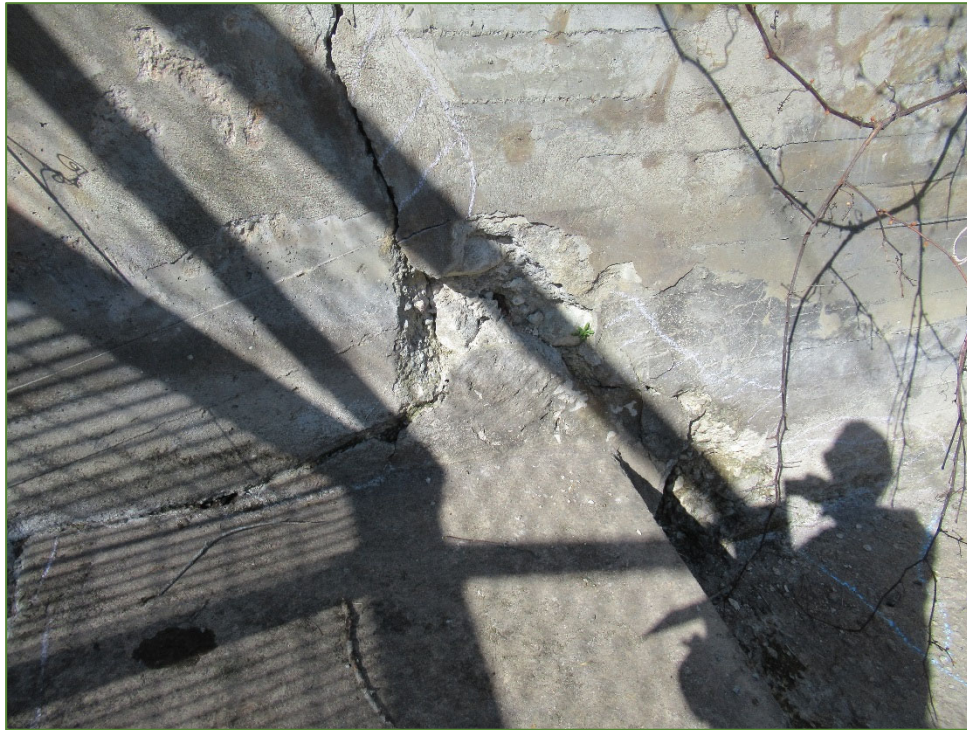
**Photo P13 West Abutment and Retaining Wall** (wide crack, spall and delamination)

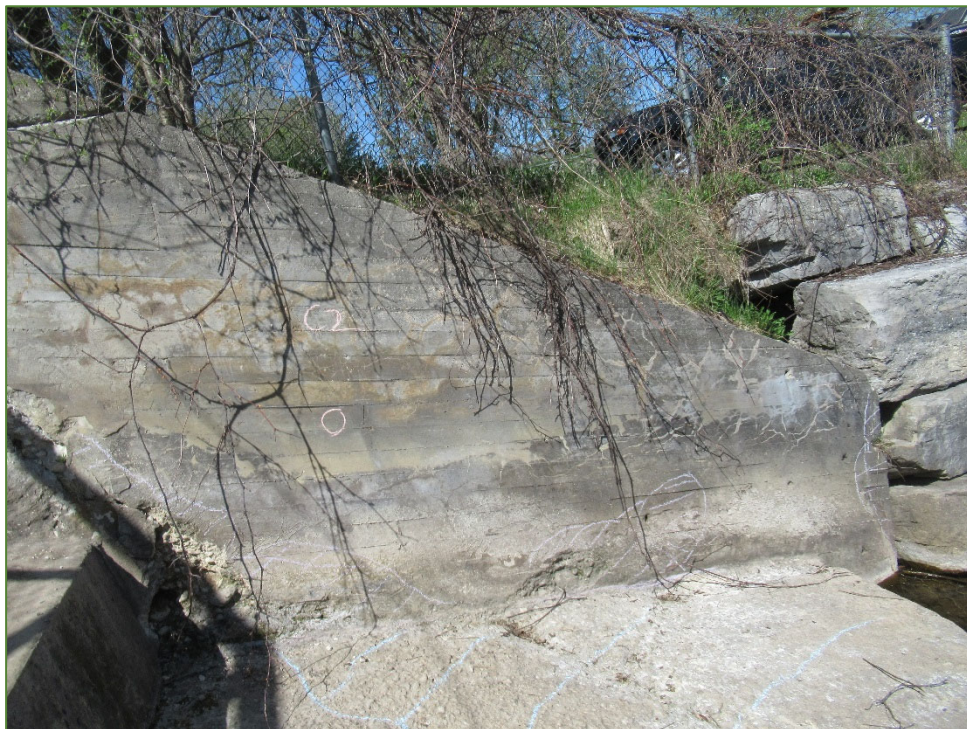
**Photo P14 West Abutment and Retaining Wall** (cracks, spall and delamination)

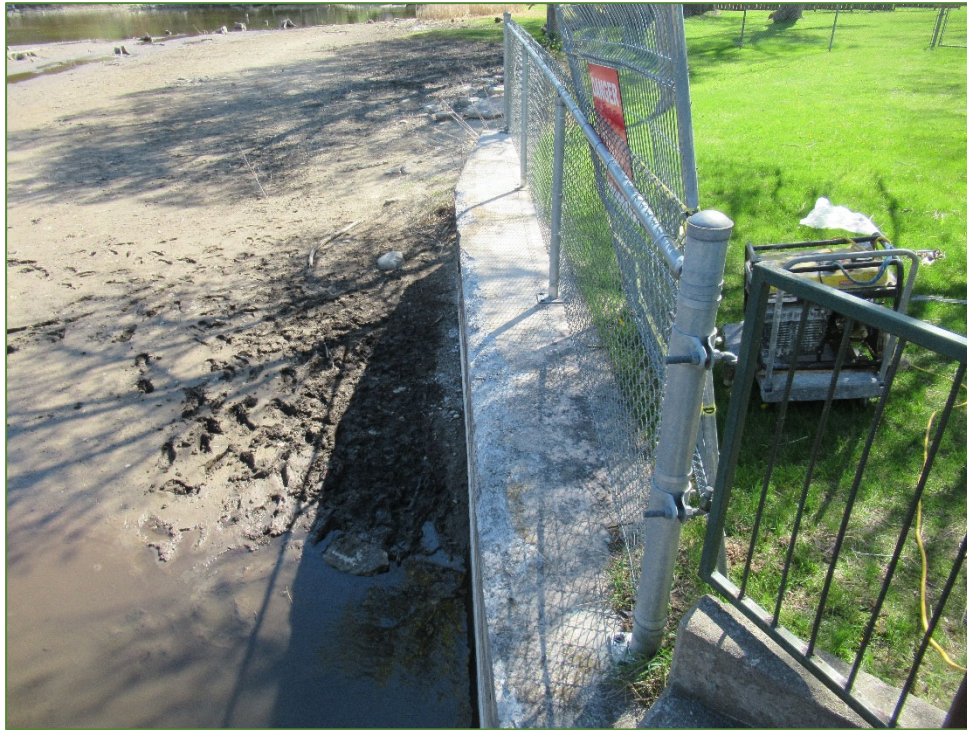
**Photo P15 West Abutment and Retaining Wall – Top Face** (spall and light scaling)

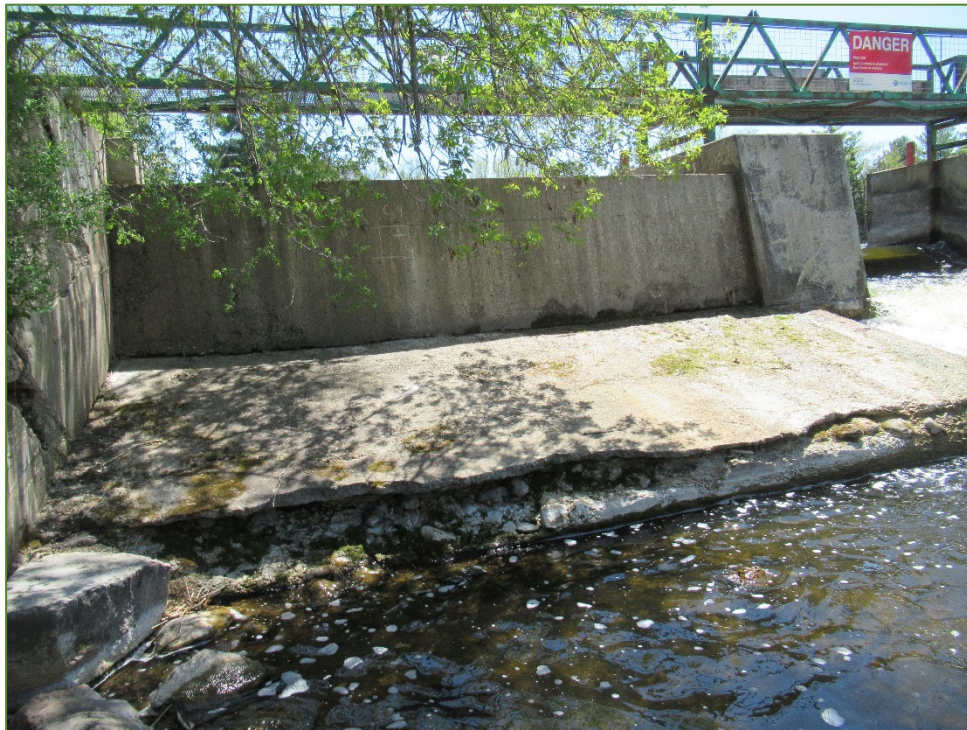
**Photo P16 East Weir and Apron Slab, North Elevation** (fair to poor condition – cracks, spall, delamination, honeycombing and light to medium scaling)

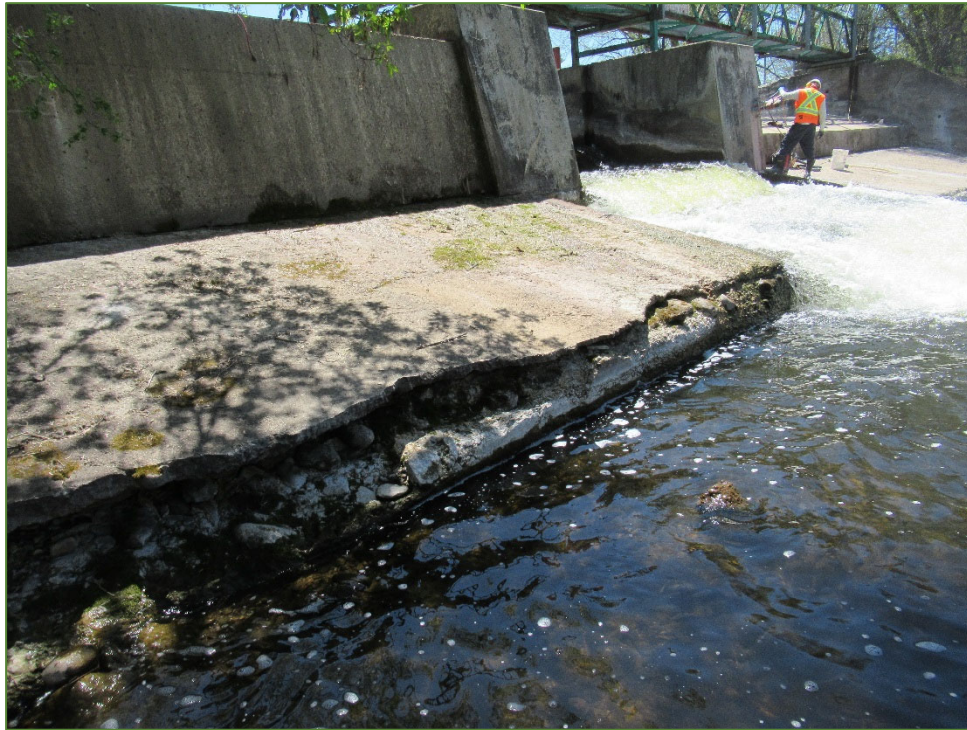
**Photo P17 East Weir and Apron Slab, North Elevation** (spall, delamination and medium scaling)

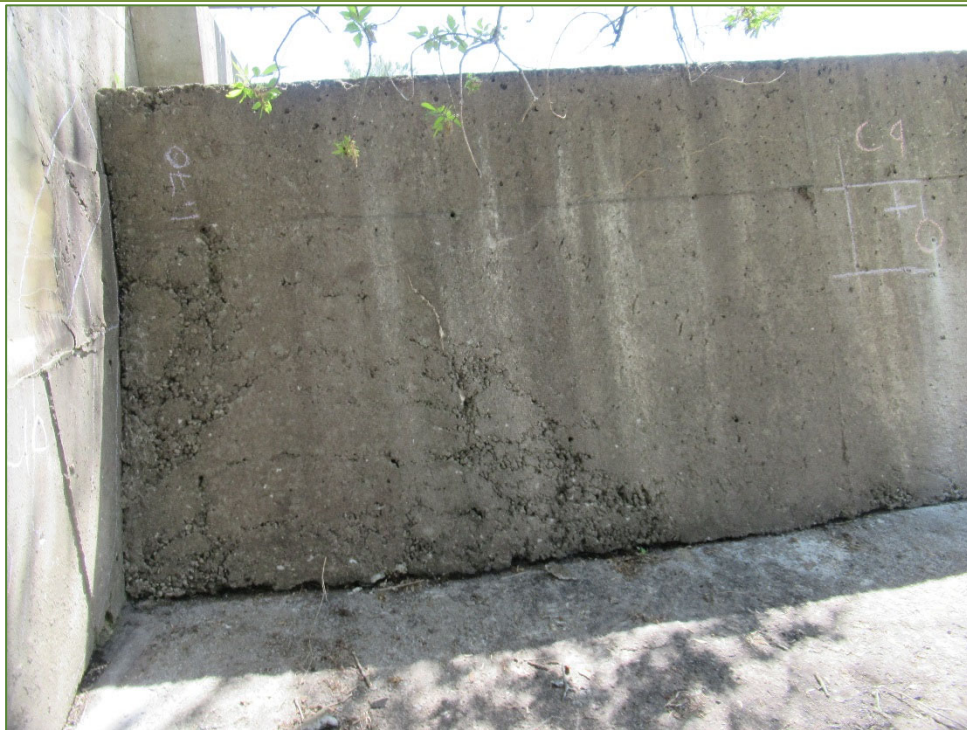
**Photo P18 East Weir, North Elevation** (cracks, spall and honeycombing)

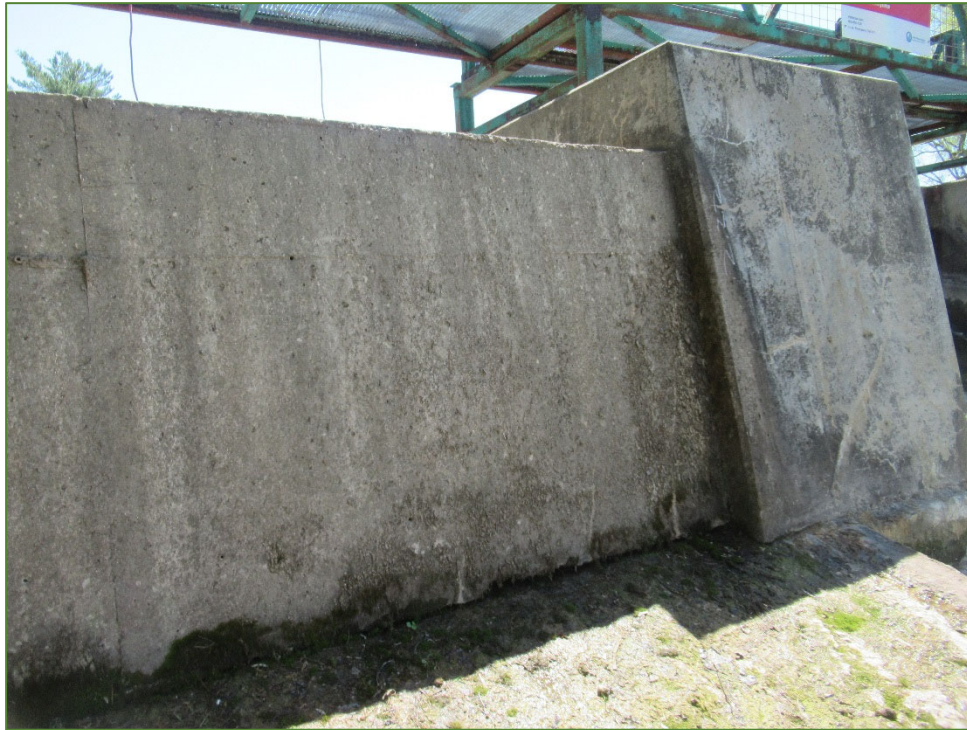
**Photo P19 East Weir, North Elevation** (light to medium scaling)

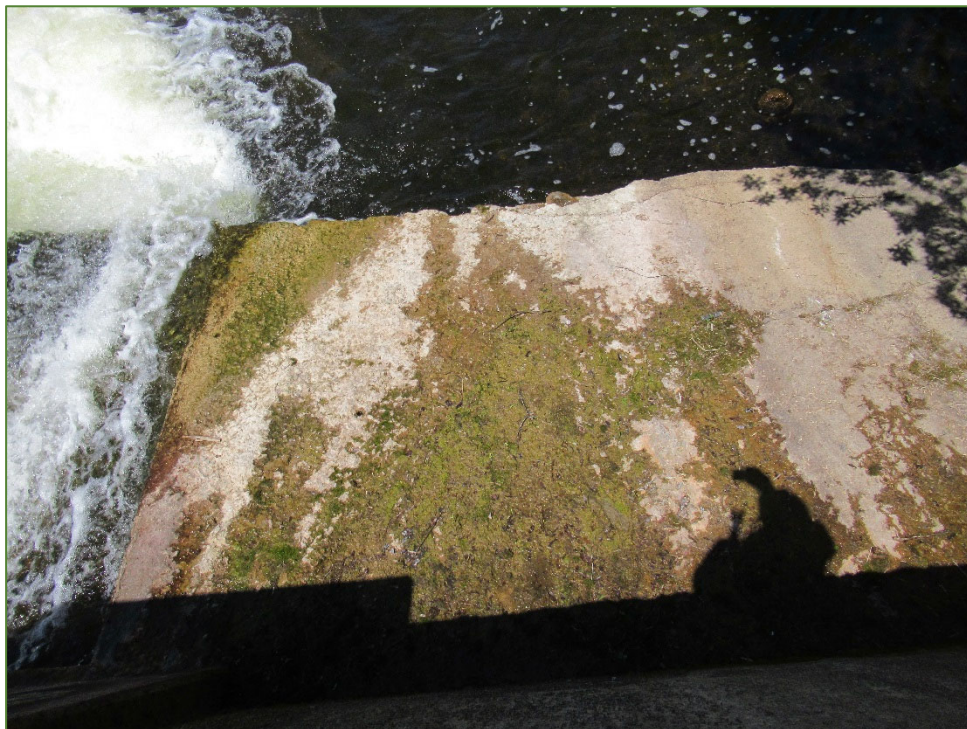
**Photo P20 East Apron Slab Plan** (cracks, spall and light scaling and staining)

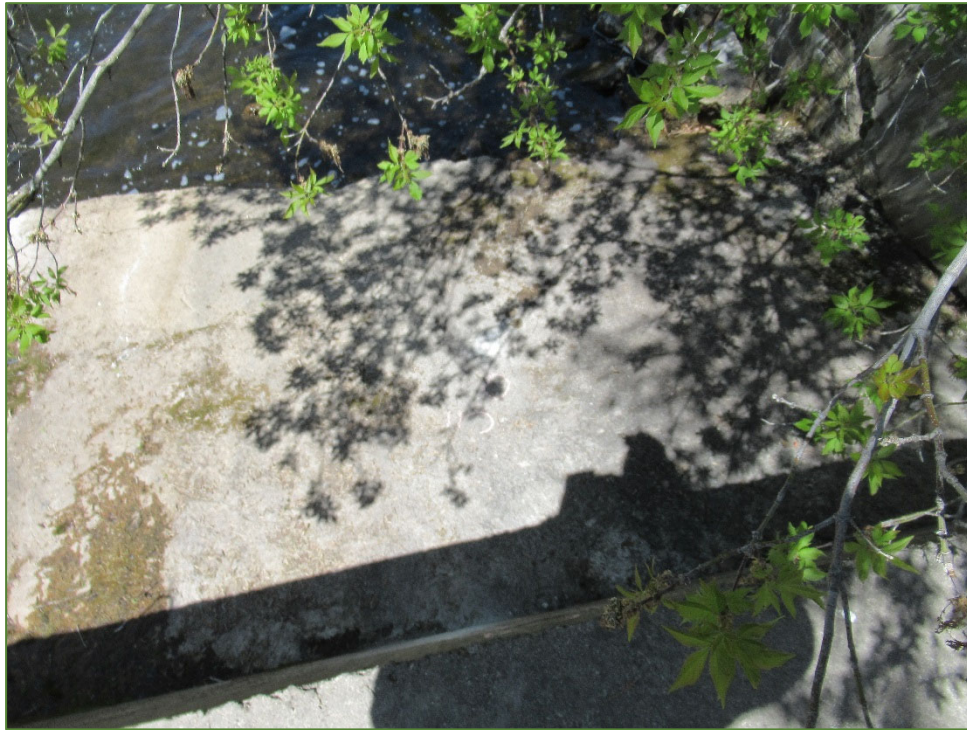
**Photo P21 East Apron Slab Plan** (cracks, spall and light scaling and staining)

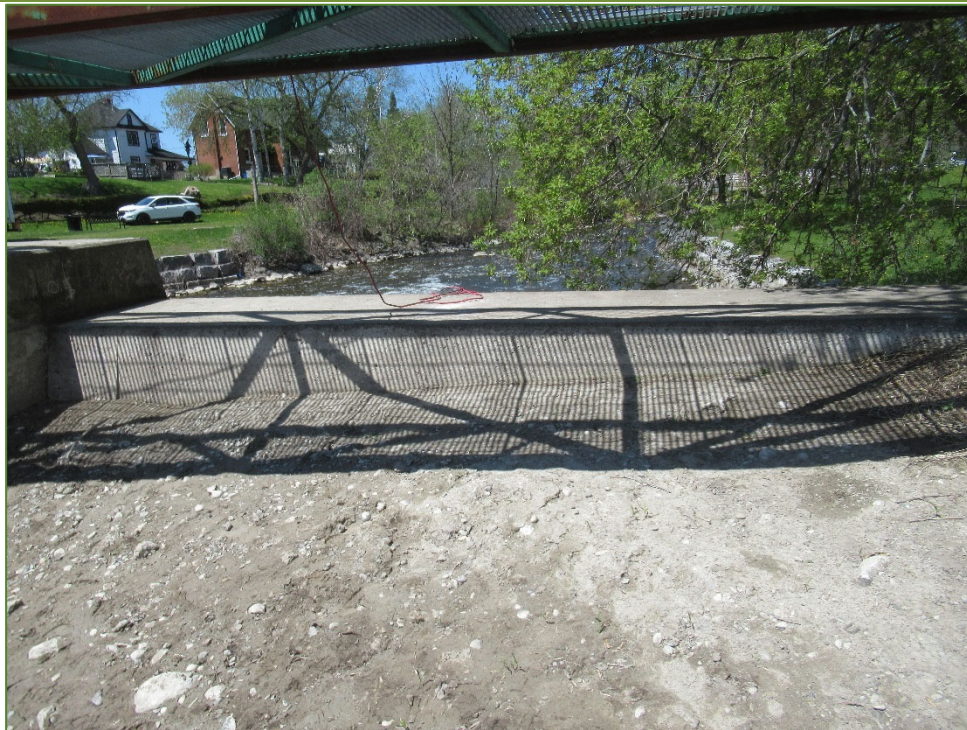
**Photo P22 East Weir – South Elevation** (good condition – light scaling)

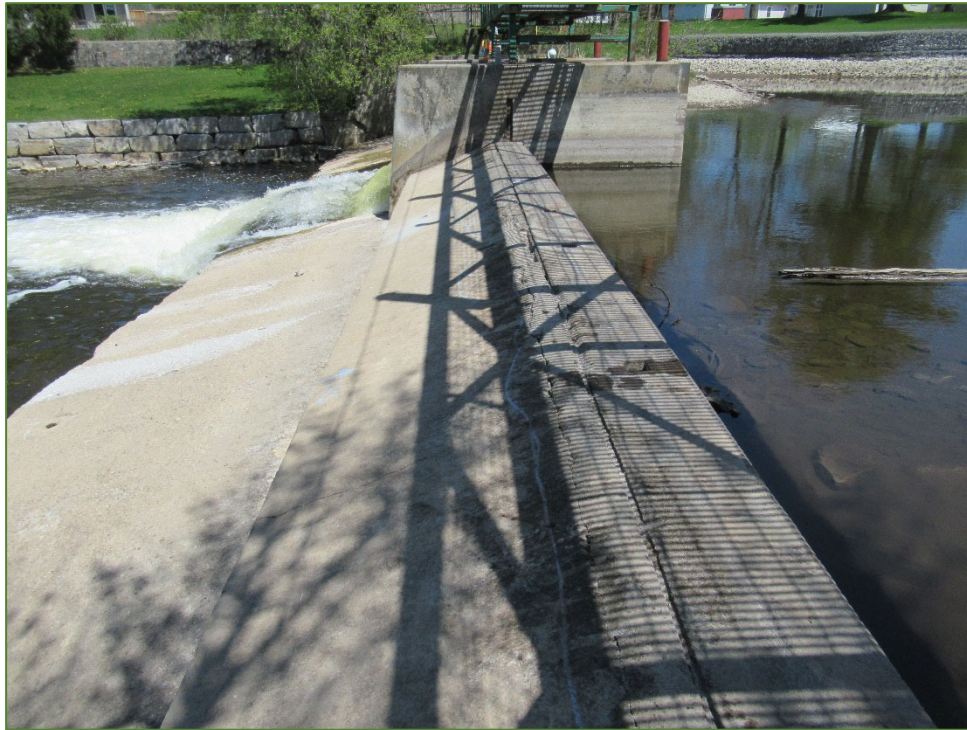
**Photo P23 West Weir and Apron Slab Plan** (poor condition – wide cracks, spall, delamination and light to medium scaling)

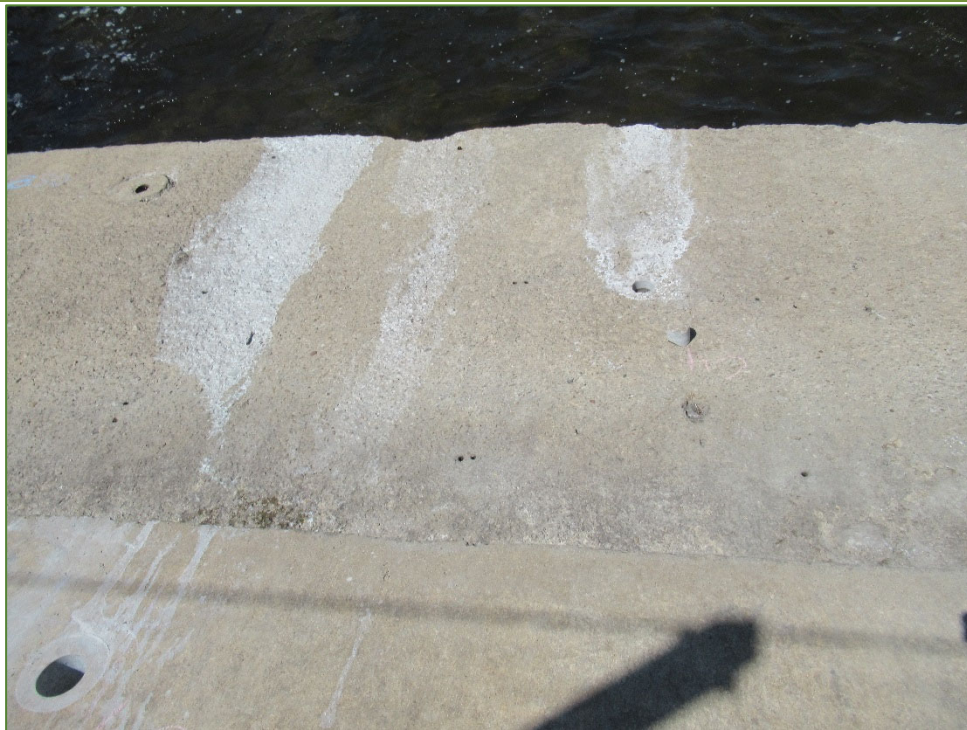
**Photo P24 West Apron Slab Plan** (spall and medium scaling)
