## **Structural Design Memorandum**

### **Pefferlaw Dam**

**Town of Georgina  
Regional Municipality of York**

**D.M. Wills Project Number 19-5381**

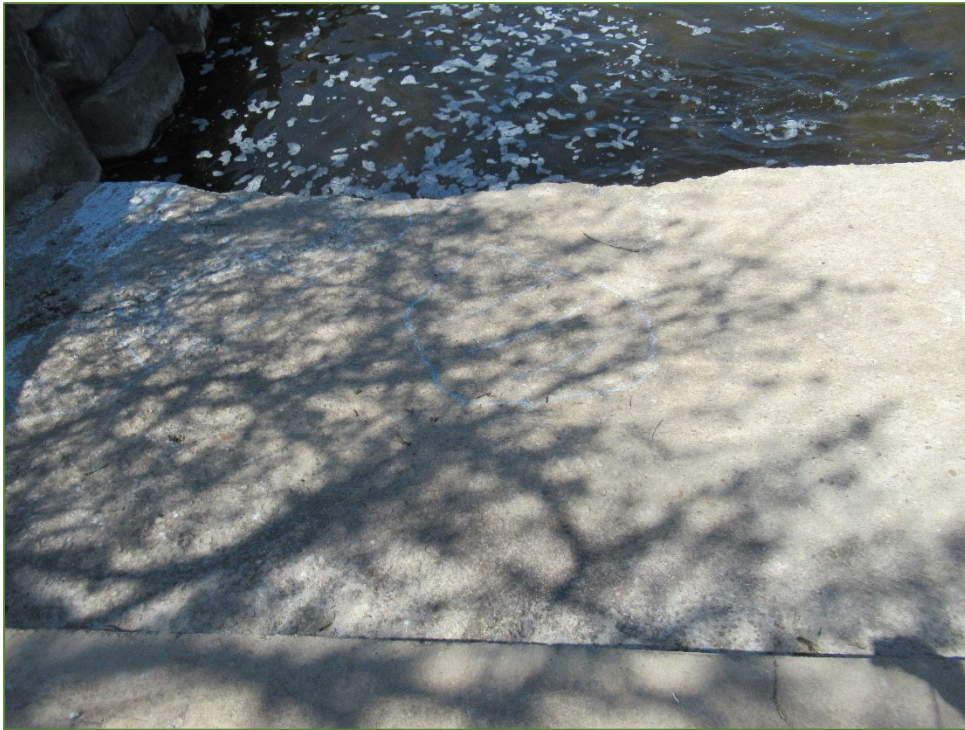
**Photo P25 West Apron Slab Plan** (spall, delamination and medium scaling)

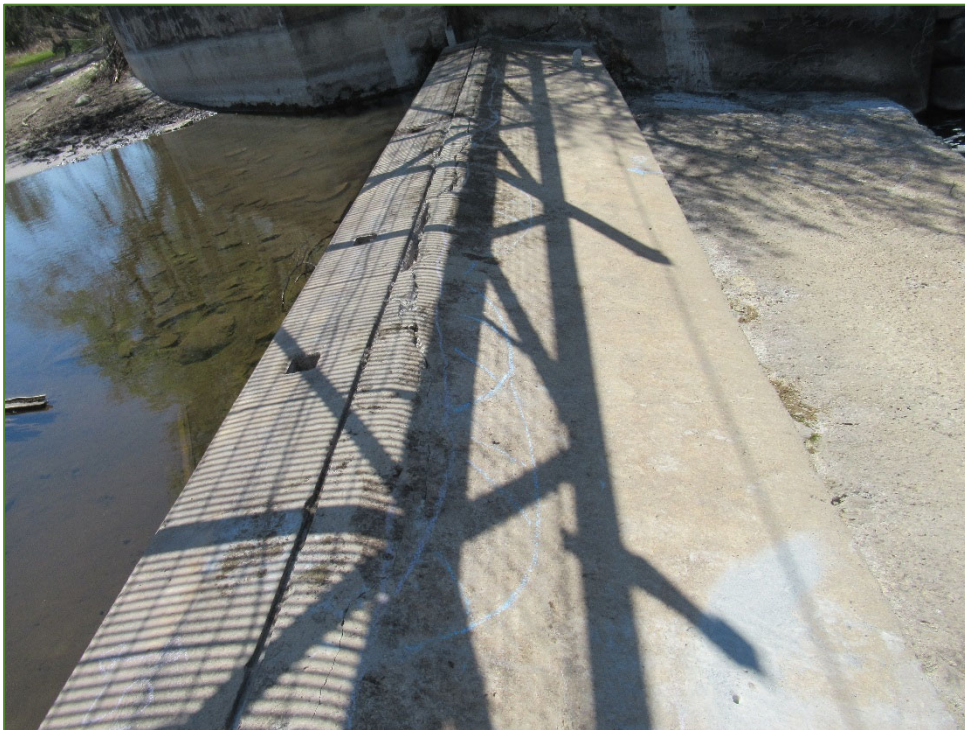
**Photo P26 West Weir Plan** (wide cracks, spall and delamination)

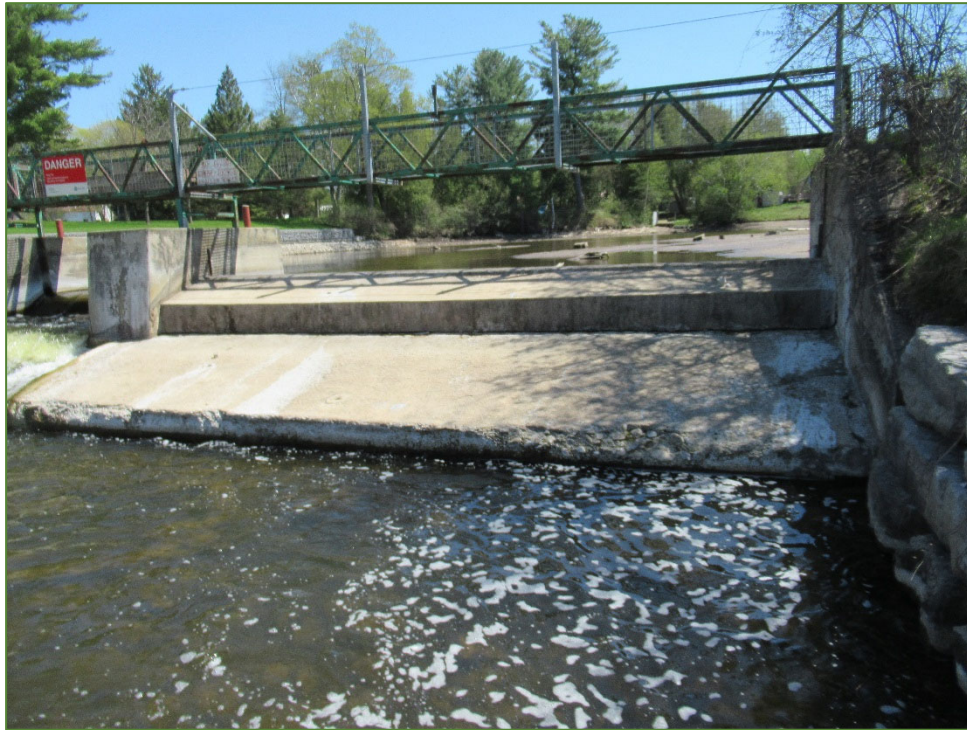
**Photo P27 West Weir and Apron Slab – North Elevation** (fair to poor condition – spall and medium scaling)

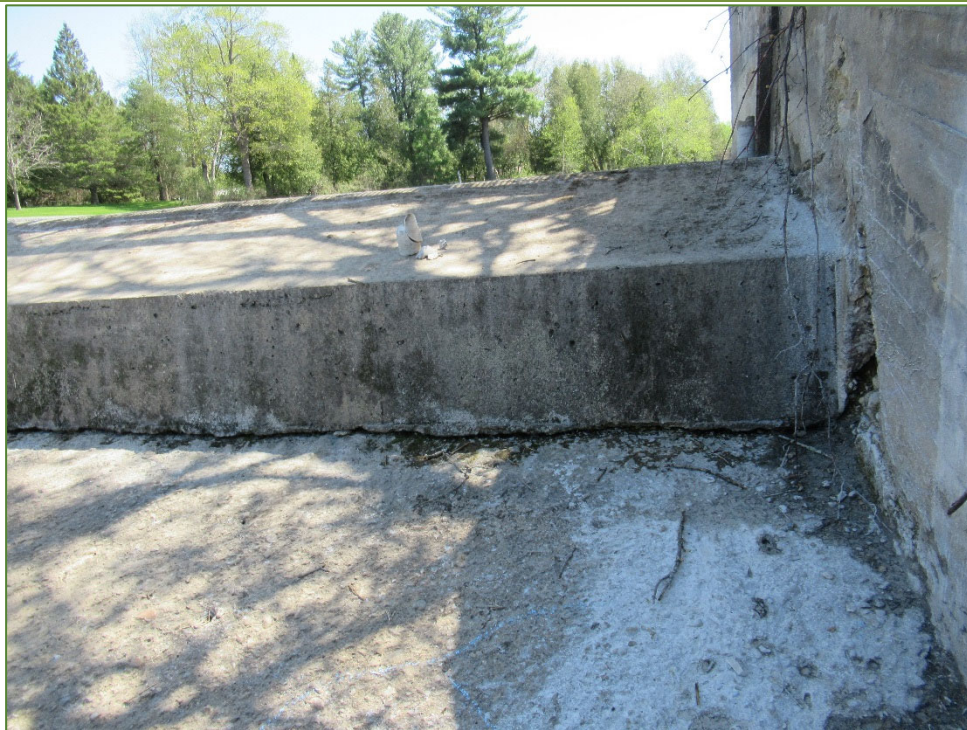
**Photo P28 West Weir and Apron Slab – North Elevation** (spall, delamination and medium scaling) note, undermining

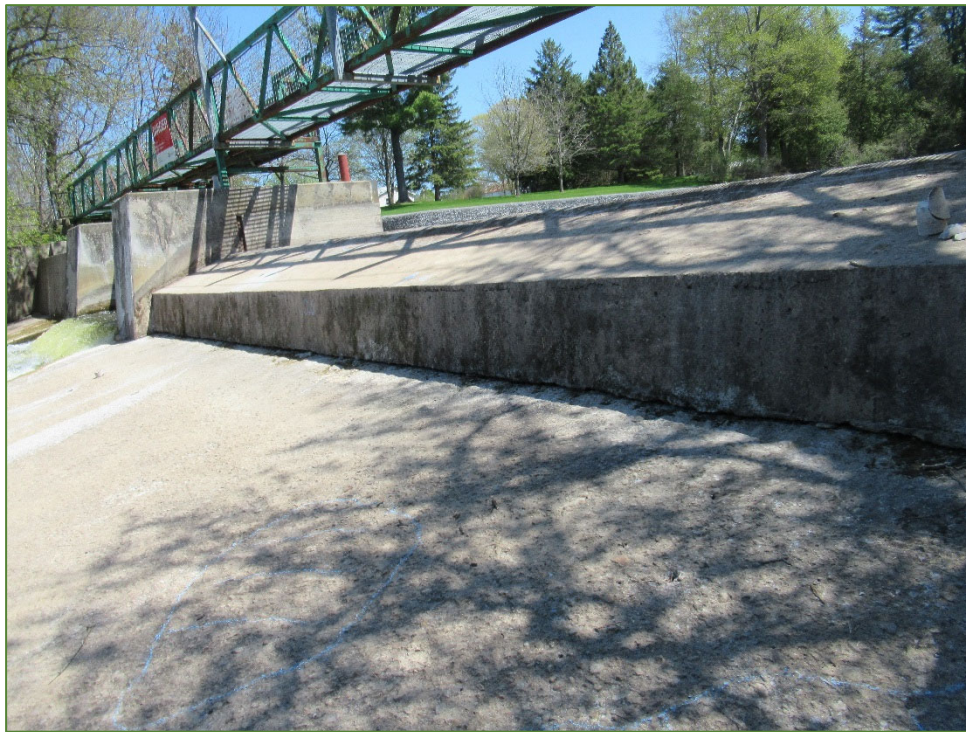
**Photo P29 West Weir and Apron Slab – North Elevation** (spall, delamination and medium scaling) note, undermining

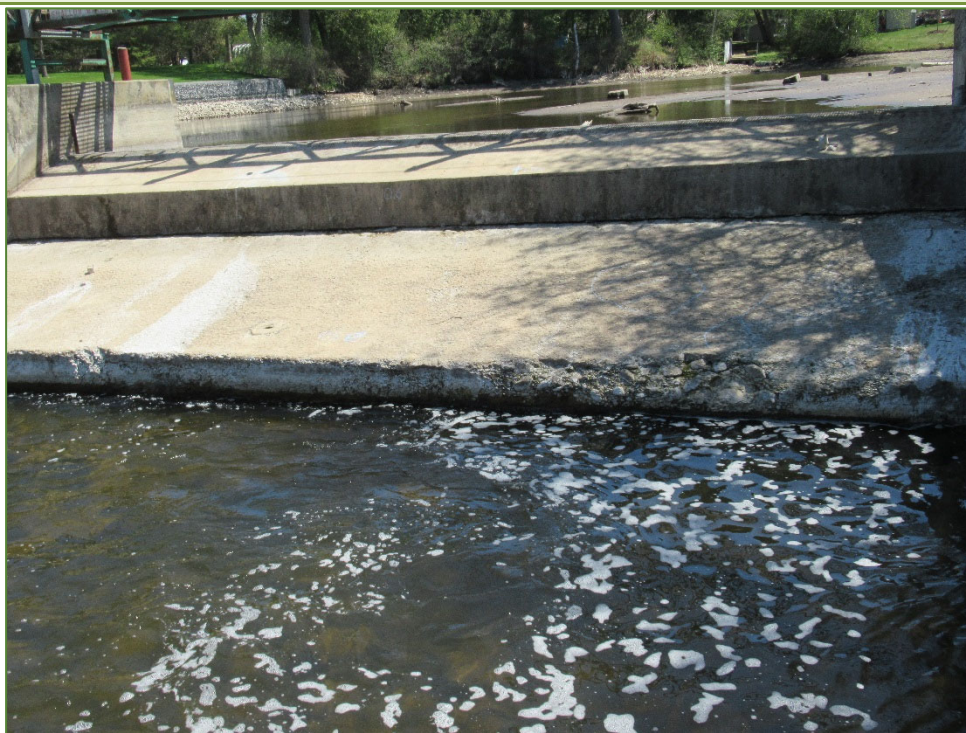
**Photo P30 West Weir and Apron Slab – North Elevation** (spall and medium scaling)

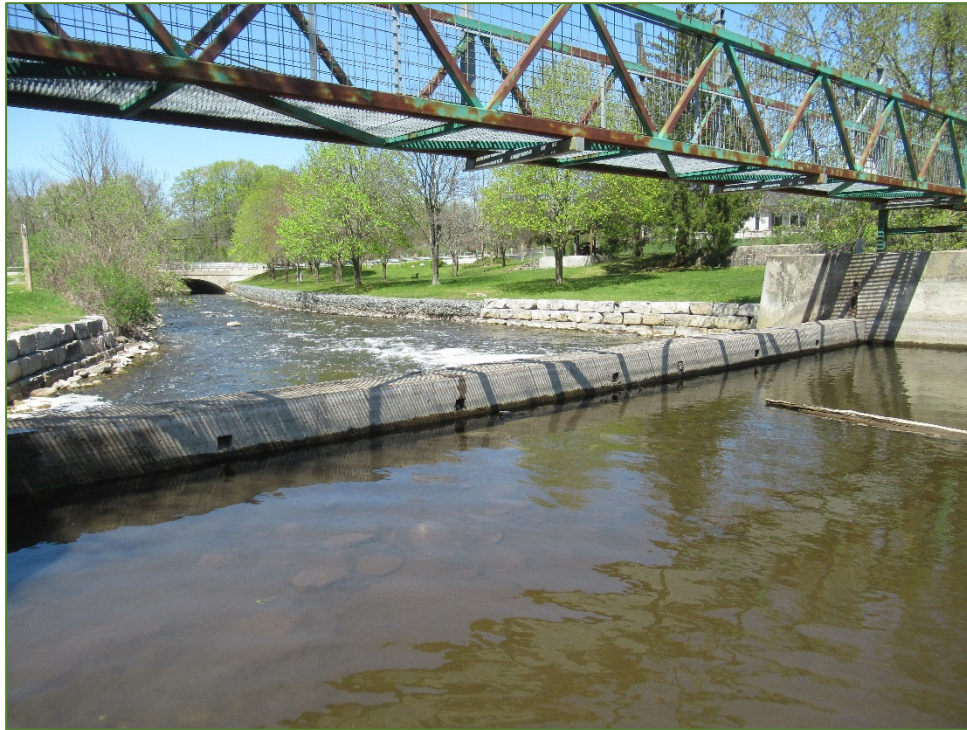
**Photo P31 West Weir – South Elevation** (good condition – spall and light scaling)

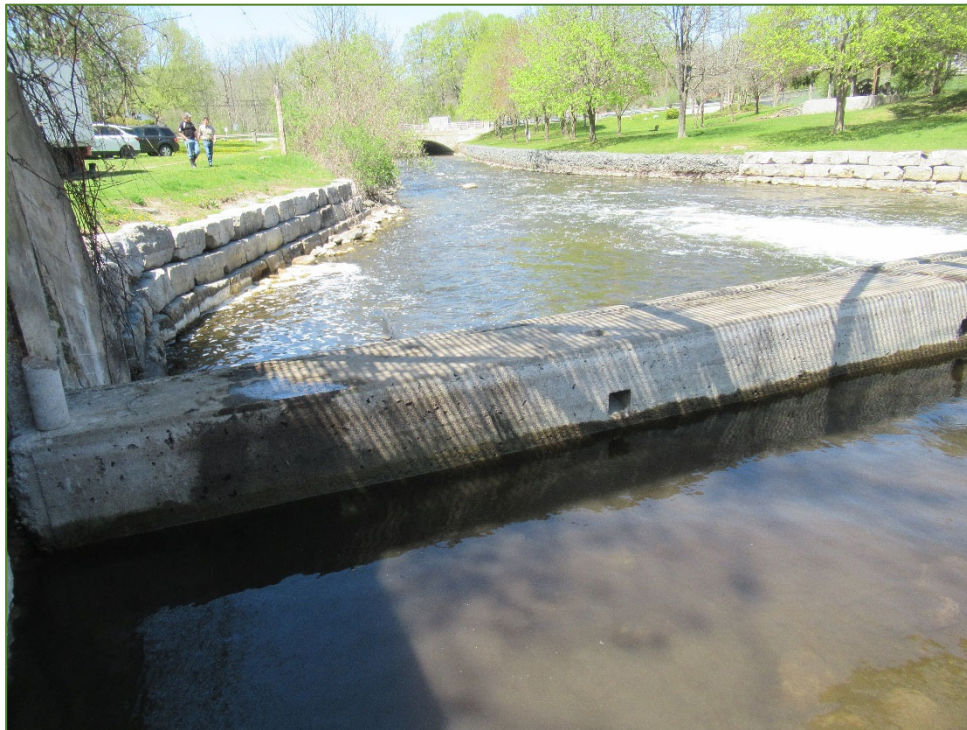
**Photo P32 West Weir – South Elevation** (spall and light scaling)

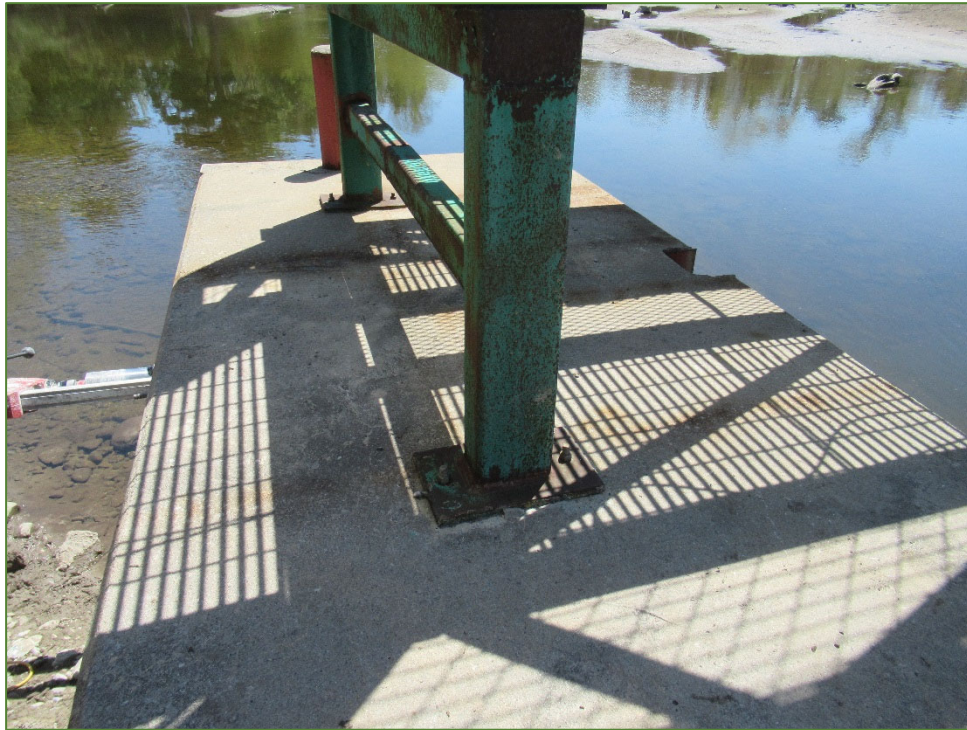
**Photo P33 East Pier – Top Face** (good condition – cracks and light scaling)

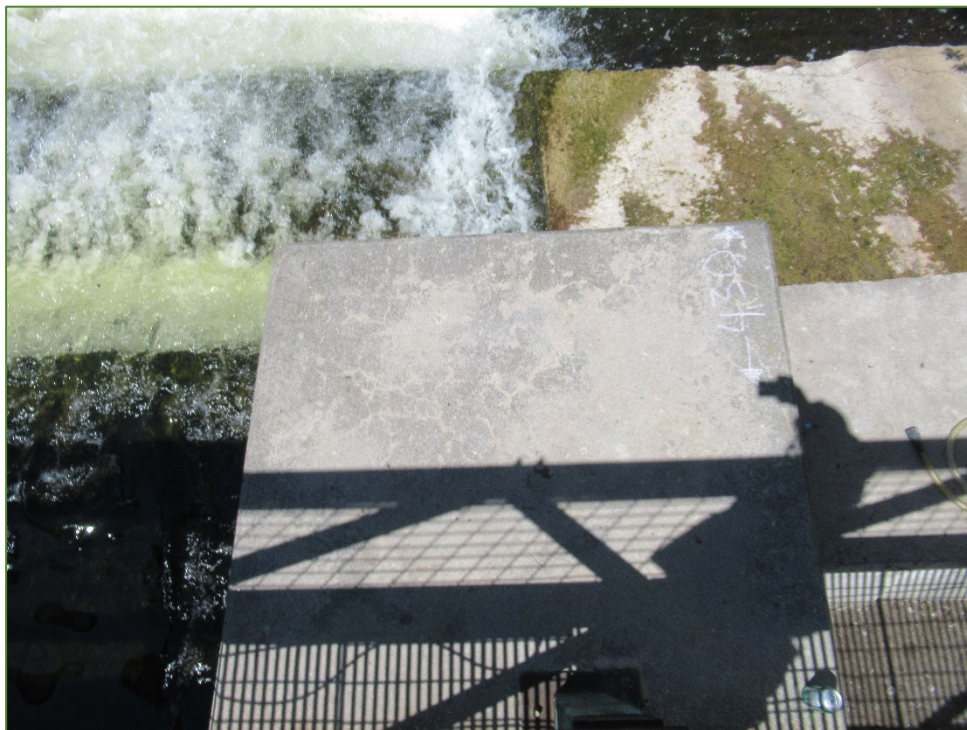
**Photo P34 East Pier – Top Face** (cracks)

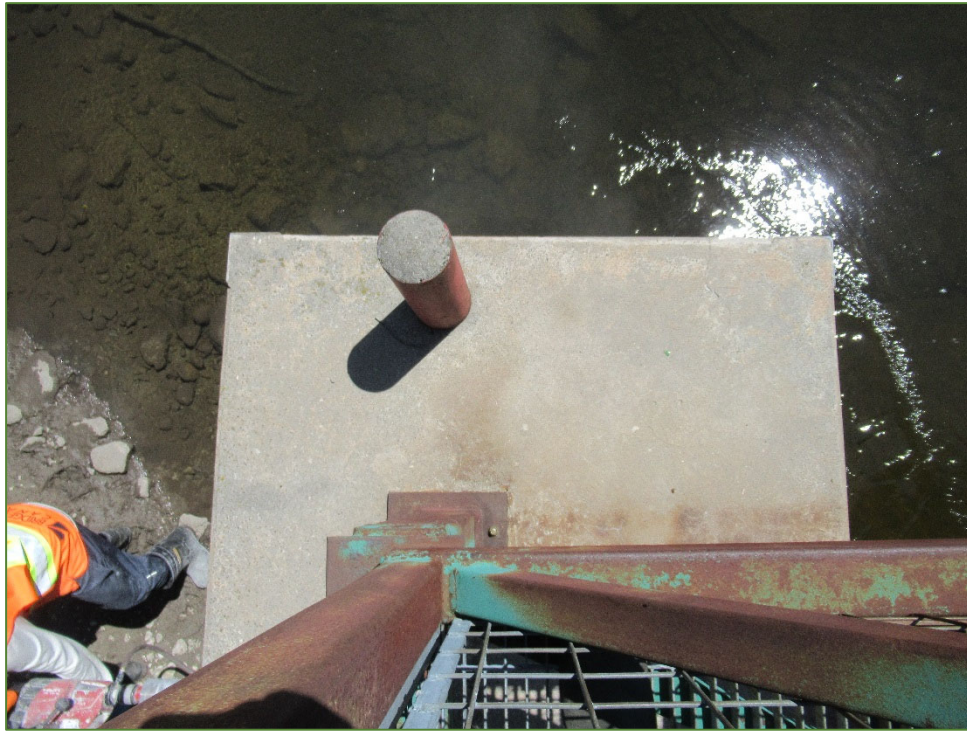
**Photo P35 East Pier – Top Face** (cracks and staining)

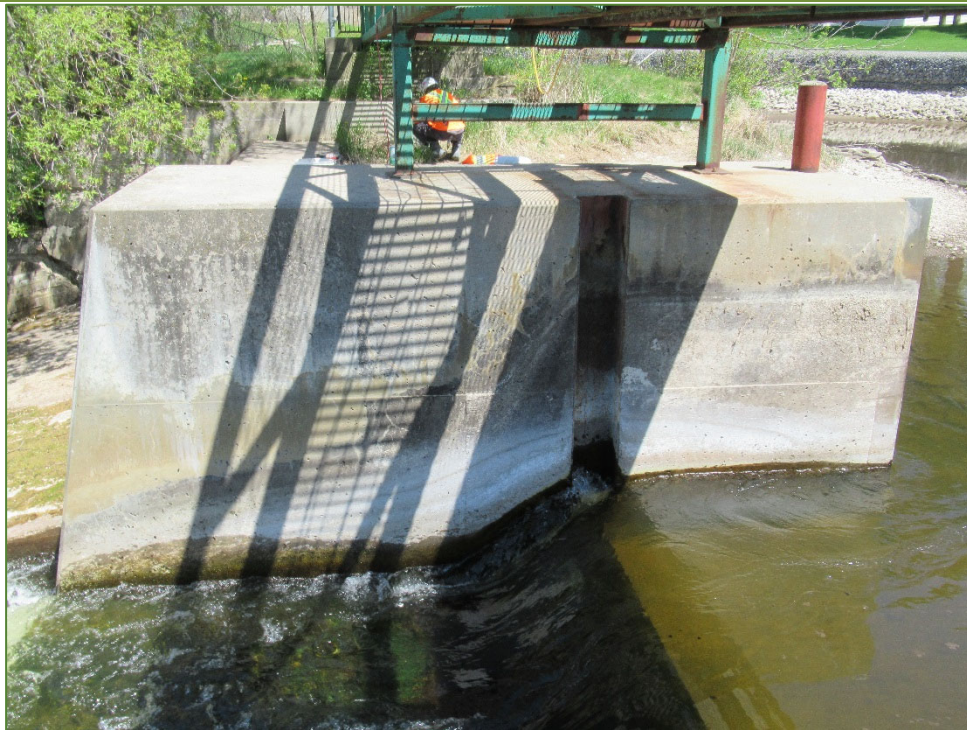
**Photo P36 East Pier – West Face** (fair to good condition – cracks, light scaling and wet stain)

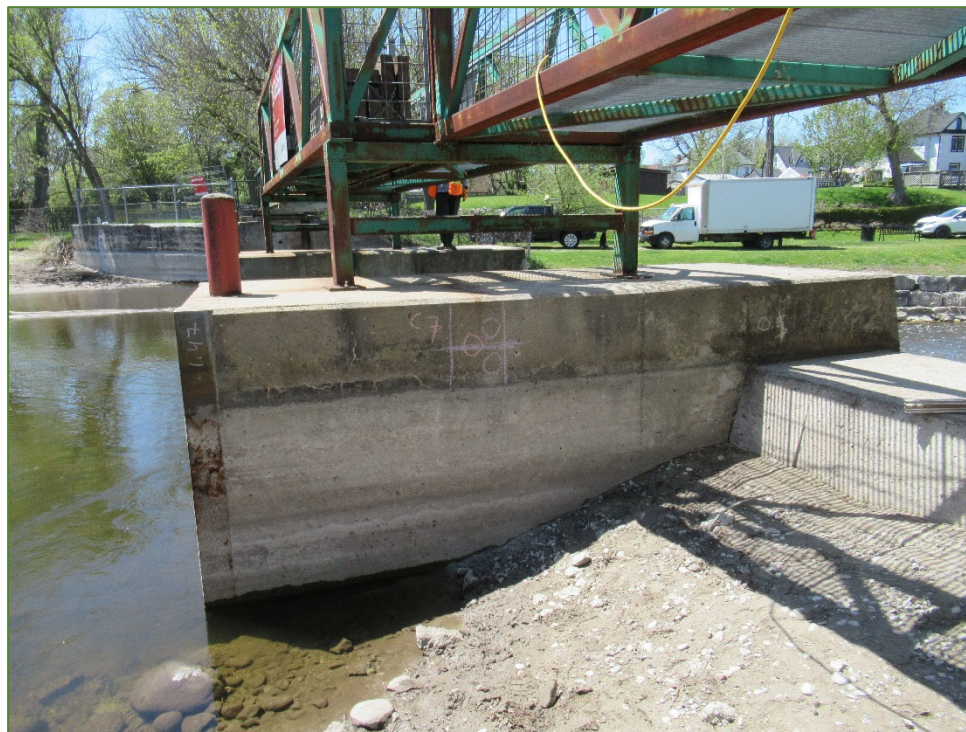
**Photo P37 East Pier – East Face** (fair to good condition – cracks, light scaling and wet stain)

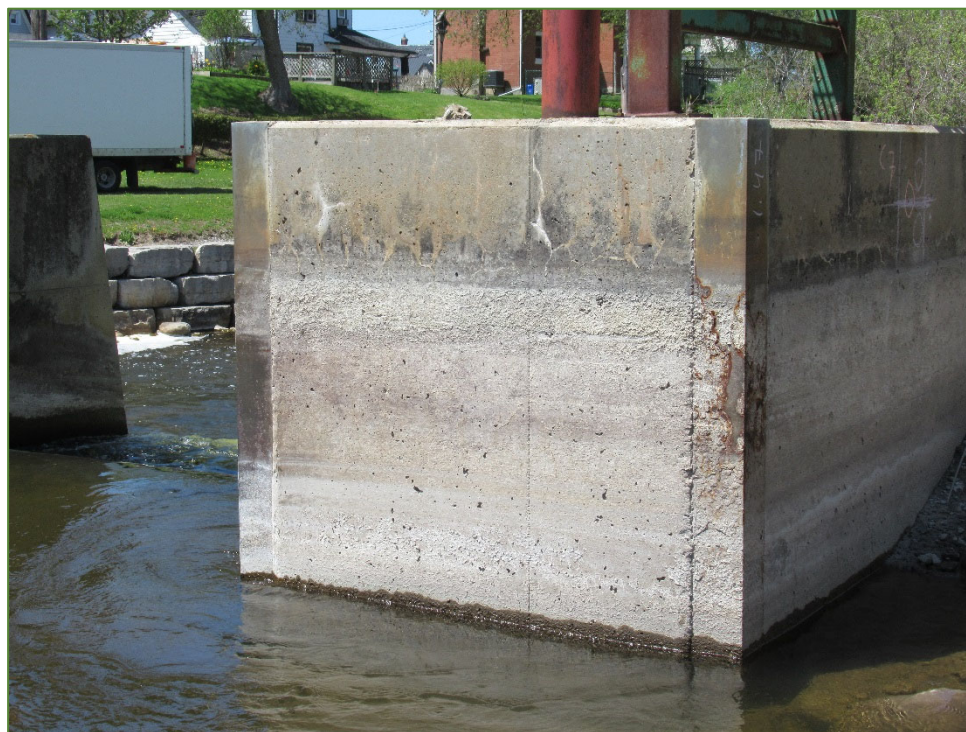
**Photo P38 East Pier – South Face** (fair to good condition - cracks, light scaling and wet stain )

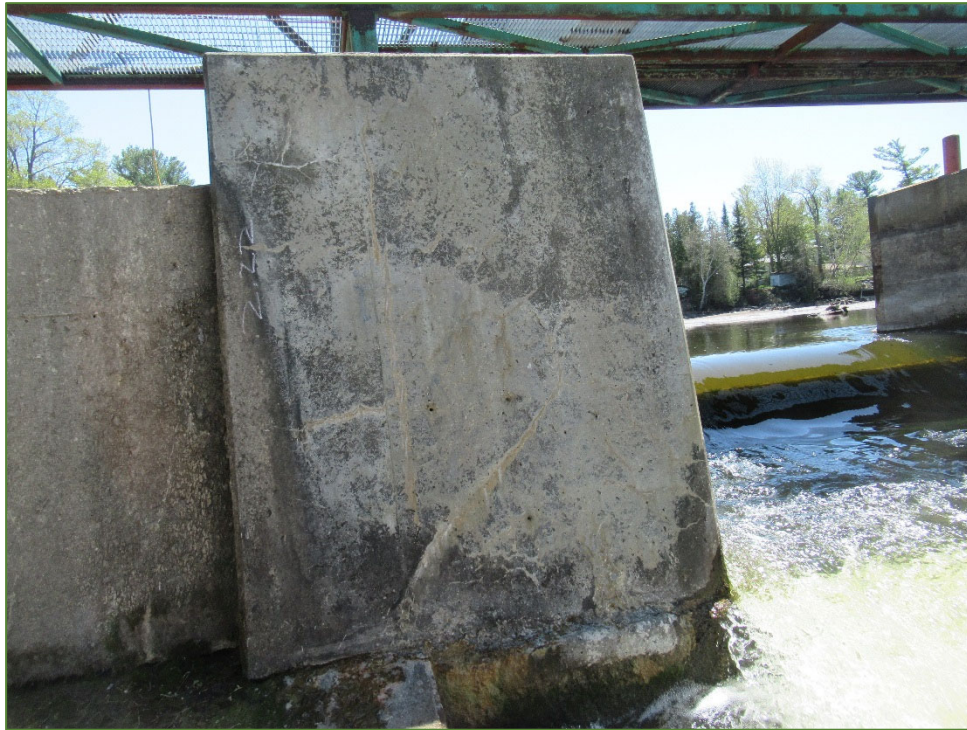
**Photo P39 East Pier – North Face** (fair condition - cracks, medium scaling and wet stain)

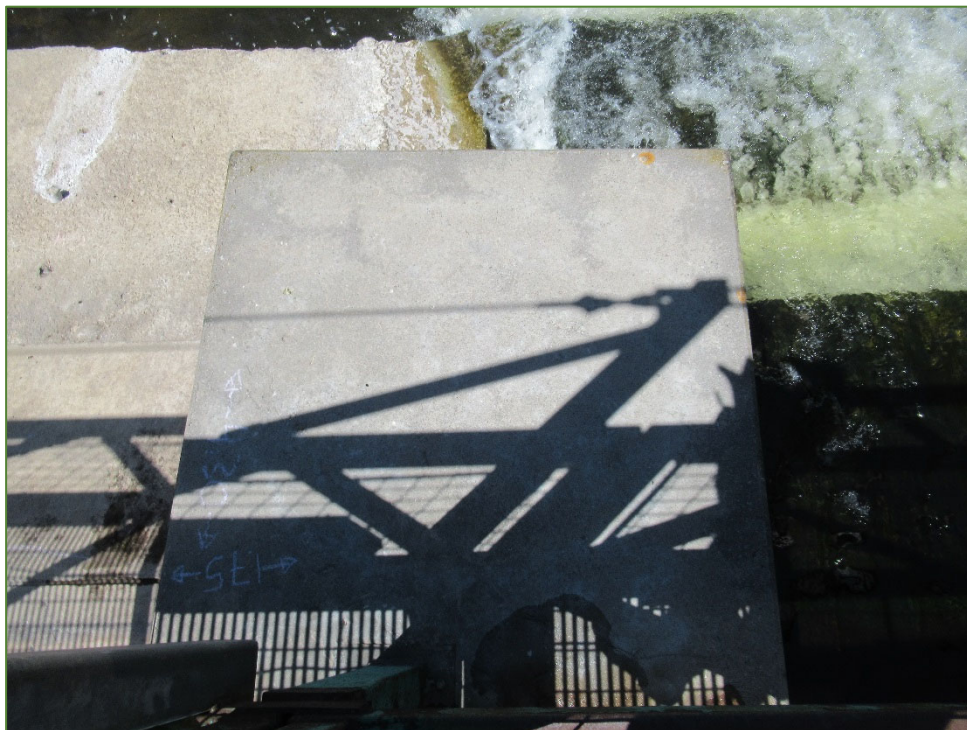
**Photo P40 West Pier – Top Face** (good condition - cracks and light scaling)

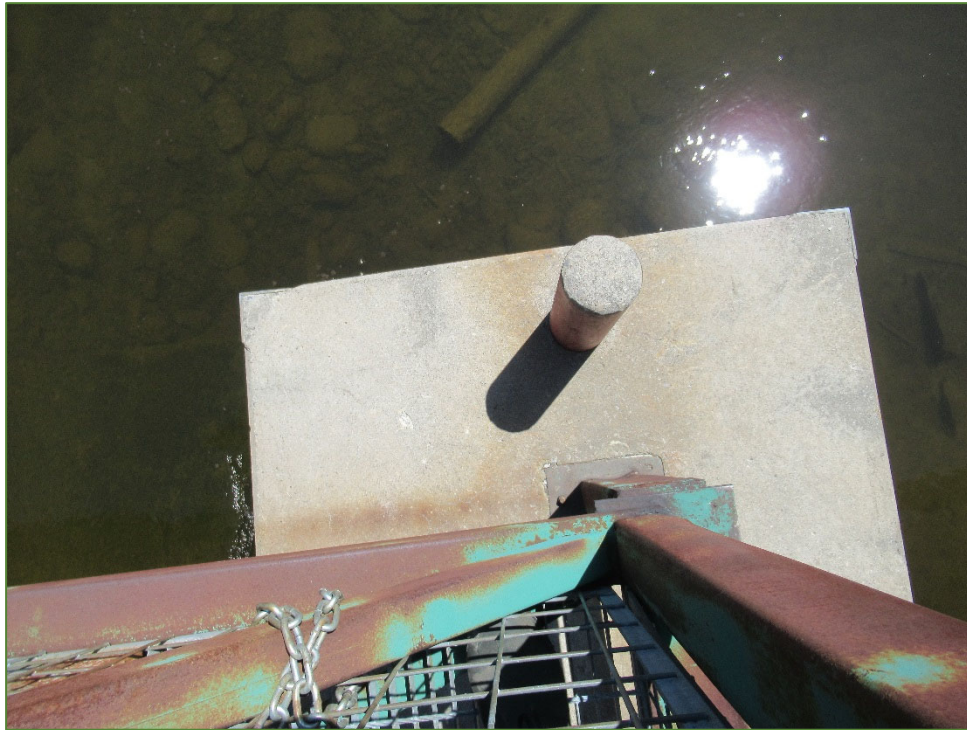
**Photo P41 West Pier – Top Face (light scaling)**

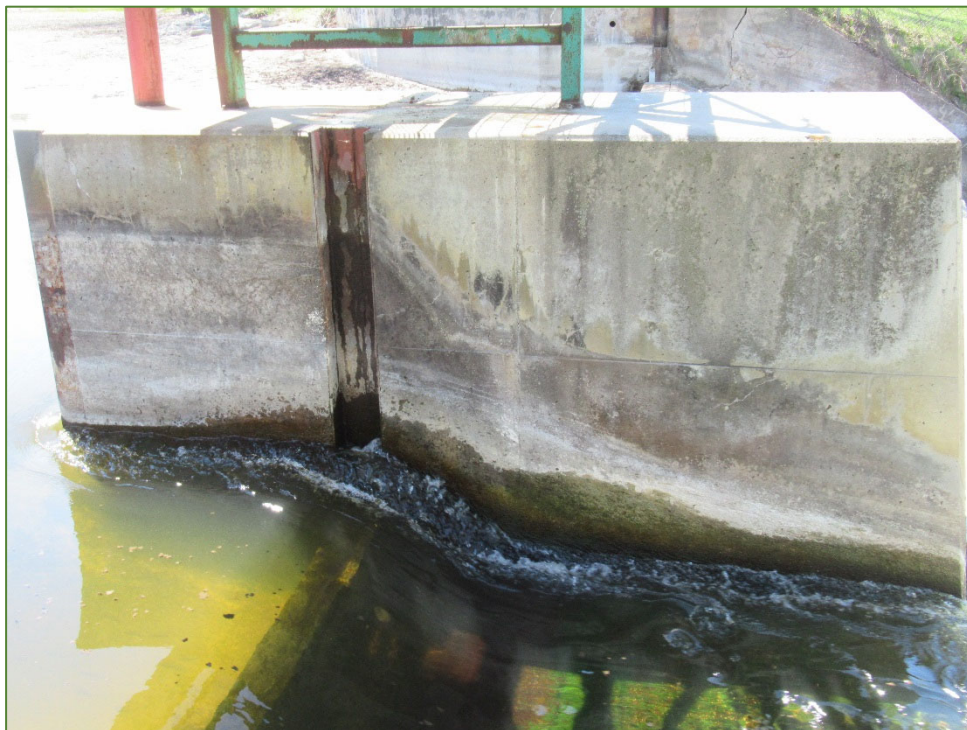
**Photo P42 West Pier – East Face (fair to good condition – cracks, light scaling and wet stain)**

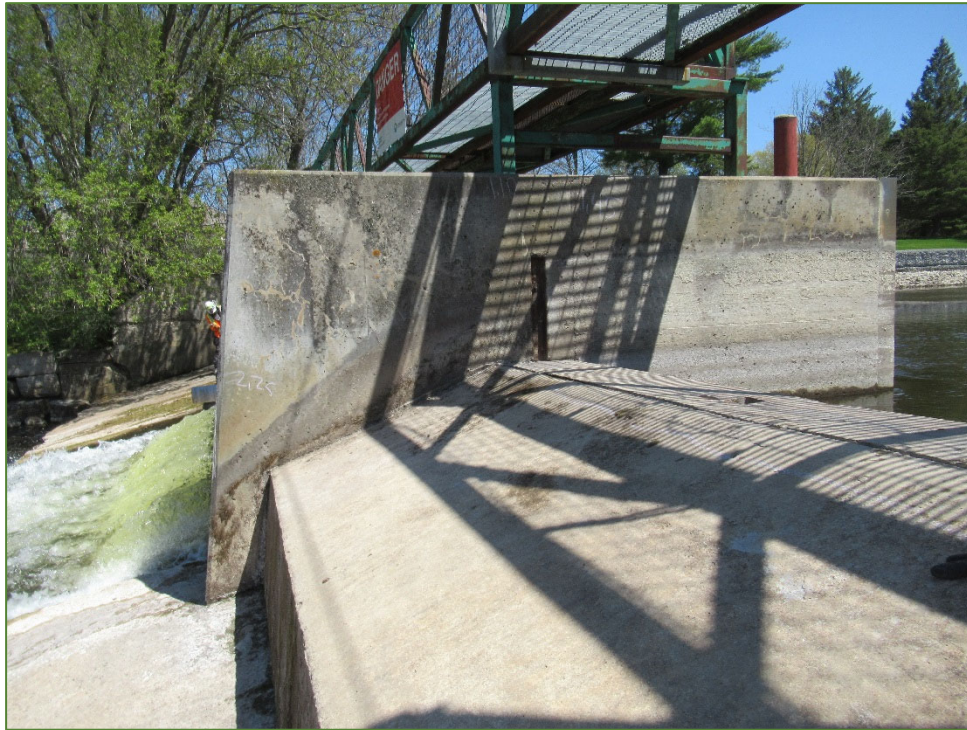
**Photo P43 West Pier – West Face** (fair to good condition – cracks, light scaling and wet stain)

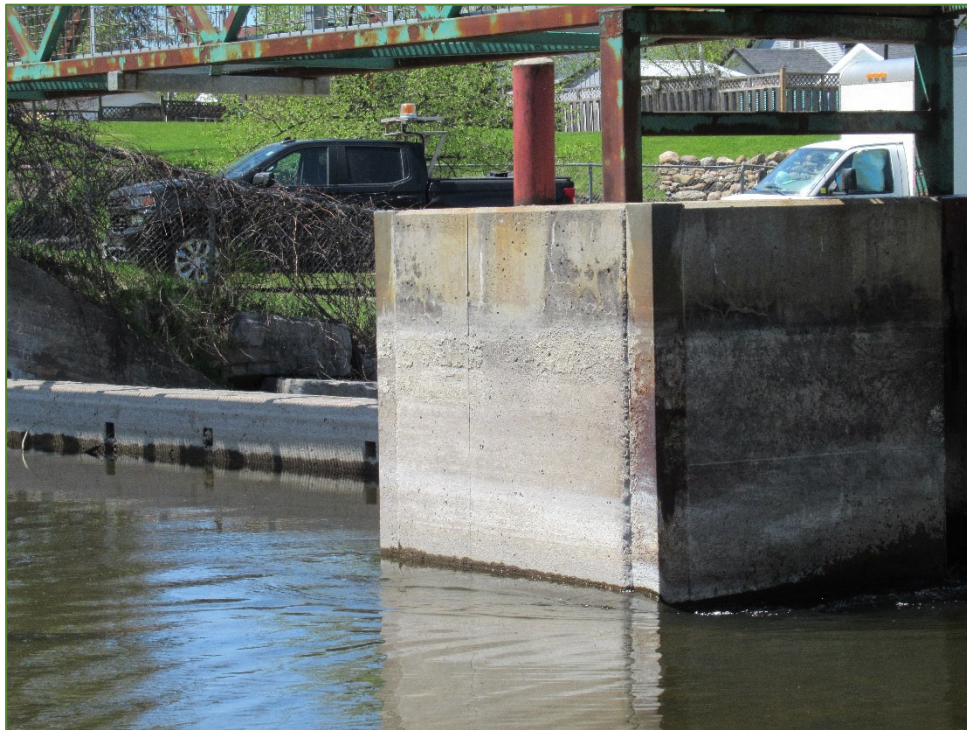
**Photo P44 West Pier – South Face** (fair to good condition – cracks, light scaling and wet stain)

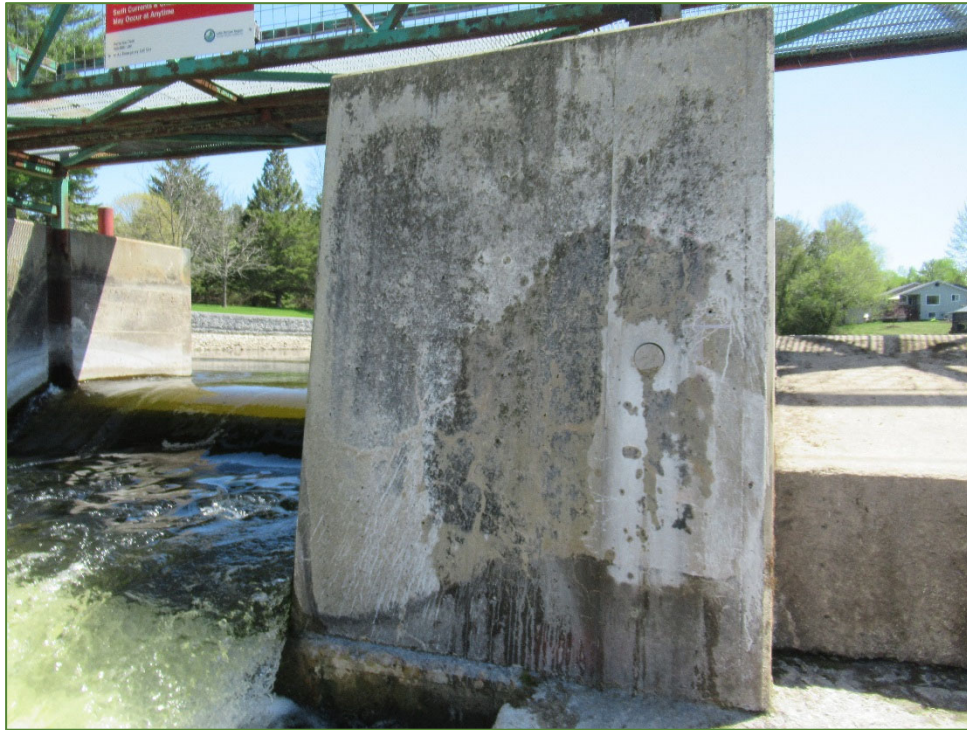
**Photo P45 West Pier – North Face** (fair to good condition – cracks, light scaling and wet stain)

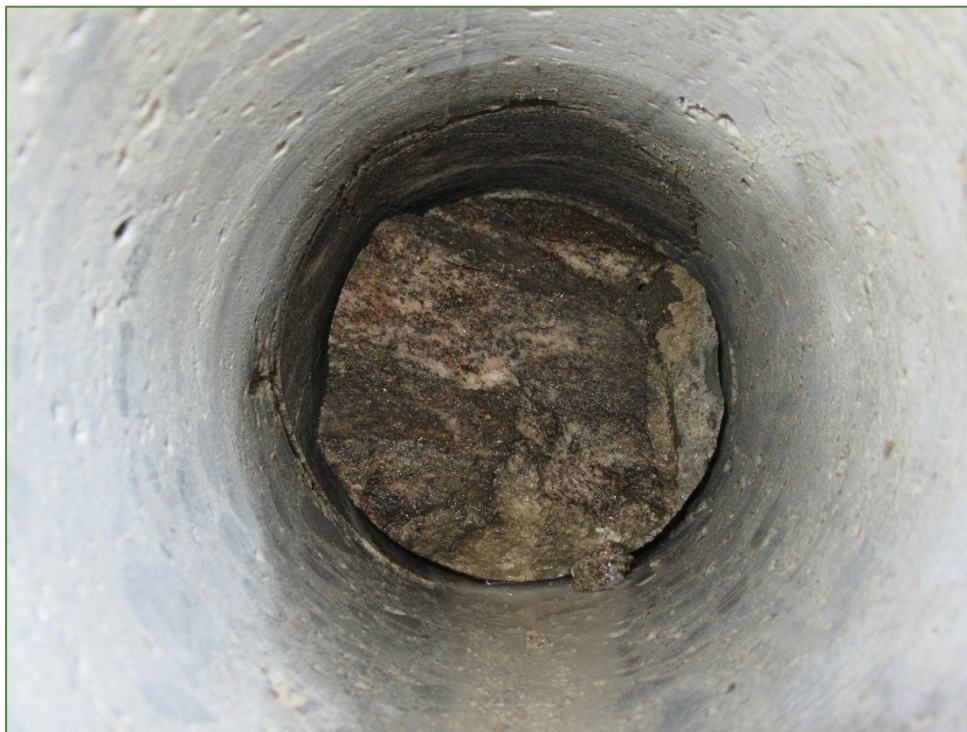
**Photo P46 Typical Condition of Inside Core – C1** (delamination)
