Final Report

**Pefferlaw Dam
Public Safety Risk Assessment**

Town of Georgina, Pefferlaw, Ontario

D.M. Wills Project Number 19-5381

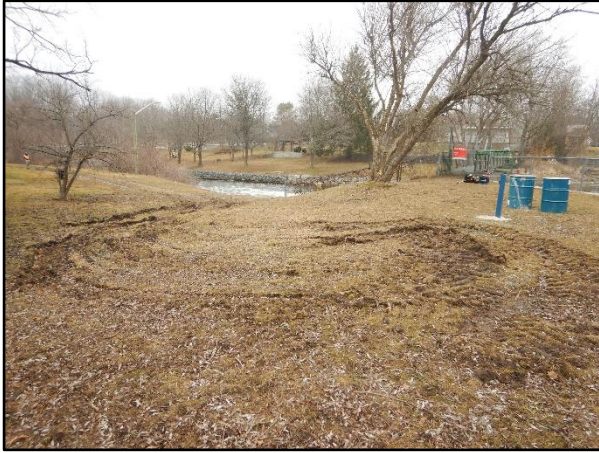
Photo 7 – West Earth Embankment

The primary hazards on the earth embankments include steep or slippery slopes and open holes or tripping. As shown in **Photo 7** and **Photo 8**, the embankments have some uneven surfaces (tripping) and could be slippery under certain conditions.

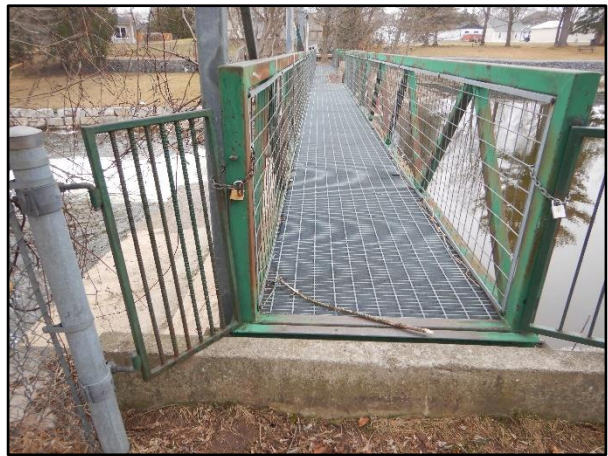
Photo 12 – Pedestrian Crossing

There are two main dam components that contribute to the potential hazards in this component area, the deck of the stoplog sluiceway and the earth embankments. The deck of the stoplog sluiceway is shown in **Photo 12** and **Photo 13** and the earth embankments are shown in **Photo 7** and **Photo 8**. It is noted that while public access to the bridge and dam deck was restricted at the time of our inspection, the PSRA assumes that the steel truss bridge and dam deck is open to public access, with the existing public safety measures in place, in order to assess the risk for a situation that may arise in the future.

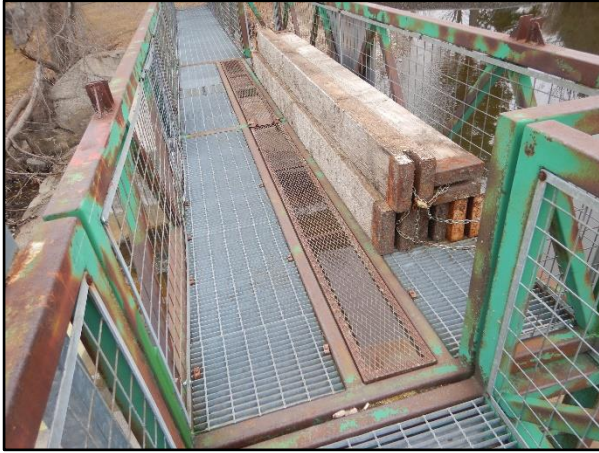
Photo 13 – Operating Deck

The potential hazard that applies to the majority of the activities within the Structure component area is falling from heights over 3 m. Adequate railings are provided on the for the majority of the steel truss bridge (**Photo 24**), and there is chain link fencing installed on the wingwalls, however, there are stoplogs stacked on the operational section of the steel truss. If climbed, the railing would not be high enough to protect against falling from heights (**Photo 13**).

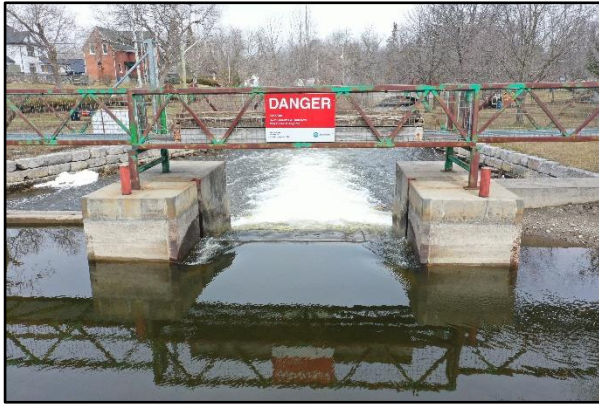
Photo 19 – Stoplog Sluiceway

There are three main dam components that contribute to the potential hazards in this component area: the stoplog sluiceway, the concrete weir with flashboards and the east concrete weir. The upstream side of the stoplog spillway, concrete weir and overflow weir are shown, under spring conditions, in **Photo 19**, **Photo 20** and **Photo 21**, respectively.

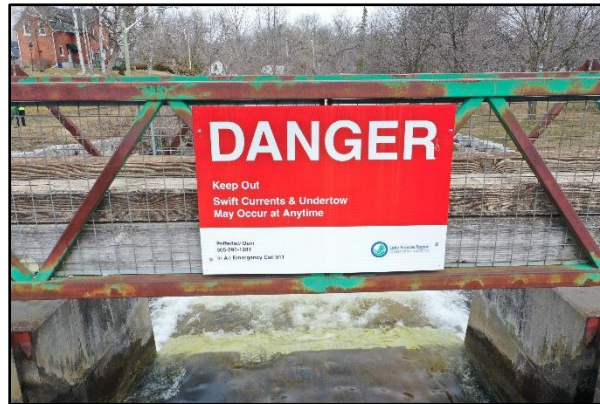
Photo 23 – Upstream Facing Public Safety Sign

- **Public Safety Signs** – There is an upstream facing public safety sign (36 inches x 53 inches) mounted to the railing on the upstream side of the concrete structure. The sign is large enough to be visible from upstream and generally meets the current recommendations for signs outlined in the Best Management Practices for Public Safety Around Dams (MNR, 2011). The sign includes the LSRCA's logo and phone number and directs people to call "911" in the event of an emergency.
- **Operational Procedures** – The Operations Manual (LSRCA, 2022) outlines operational procedures that require dam operators to ensure that the area is clear of unauthorized persons before dam operations take place.

1. Replace the large upstream facing public safety sign with a new large “DANGER, Dam Ahead, Keep Out” sign. The new sign should be installed in accordance with the Best Management Practices for Public Safety Around Dams (MNR, 2011) and should include:

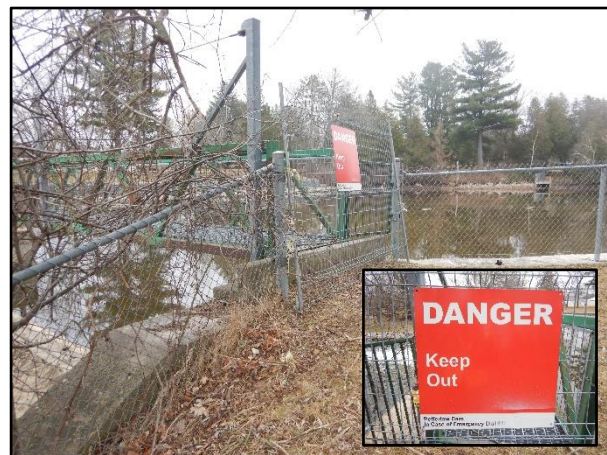
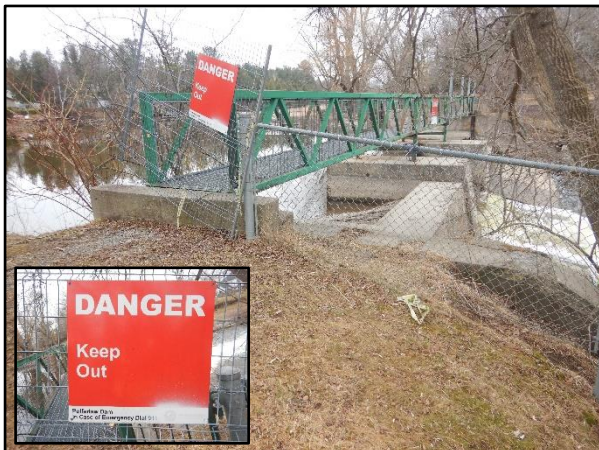
- **Public Safety Signs** – There are small (24 inch by 24 inch) public safety signs installed on the temporary fencing that blocks access to the steel truss bridge (**Photo 25** and **Photo 26**). These signs generally meet the current recommendations for signs outlined in the Best Management Practices for Public Safety Around Dams (MNR, 2011); however, the signs do not indicate the potential hazards and the LSRCA logo has been spray painted white.

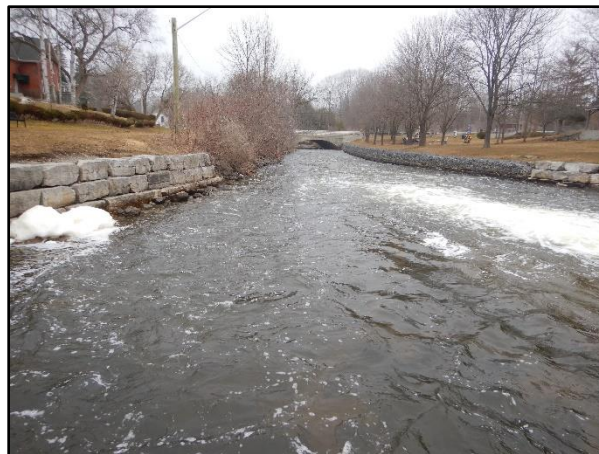
Photo 28 – Tailrace Channel and Retaining Walls

The site components that contribute to the potential hazards in this component area include the stoplog sluiceway (Photo 10 – Sluiceway **Photo 10**) and the retaining walls on both sides of the tailrace channel (**Photo 28**).

The potential hazards in the tailrace include the strong currents or undertows created by the flow through the sluiceway, steep or slippery banks and open holes or tripping. This area is easily accessible by members of the public. If members of the public access the retaining walls on both sides of the channel, they could be at risk of injury through tripping in open holes in the rocks or by encountering slippery surfaces.

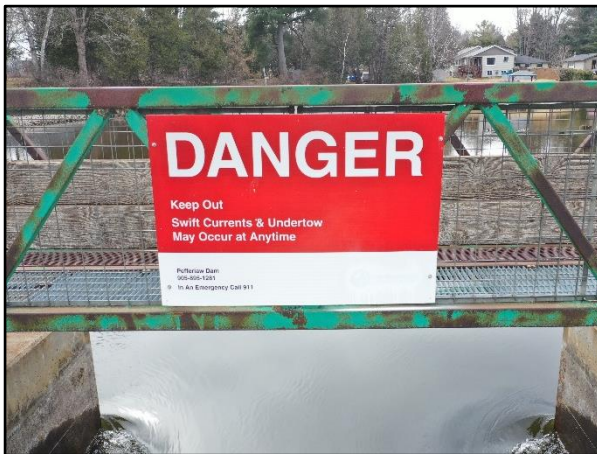
Photo 29 – Downstream Facing Public Safety Sign

- **Public Safety Signs** – There is a downstream facing public safety sign (36 inches x 53 inches) mounted to the railing on the downstream side of the concrete structure. The sign is large enough to be visible from downstream and generally meets the current recommendations for signs outlined in the Best Management Practices for Public Safety Around Dams (MNR, 2011). The sign includes the LSRCA’s phone number and directs people to call “911” in the event of an emergency. The LSRCA logo has been spray painted white.

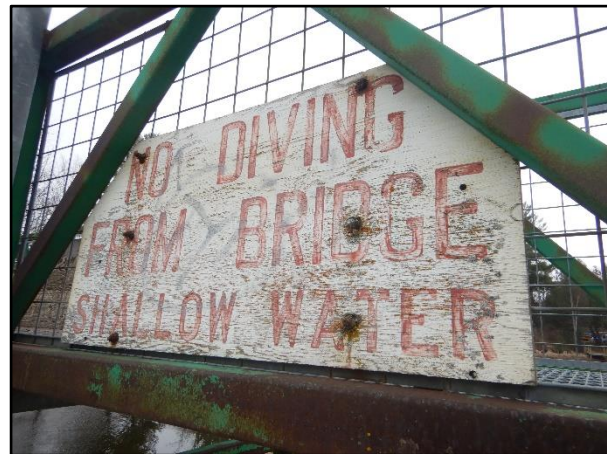
Photo 30 - Downstream Facing Public Safety Sign

standard public safety around dams sign and is in very poor condition. The signs are shown in **Photo 19** and **Photo 30**.
