Final Report

**Pefferlaw Dam
Public Safety Risk Assessment**

Town of Georgina, Pefferlaw, Ontario

D.M. Wills Project Number 19-5381

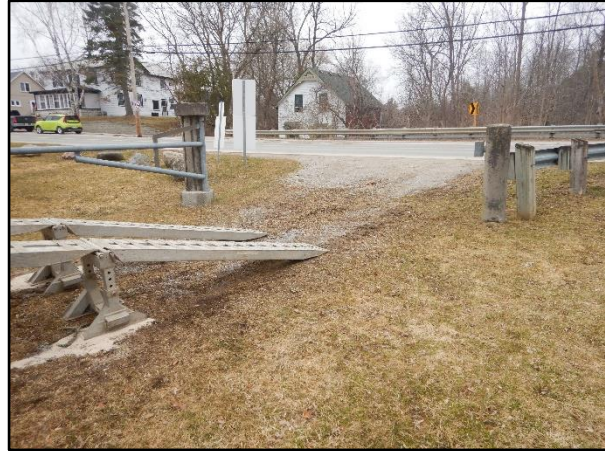
Photo 2 – Access Gate, West Side of Dam

- **Operational Procedures** – The Operations Manual (LSRCA, 2022) outlines operational procedures that require dam operators to ensure that the area is clear of unauthorized persons before dam operations take place.
- **Vehicle Barricades** – There are gates and boulders that prevent unauthorized vehicles from gaining entry to the dam site and tailrace area (**Photo 2** and **Photo 3**).

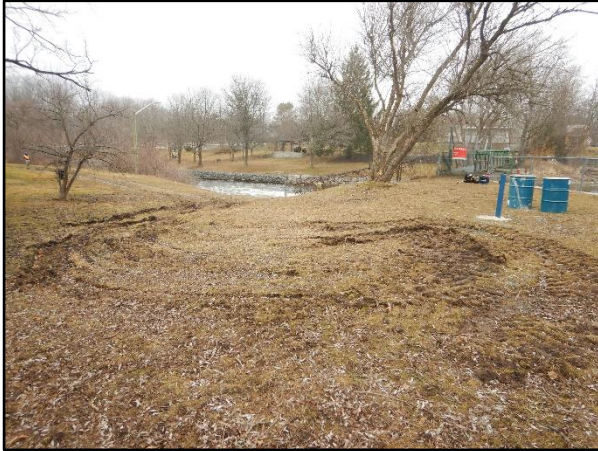
Photo 7 – West Earth Embankment

The primary hazards on the earth embankments include steep or slippery slopes and open holes or tripping. As shown in **Photo 7** and **Photo 8**, the embankments have some uneven surfaces (tripping) and could be slippery under certain conditions.

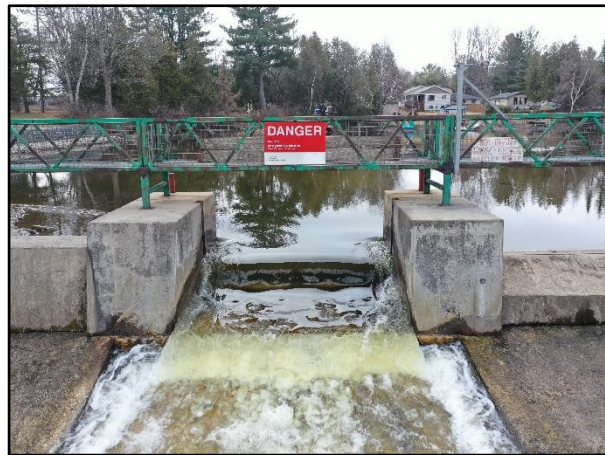
Photo 10 – Sluiceway

The site components that contribute to the potential hazards in this component area include the stoplog sluiceway (Photo 10 – Sluiceway **Photo 10**) and the retaining walls on both sides of the tailrace channel (**Photo 28**).

The potential hazards in the tailrace include the strong currents or undertows created by the flow through the sluiceway, steep or slippery banks and open holes or tripping. This area is easily accessible by members of the public. If members of the public access the retaining walls on both sides of the channel, they could be at risk of injury through tripping in open holes in the rocks or by encountering slippery surfaces.

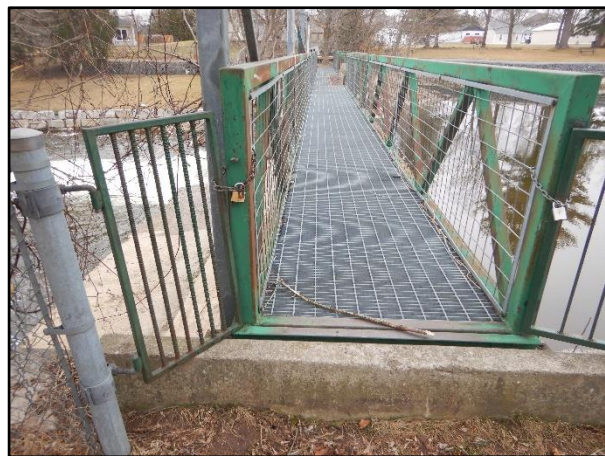
Photo 12 – Pedestrian Crossing

- A steel truss bridge with a pedestrian crossing (**Photo 12**) and an operating deck above the stoplog sluiceway (**Photo 13**).
- A masonry wall from the former mill structure (**Photo 14**).
- A municipal park area (**Photo 15**).
- A private dock located on the east side of the dam (**Photo 16**).
- The Pefferlaw River upstream of the dam (**Photo 17**).
- The Main Street Dam (**Photo 18**) located on the adjacent branch of the Pefferlaw River.

There are two main dam components that contribute to the potential hazards in this component area, the deck of the stoplog sluiceway and the earth embankments. The deck of the stoplog sluiceway is shown in **Photo 12** and **Photo 13** and the earth embankments are shown in **Photo 7** and **Photo 8**. It is noted that while public access to the bridge and dam deck was restricted at the time of our inspection, the PSRA assumes that the steel truss bridge and dam deck is open to public access, with the existing public safety measures in place, in order to assess the risk for a situation that may arise in the future.

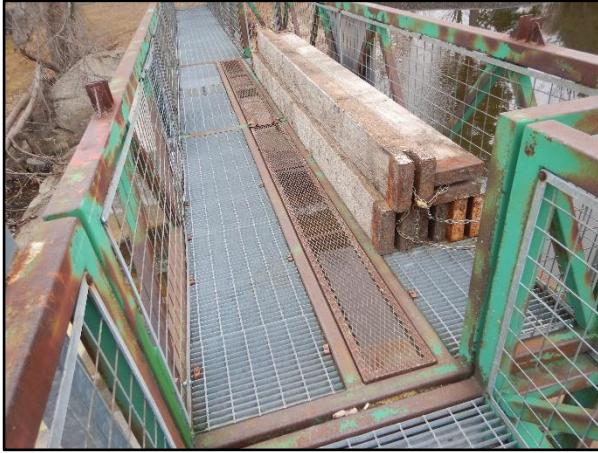
Photo 13 – Operating Deck

The potential hazard that applies to the majority of the activities within the Structure component area is falling from heights over 3 m. Adequate railings are provided on the for the majority of the steel truss bridge (**Photo 24**), and there is chain link fencing installed on the wingwalls, however, there are stoplogs stacked on the operational section of the steel truss. If climbed, the railing would not be high enough to protect against falling from heights (**Photo 13**).

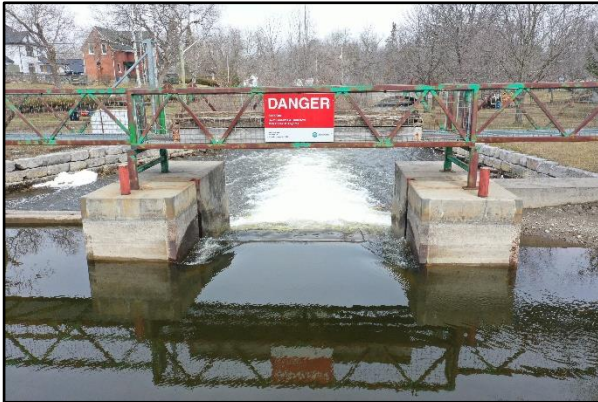
Photo 19 – Stoplog Sluiceway

There are three main dam components that contribute to the potential hazards in this component area: the stoplog sluiceway, the concrete weir with flashboards and the east concrete weir. The upstream side of the stoplog spillway, concrete weir and overflow weir are shown, under spring conditions, in **Photo 19**, **Photo 20** and **Photo 21**, respectively.

The potential hazards in the headpond for the activities from water/ice include strong currents or undertows, the presence of the spillway with stoplogs, steep or slippery banks and thin ice. During normal (summer) operating conditions, the stoplogs are installed and water is flowing over the stoplogs as well as the flashboards. There are potentially strong currents or undertows in this area that could result in a member of the public being drawn into the structure. During higher flow events, such as in the spring or after major precipitation events, the current has the potential to draw boats in towards the structure. If a boat were to come into contact with the dam, they could get stuck up against the dam or could be swept through the sluiceway or over one of the weirs to the downstream side. There is also the potential for the boat to capsize in the turbulent water. In all cases, it is anticipated that the most likely outcome would be the requirement for rescue and medical treatment.

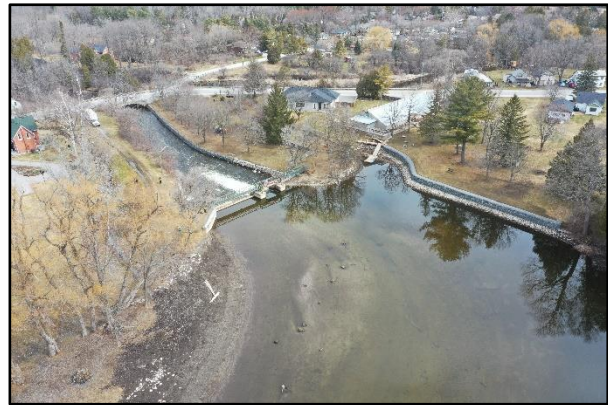
Photo 22 – Headpond Area

The potential hazards in the headpond for the activities from shore/structure include steep or slippery banks and open holes and tripping. These hazards are present in most areas along the shorelines of lakes and rivers and are not considered to be unique to the dam site, though they are caused by the presence of the waterbody created by the dam. Encountering the identified hazards along the shore would most likely result in no injuries. An aerial view of the headpond area is shown in **Photo 22**.

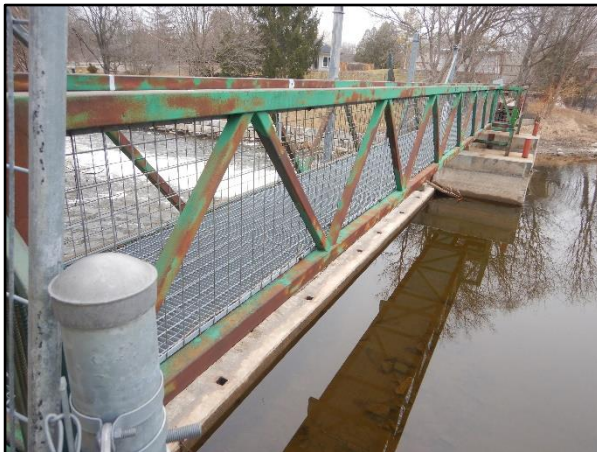
Photo 24 – Typical Truss Bridge Railing

- **Fencing/Railings** – The deck railings are formed as part of the truss bridge where welded wire mesh has been added to the inside of the truss to cover the gaps between the truss sections (**Photo 24**). There is chain link fencing along the tops of the wingwalls as well as temporary fencing sections at the access points to the truss bridge (**Photo 25** and **Photo 26**).
- **Locks on Flow Control Equipment** – The stoplog gain cover and stored stoplogs are locked to prevent unauthorized access to the flow control equipment (**Photo 27**).
- **Operational Procedures** – The Operations Manual (LSRCA, 2022) outlines operational procedures that require dam operators to ensure that the area is clear of unauthorized persons before dam operations take place.

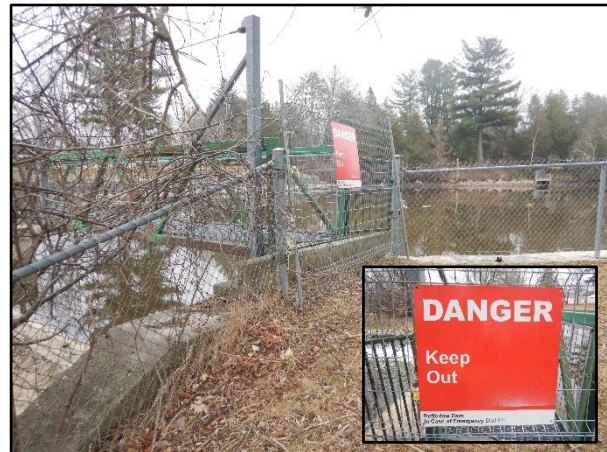
Photo 25 – Fencing and Sign on Left Side

- **Public Safety Signs** – There are small (24 inch by 24 inch) public safety signs installed on the temporary fencing that blocks access to the steel truss bridge (**Photo 25** and **Photo 26**). These signs generally meet the current recommendations for signs outlined in the Best Management Practices for Public Safety Around Dams (MNR, 2011); however, the signs do not indicate the potential hazards and the LSRCA logo has been spray painted white.

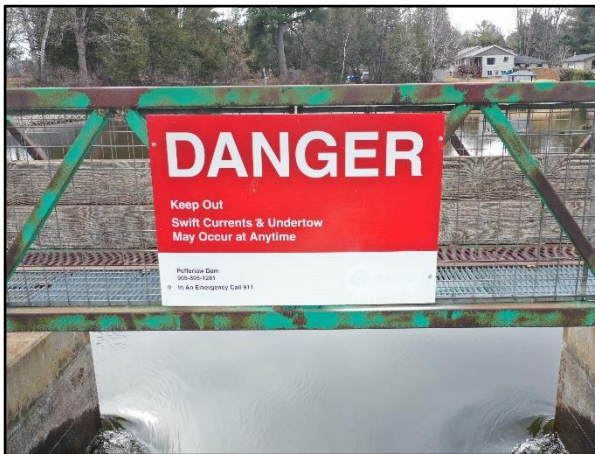
Photo 29 – Downstream Facing Public Safety Sign

- **Public Safety Signs** – There is a downstream facing public safety sign (36 inches x 53 inches) mounted to the railing on the downstream side of the concrete structure. The sign is large enough to be visible from downstream and generally meets the current recommendations for signs outlined in the Best Management Practices for Public Safety Around Dams (MNR, 2011). The sign includes the LSRCA's phone number and directs people to call "911" in the event of an emergency. The LSRCA logo has been spray painted white.
