THE CORPORATION OF THE TOWN OF GEORGINA**HERITAGE ADVISORY COMMITTEE****AGENDA**

Thursday, August 1, 2019

**THE CORPORATION OF THE TOWN OF GEORGINA
HERITAGE ADVISORY COMMITTEE
MINUTES**

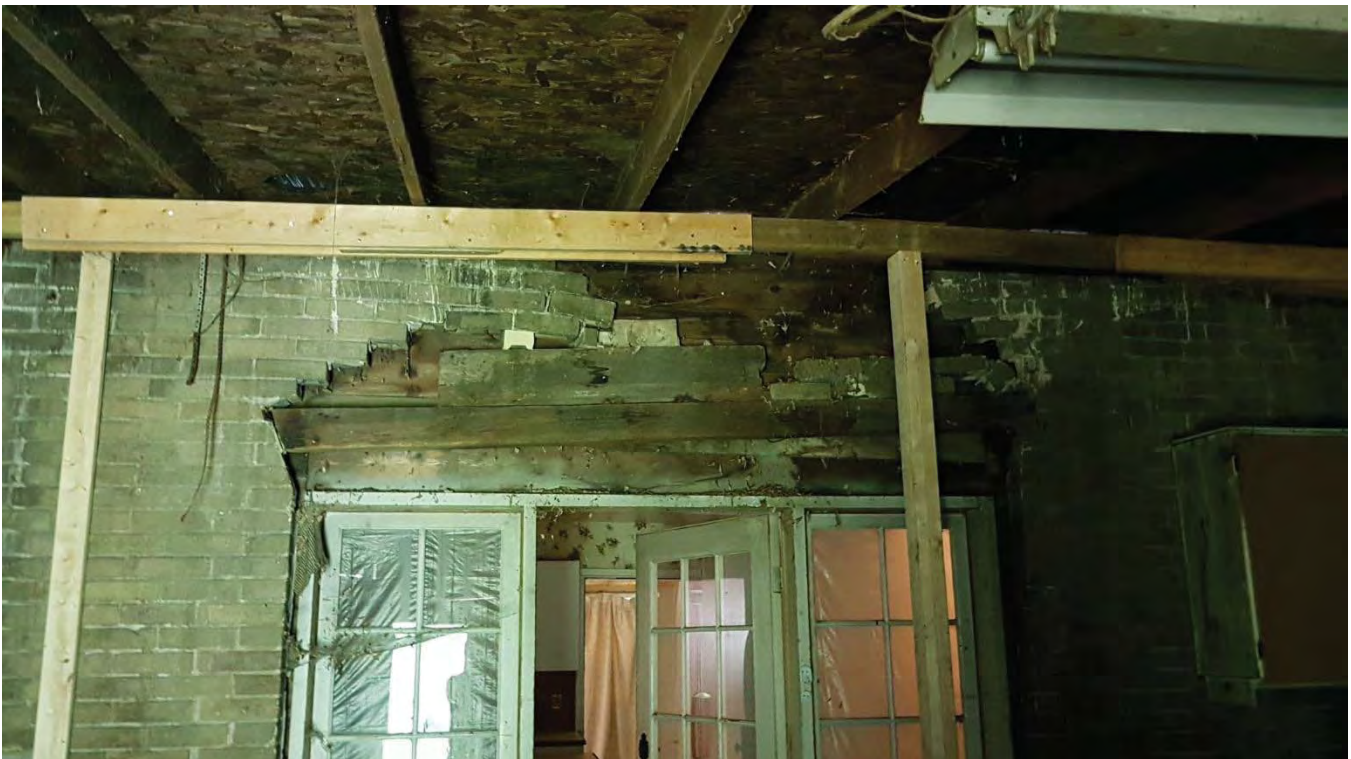
Figure 61: Deteriorating brick in the east lean-to.

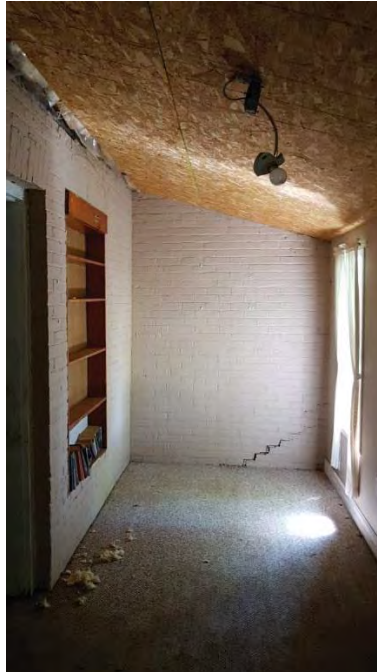
Figure 62: Interior of west addition, facing south.

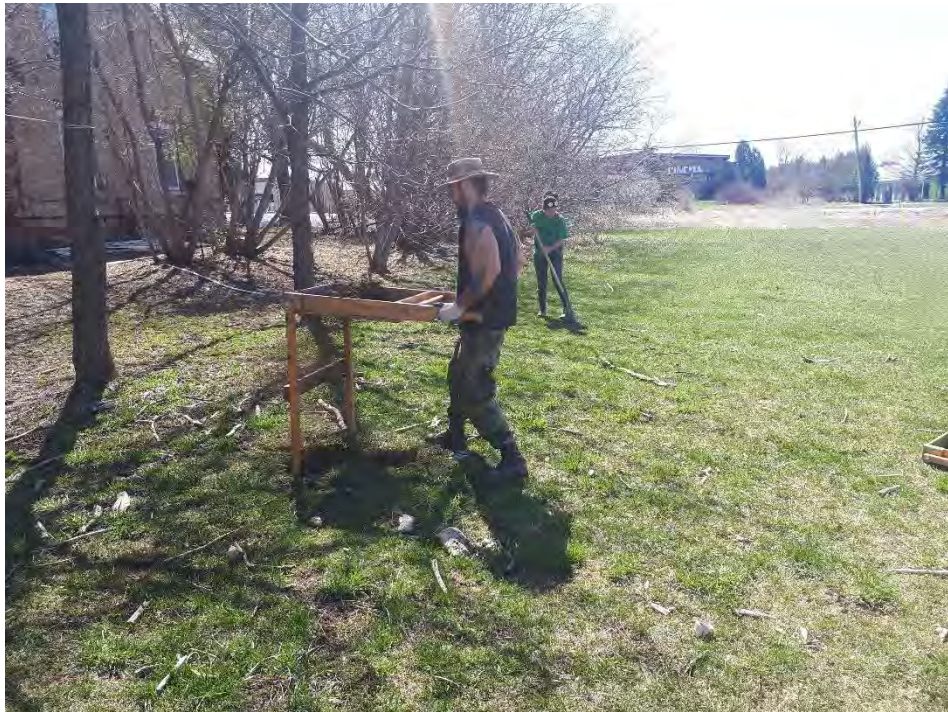
Image 12: Test Pit Survey in Progress. Facing Southeast.

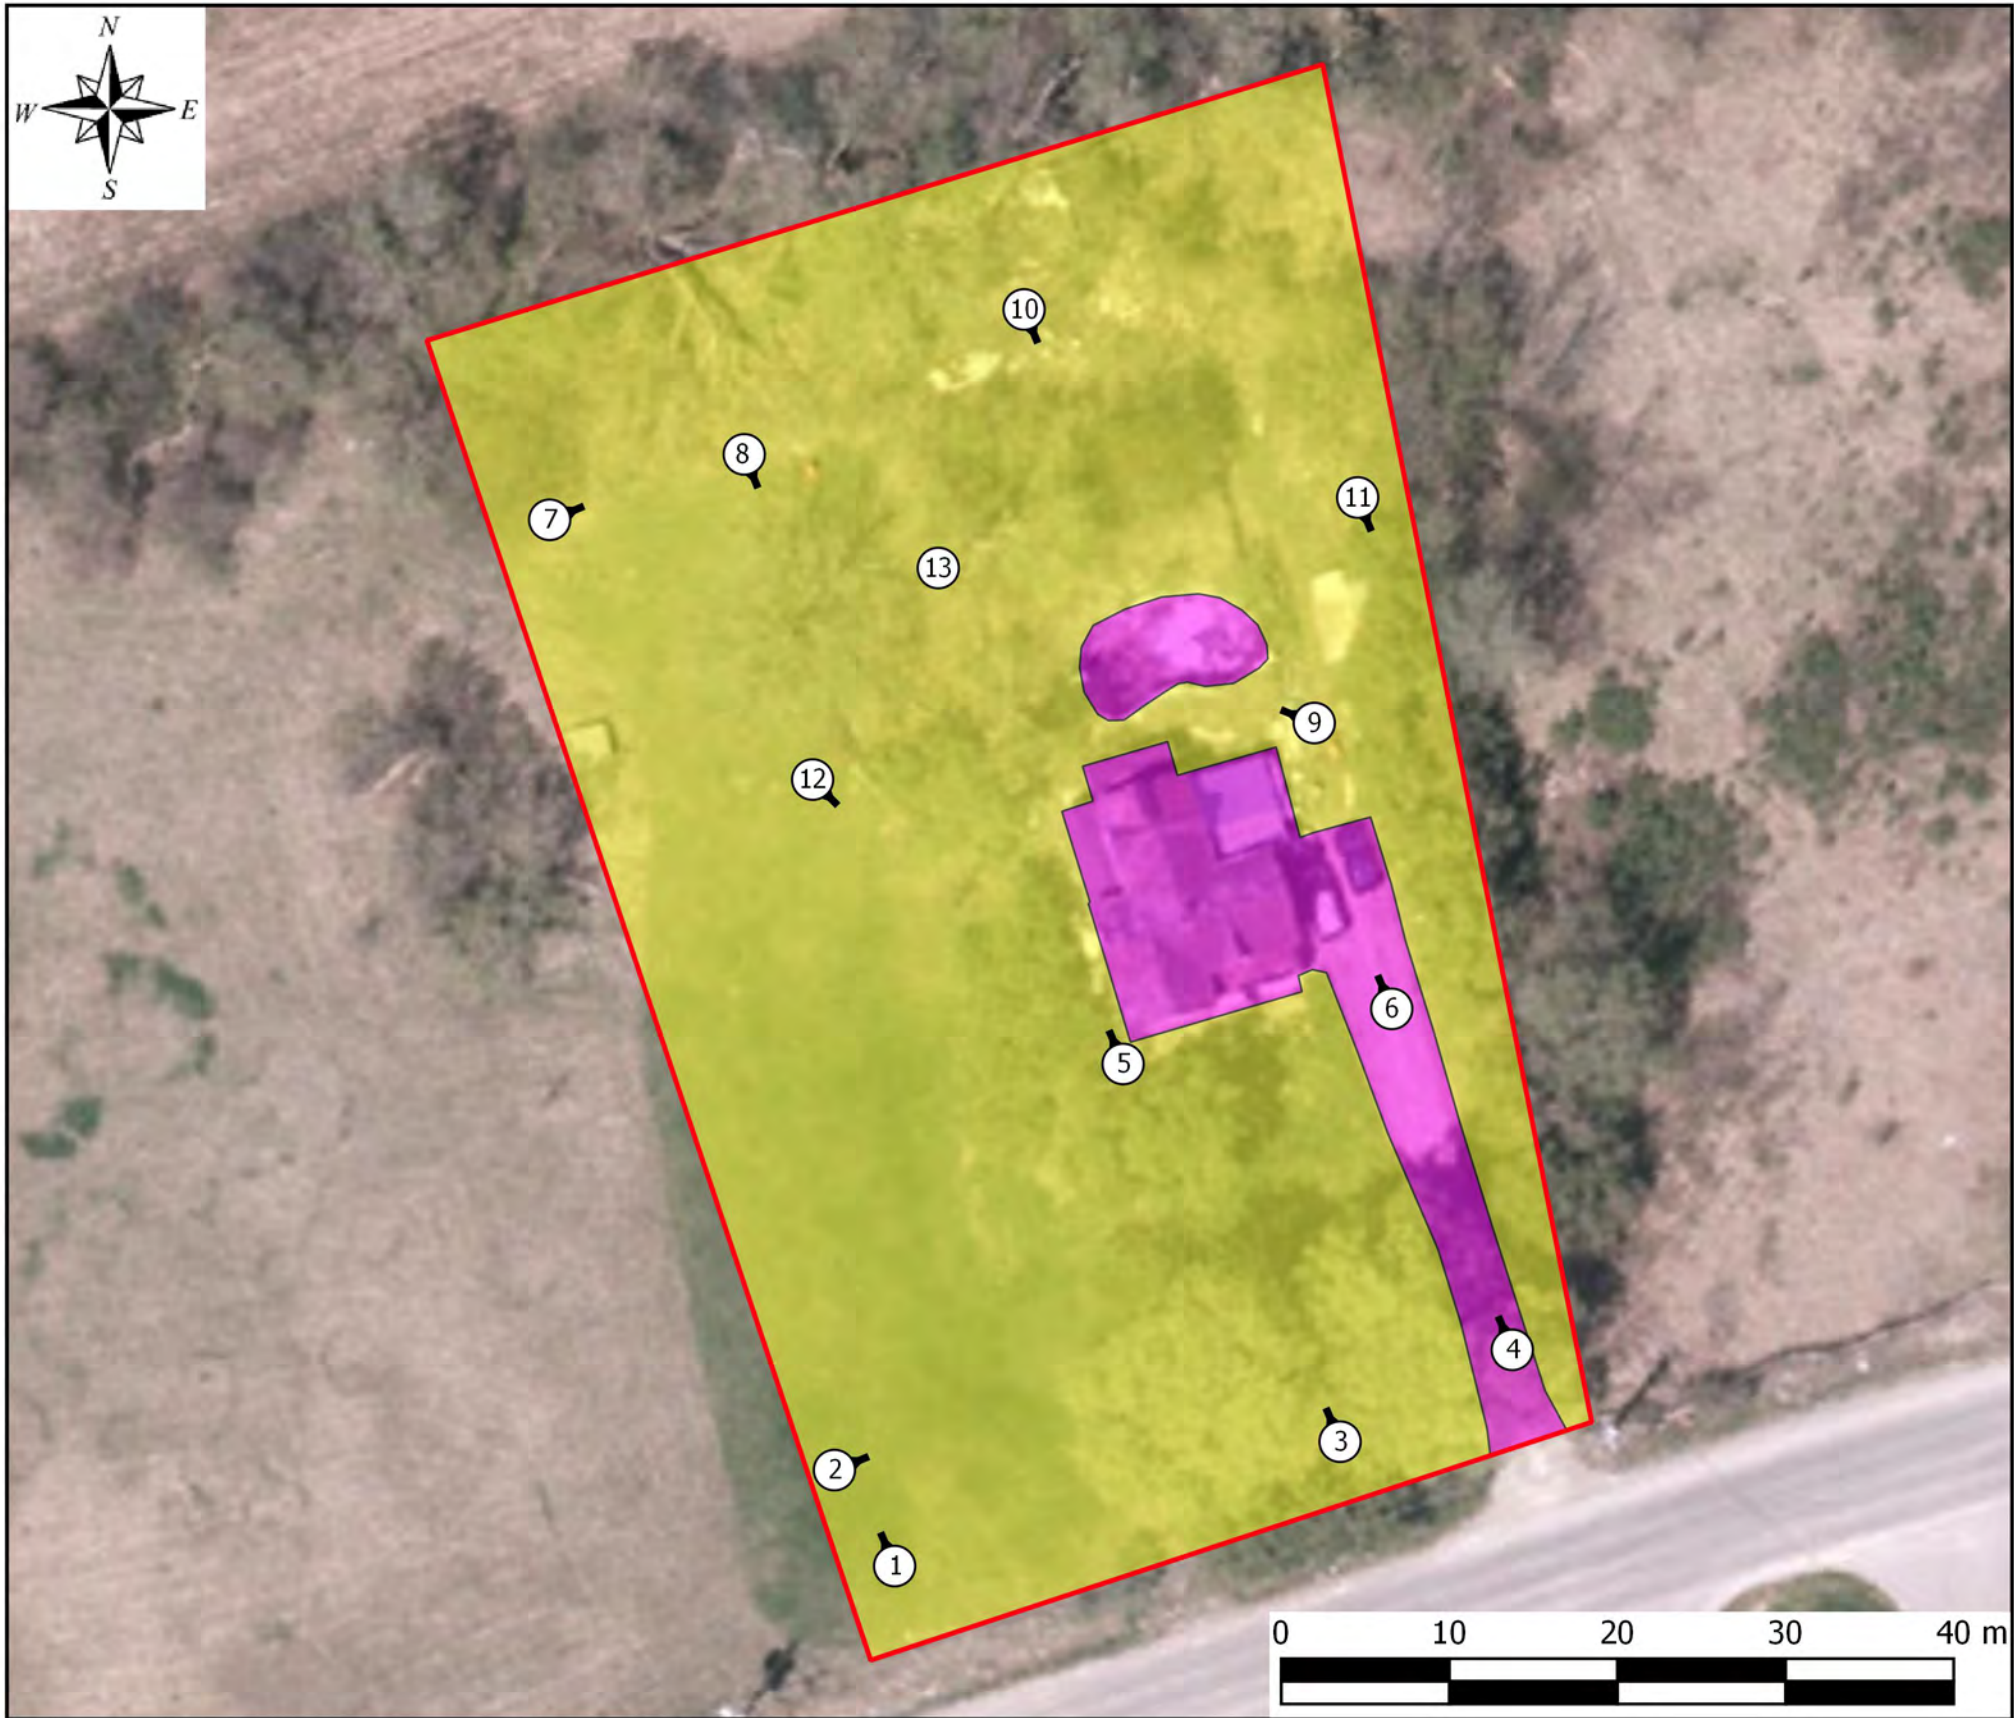
- Study Area
- Area Subject to Test Pit Survey - 5 metre Intervals
- Area of Subsurface Disturbance - Not Assessed
- Photo Location and Direction

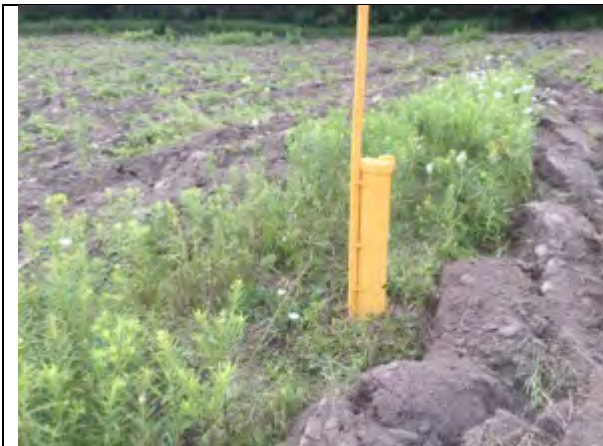
THE CONTRACTOR SHALL BE RESPONSIBLE FOR THE PROTECTION OF ALL TREES AND SHRUBS FOR WINTER PROTECTION AND FROM RODENT INJURY FOR THE DURATION OF GUARANTY PERIOD. PROTECTIVE GUARDS SHALL BE EMPLOYED AROUND ALL DECIDUOUS TREES. GUARDS TO BE 100MM DIA. PVC PIPE OR AS MUNICIPAL GUIDELINES. GUARDS SHALL BE INSTALLED PRIOR TO THE APPLICATION OF THE MULCH AND SHOULD BE PLACED A MINIMUM OF 50MM (2") OUT FROM THE TREE TRUNK ON ALL SIDES.

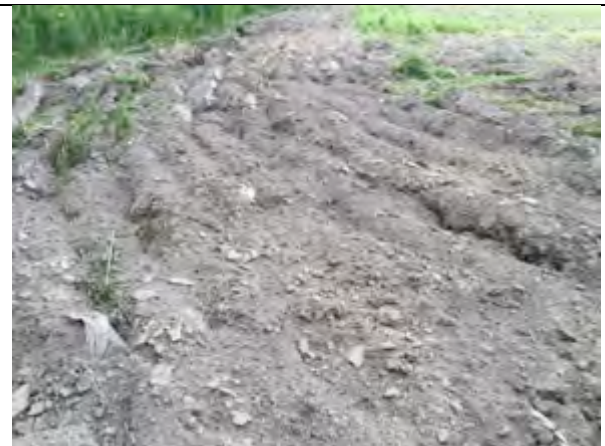
GENERAL REQUIREMENTS
