## **Structural Design Memorandum**

### **Pefferlaw Dam**

**Town of Georgina  
Regional Municipality of York**

**D.M. Wills Project Number 19-5381**

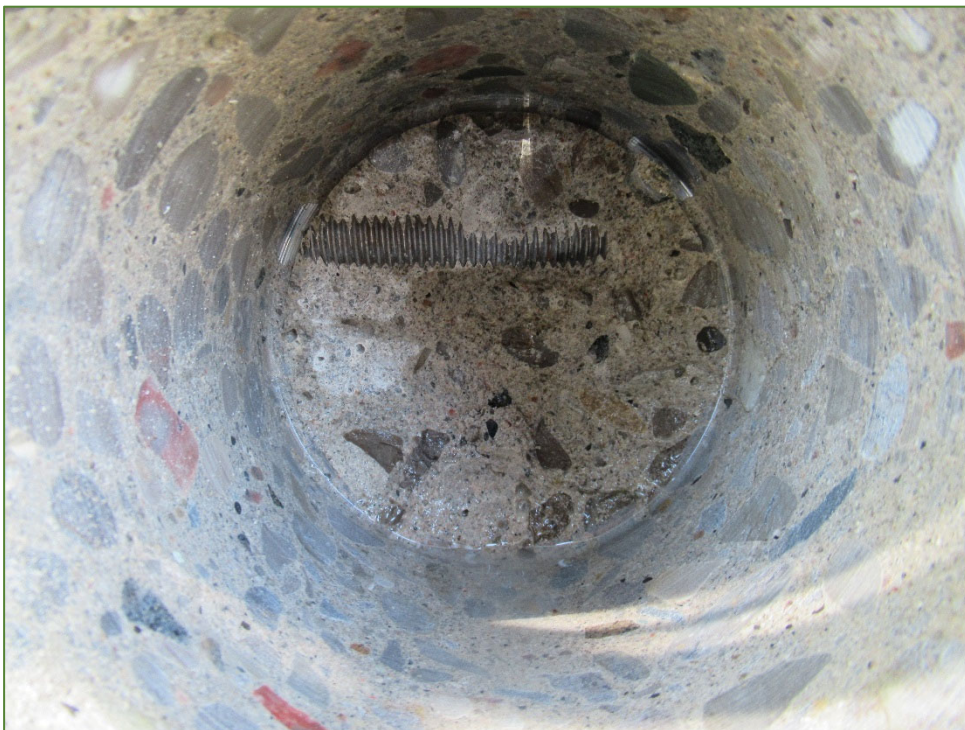
**Photo P52 Typical Condition of Inside Core – C12**

| Core No. | | C10 | | C11 | | C12 | |
|--|---|---|---|---|---|---|---|
| REMARKS<br>- orientation of rebars and cover<br>- presence of overlay, patch and thickness<br>- other observed defects | | Delamination plane @ 175-180mm. | | | | Rebar imprint @ 110mm (Horizontal). | |
