Final Report

**Pefferlaw Dam
Public Safety Risk Assessment**

Town of Georgina, Pefferlaw, Ontario

D.M. Wills Project Number 19-5381

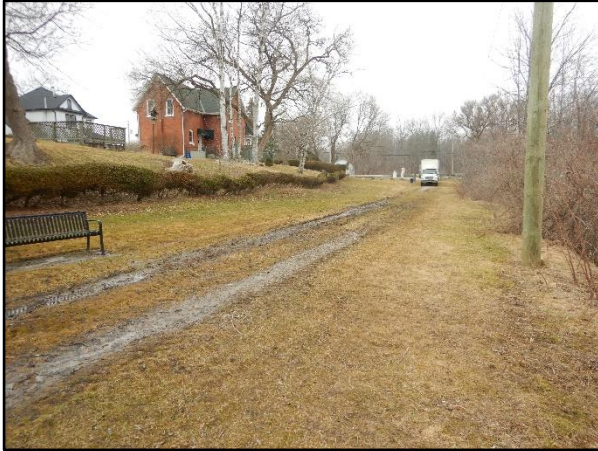
**Photo 1 – Main Access Driveway,
West Side of Dam**

- An access driveway and gate (**Photo 1** and **Photo 2**) on the west side of the river and an access gate (**Photo 3**) on the east side of the river. The access gates are locked, blocking public vehicular access to dam site and parking area (**Photo 4**).
- A 31 m long concrete gravity structure (**Photo 5** and **Photo 6**) with a 20 m long earth embankment on the west side (**Photo 7**) and a 30 m long earth embankment on the east side (**Photo 8**).

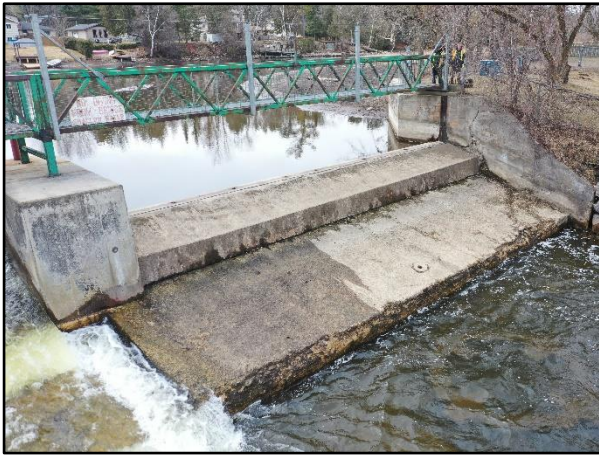
Photo 9 – West Concrete Weir

The concrete gravity structure includes a 13 m long concrete weir (**Photo 9**) topped with timber flash boards on the left (west) side of the structure, a 4.8 m wide sluiceway (**Photo 10**) with timber stoplogs in the middle of the structure and a 7.2 m long overflow weir (**Photo 11**) on the right (east) side of the structure. There are concrete aprons below the weirs and the centre sluiceway.

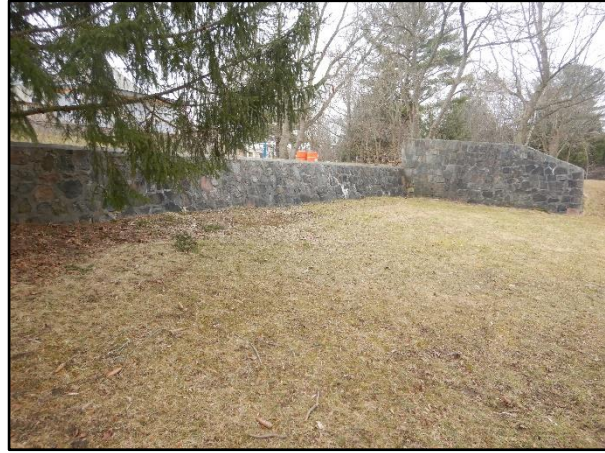
Photo 14 – Former Mill Structure

- A steel truss bridge with a pedestrian crossing (**Photo 12**) and an operating deck above the stoplog sluiceway (**Photo 13**).
- A masonry wall from the former mill structure (**Photo 14**).
- A municipal park area (**Photo 15**).
- A private dock located on the east side of the dam (**Photo 16**).
- The Pefferlaw River upstream of the dam (**Photo 17**).
- The Main Street Dam (**Photo 18**) located on the adjacent branch of the Pefferlaw River.

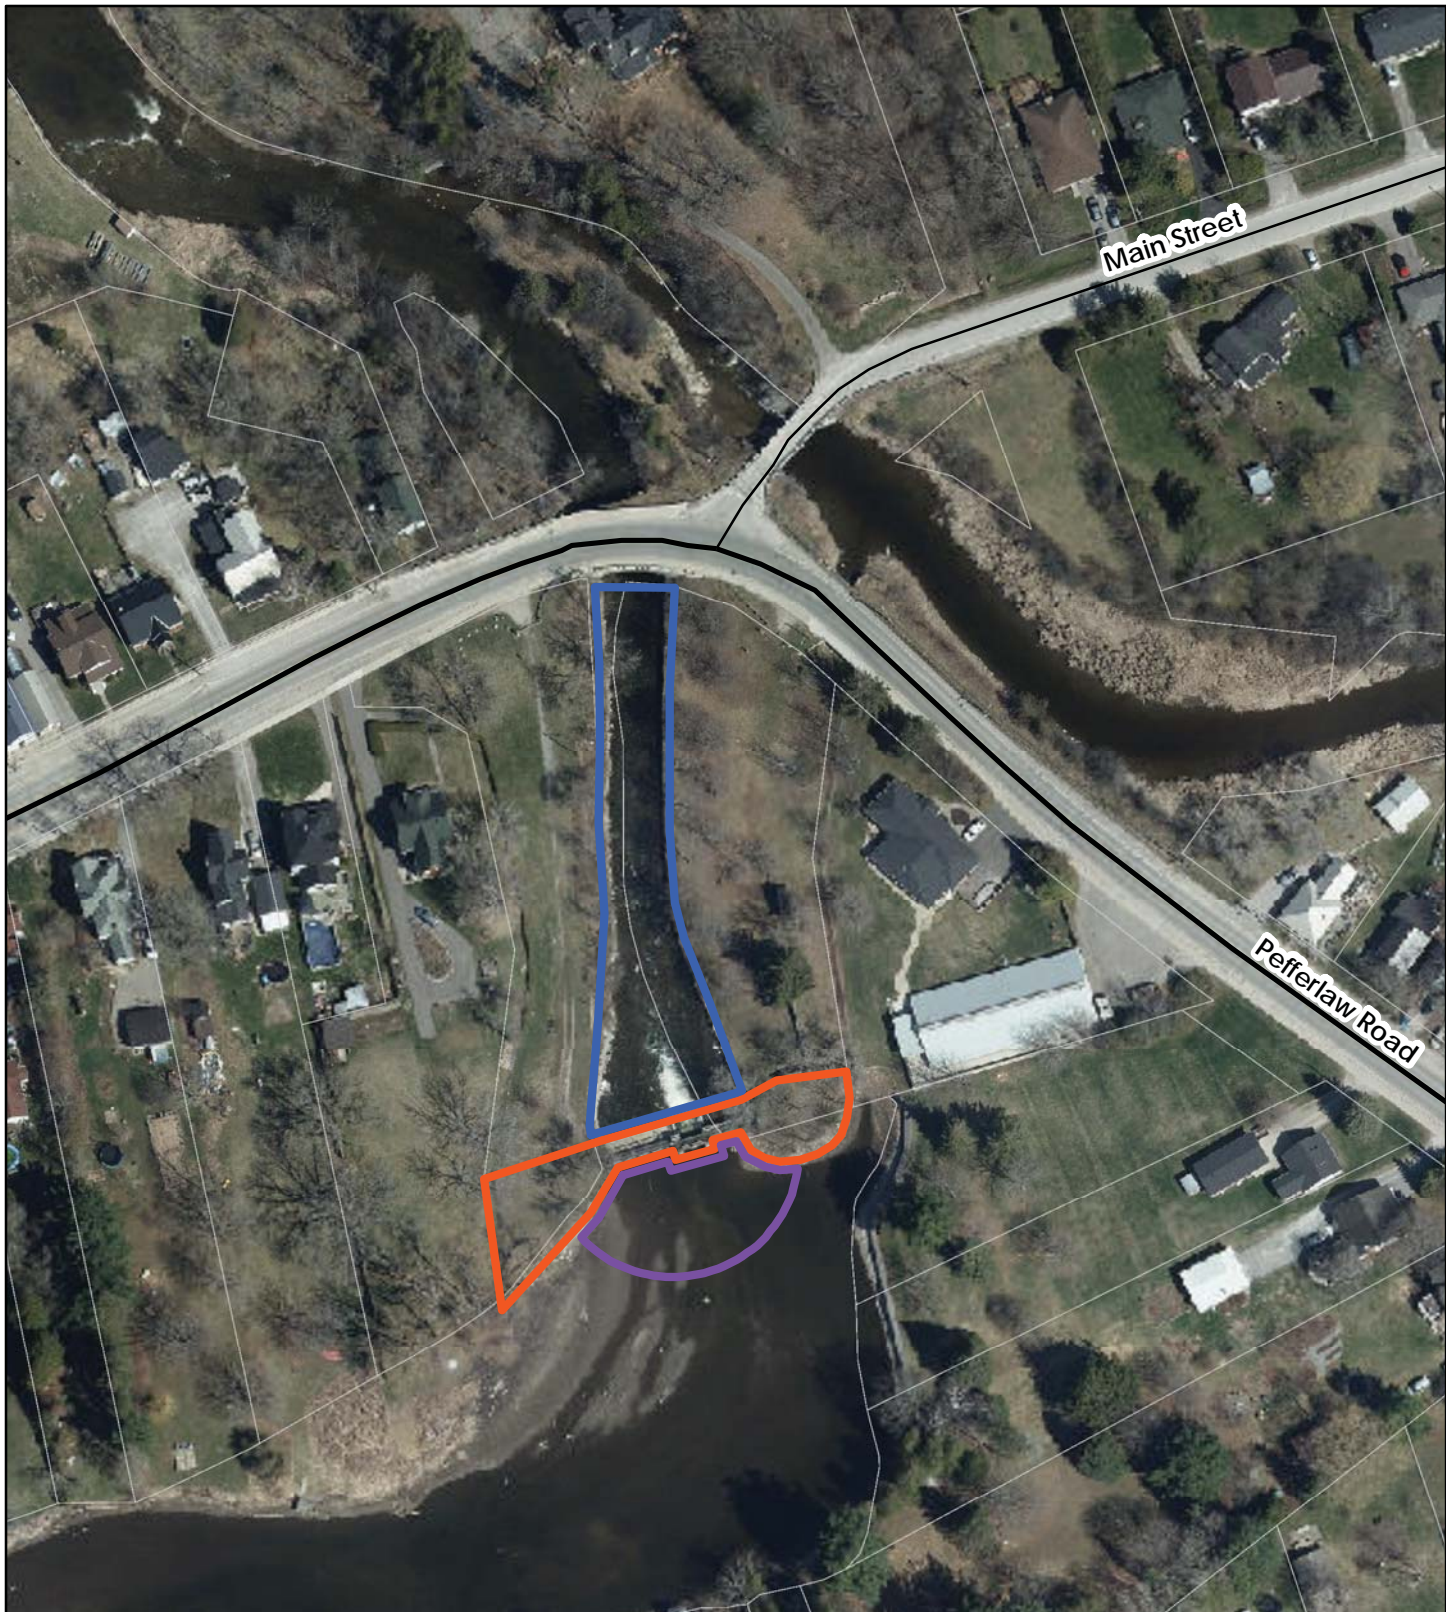
Figure 4 - Component Areas

Members of the public are generally assumed to have access to portions of all component areas. The dam and the areas up and downstream are popular places to visit and recreate due to the presence of the Pefferlaw River, municipal park land and close proximity of residential dwellings.

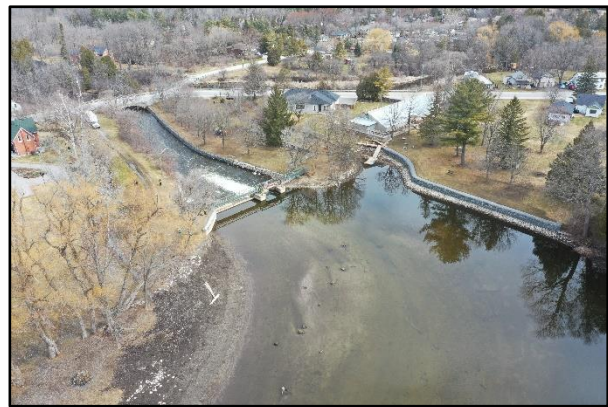
Photo 22 – Headpond Area

The potential hazards in the headpond for the activities from shore/structure include steep or slippery banks and open holes and tripping. These hazards are present in most areas along the shorelines of lakes and rivers and are not considered to be unique to the dam site, though they are caused by the presence of the waterbody created by the dam. Encountering the identified hazards along the shore would most likely result in no injuries. An aerial view of the headpond area is shown in **Photo 22**.

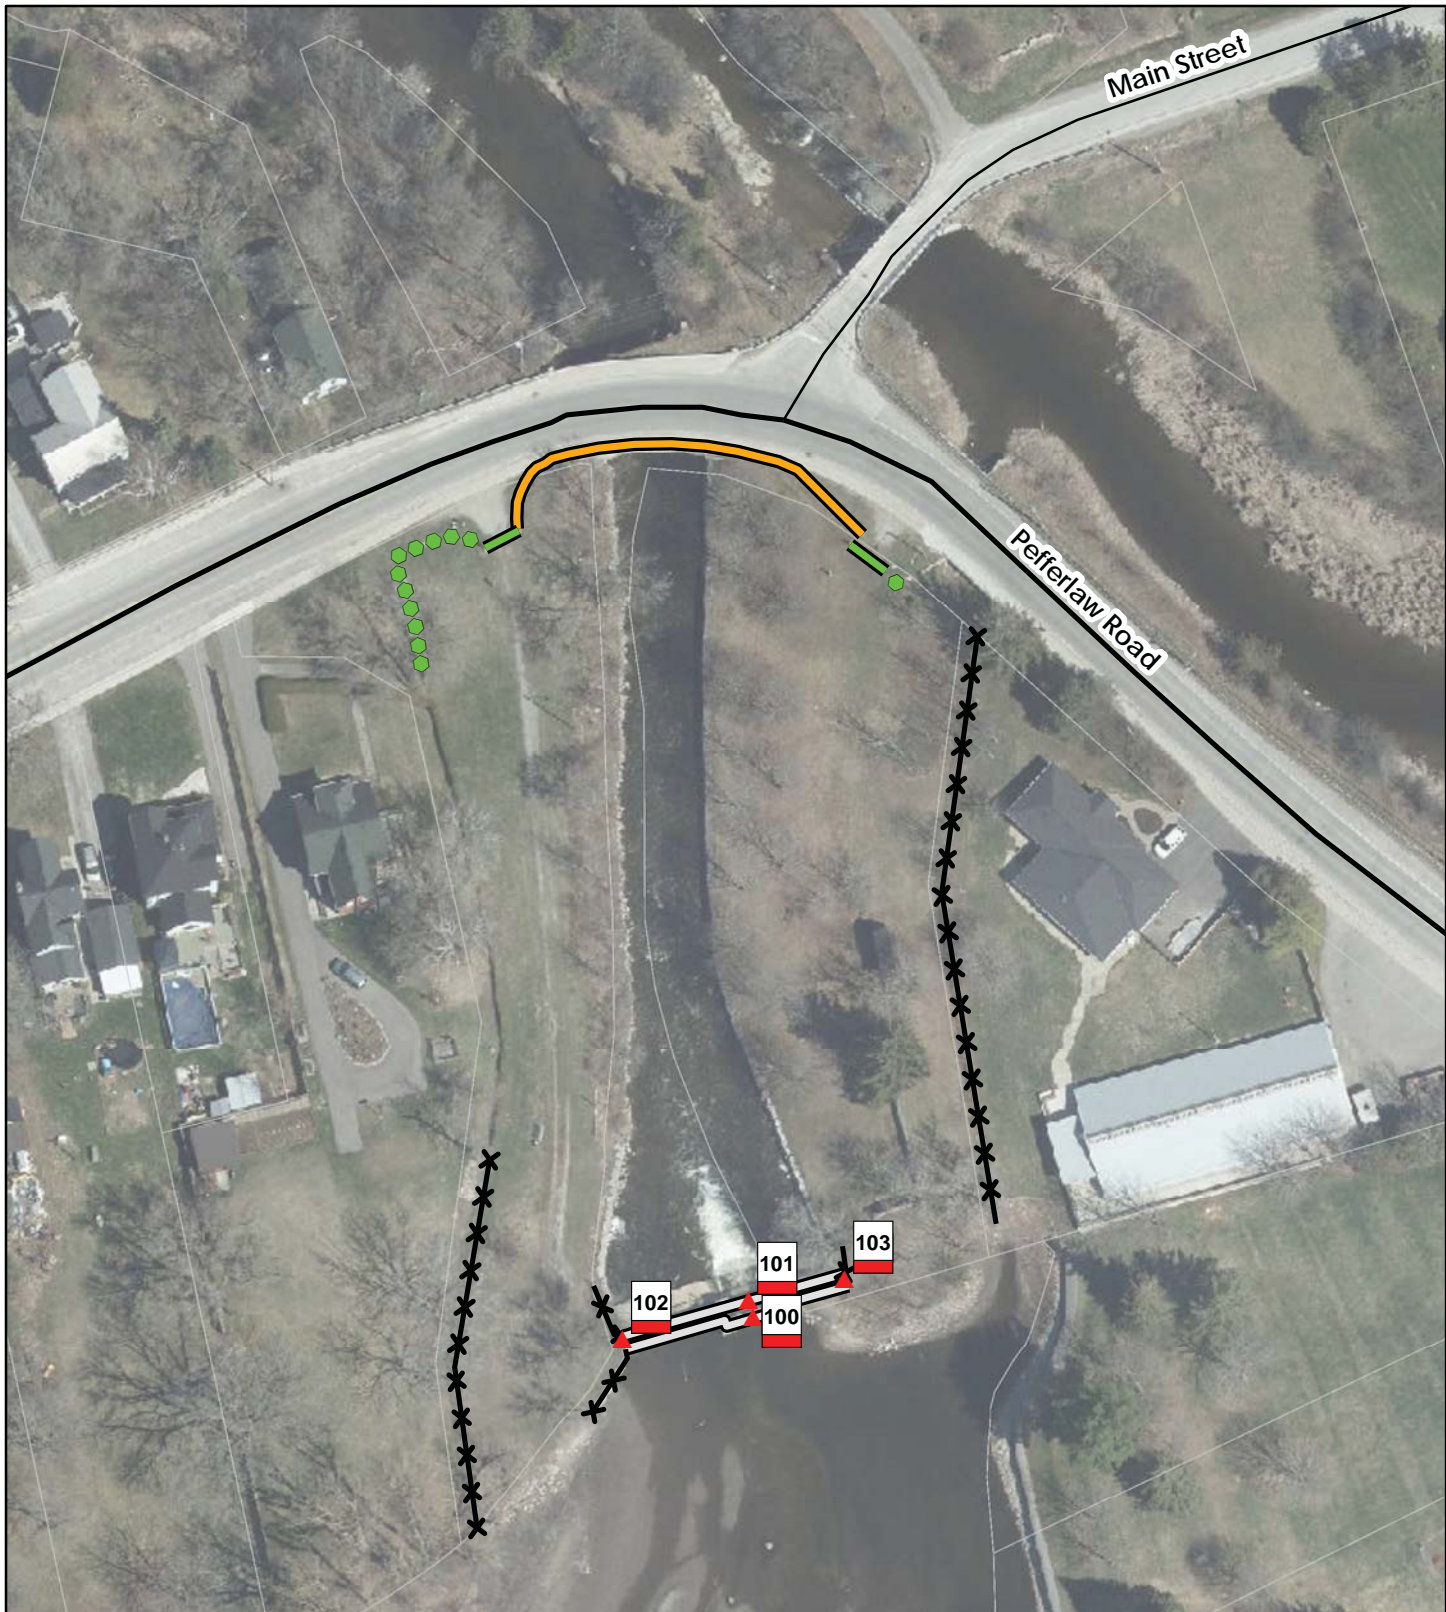
Figure 5 - Existing Public Safety Measures

The location of the existing public safety measures are shown in **Figure 5** and the sign index is included in **Appendix C**.
