# Phase I Environmental Site Assessment - 219 Pefferlaw Road, Pefferlaw, ON

April 7, 2022

Prepared for: DM Wills Associates Ltd.

Cambium Reference: 14324-002

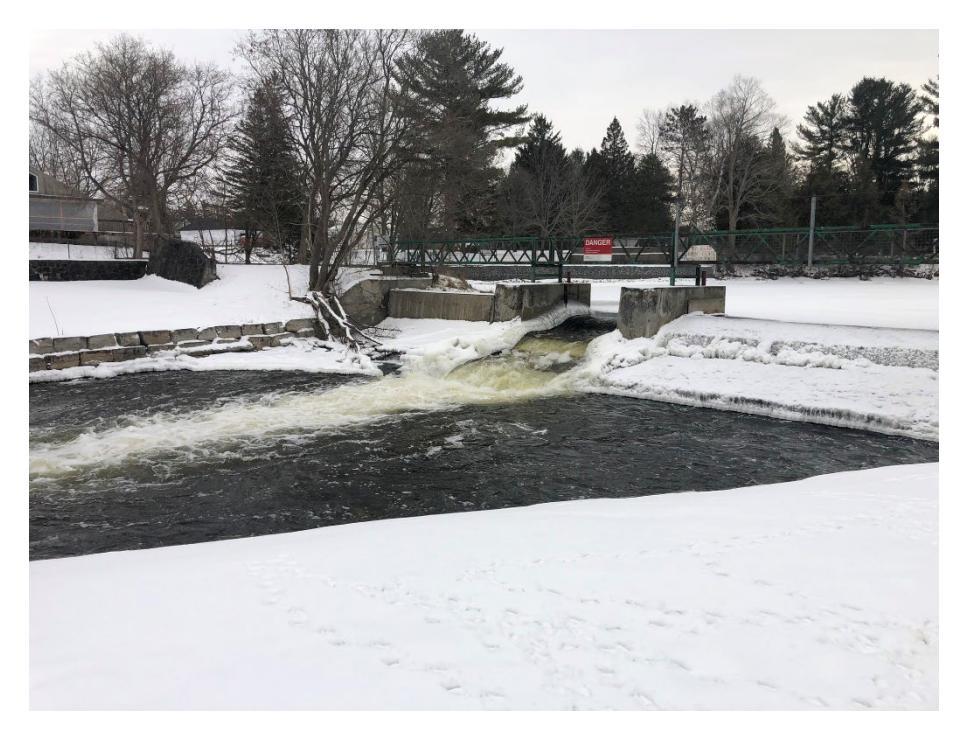
Photo 3 Pefferlaw Dam, March 2022.

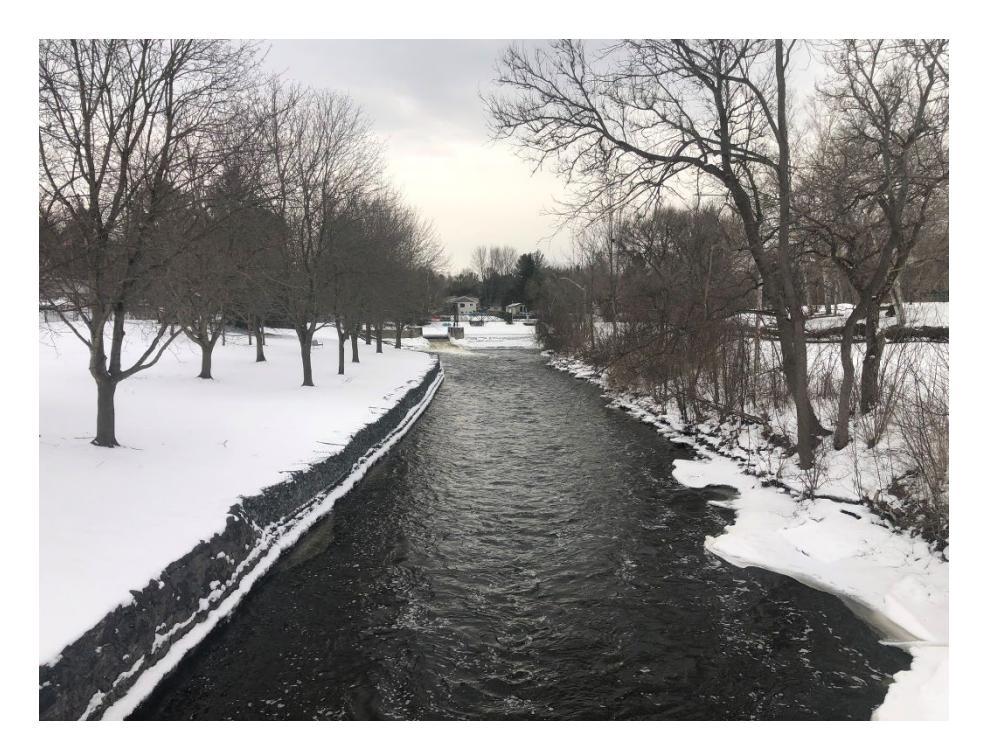
Photo 4 Pefferlaw Dam and spillway, March 2022.

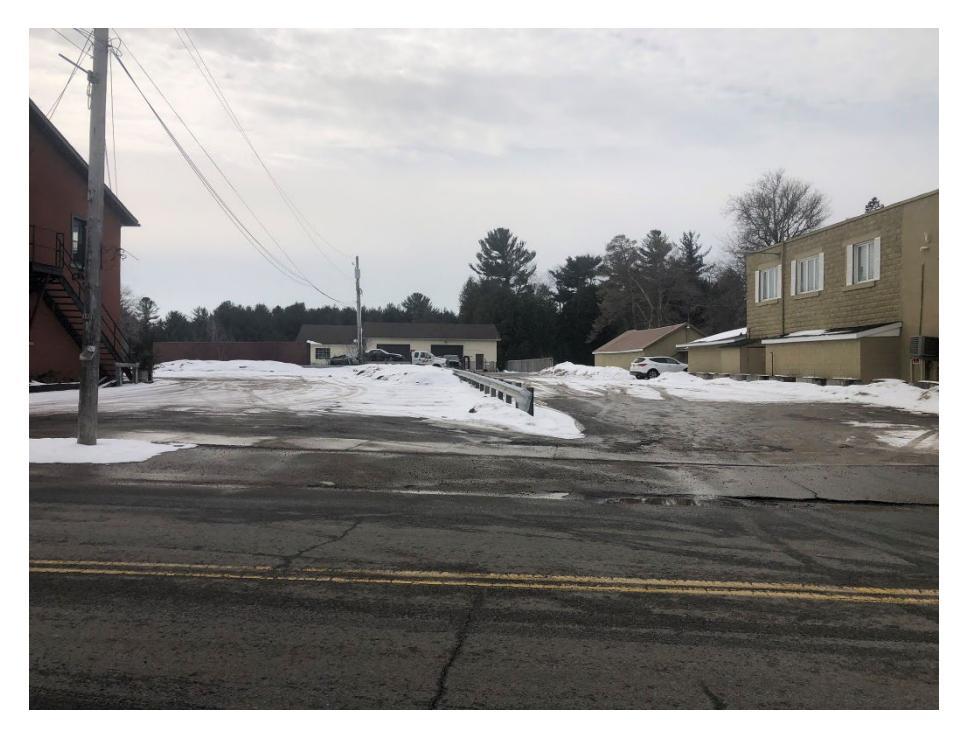
Vehicle maintenance was also observed at 253 Pefferlaw Road, in Pefferlaw, which is currently operating as Don Palmer's Auto Service. This property is approximately 158 m west of the Site, and is cross-gradient to the Site with respect to the inferred groundwater flow direction. Due to the distance to the Site and the direction of inferred groundwater flow, the presence of a vehicle maintenance at 260 Pefferlaw Road is not an environmental concern for the Site.

Photo 7 253 Pefferlaw Road - Don Palmer's Auto Service, March 2022.

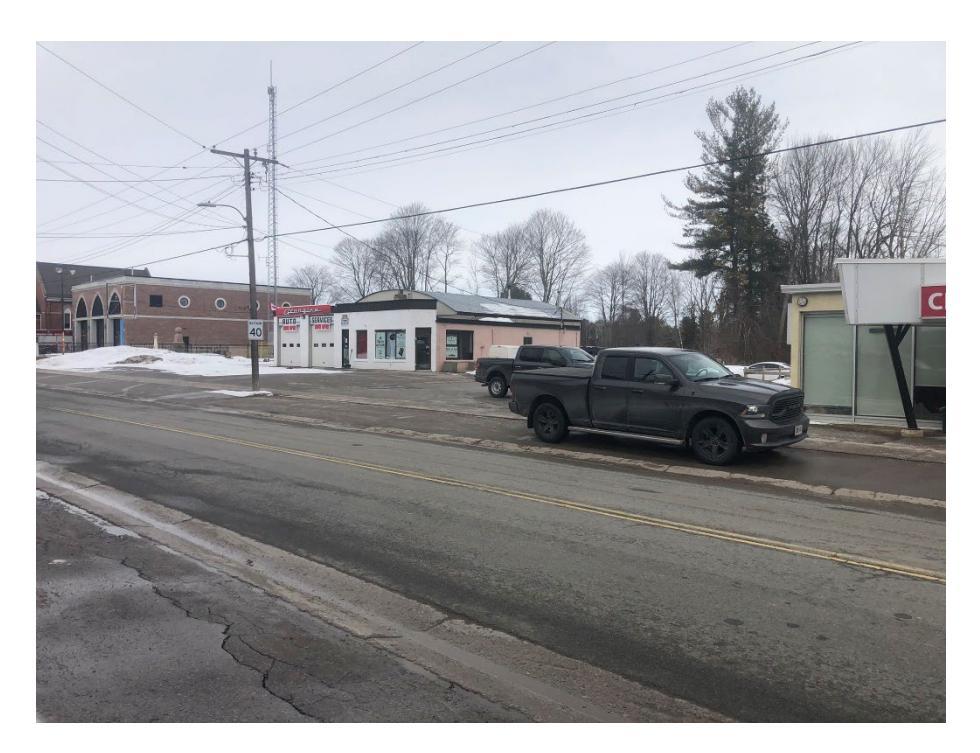
Vehicle maintenance was observed at a neighbouring property at 260 Pefferlaw Road, in Pefferlaw, which is currently operating as Georgina Auto Services. This property is approximately 198 m west of the Site, and is cross-gradient to the Site with respect to the inferred groundwater flow direction. Due to the distance to the Site and the direction of inferred groundwater flow, the presence of a vehicle maintenance at 260 Pefferlaw Road is not an environmental concern for the Site.

Photo 8 260 Pefferlaw Road - Georgina Auto Services, March 2022.

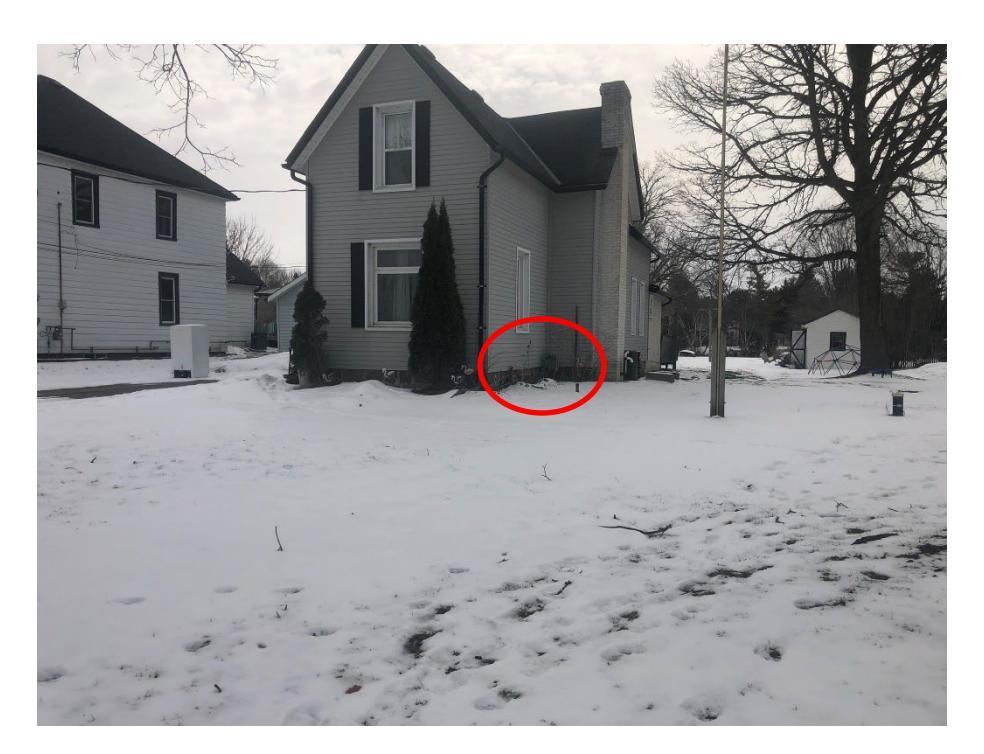
Evidence of one possible fuel oil AST was observed at a neighbouring property to the Site (i.e., possible fill/vent pipe) at 239 Pefferlaw Road. This property is approximately 60 m west of the Site, and is cross-gradient to the Site with respect to the inferred groundwater flow direction. The presence of this possible fuel oil AST is not an environmental concern for the Site.

Photo 9 Possible vent/fill pipes for a fuel oil AST at 239 Pefferlaw Road, March 2022.
