Dam Inspection Report

Pefferlaw Dam

Town of Georgina
Regional Municipality of York

December 2019

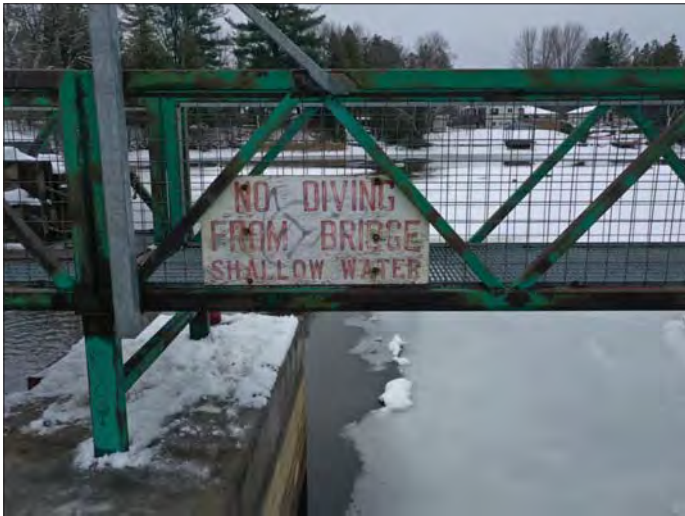
Photo 0922 - Nov. 19, 2019
Pefferlaw Dam
Public Safety Sign, Downstream Side of Dam

8. Complete a Public Safety Risk Assessment and based on the results of the assessment prepare a Public Safety Plan and implement the recommended additional public safety measures. Additional public safety measures that could be identified during the Public Safety Risk Assessment and may need to be considered as part of the Public Safety Plan include: signage on the pedestrian approaches to the dam and at the entrance to the park, a public safety boom in the head pond and additional railings/fencing around the stoplog storage area on the deck.	There is no existing Public Safety Risk Assessment or Public Safety Plan for the site and there is significant public interaction with the dam. The existing public safety measures may not be sufficient to reduce the risk to public safety.	Medium	\$15,000*	<p>The cost estimate provided is for the completion of the Public Safety Risk Assessment and Public Safety Plan. This work is typically completed by a professional consulting engineer; however, it could be completed by LSRCA staff if they have appropriate training and experience in Public Safety Risk Assessments for dams.</p> <p>Depending on the results of the study, the cost of additional public safety measures could range from \$2,500 for additional signage to \$75,000 for a public safety boom.</p> <p>As an alternate to undertaking Recommendation 8, the LSRCA could go ahead and implement additional public safety measures; however, there would be limited justification for which measures to put in which locations and limited information as to whether or not they would have the intended effect of reducing the risk to public safety.</p>

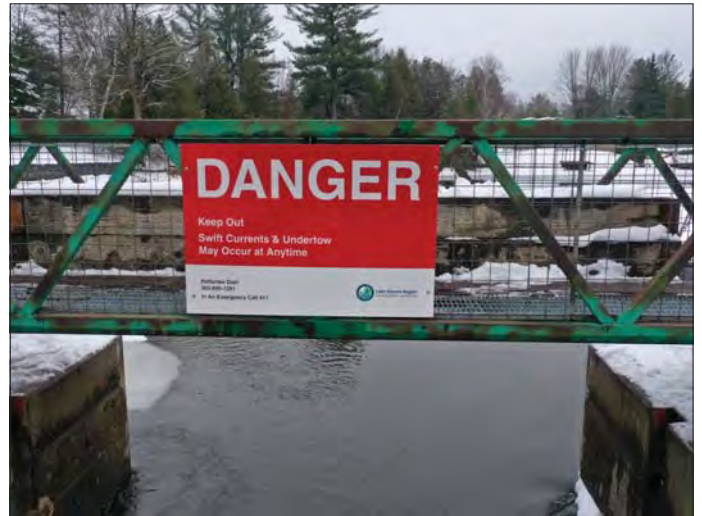
Photo 0923 - Nov. 19, 2019
Pefferlaw Dam
Public Safety Sign, Downstream Side of Dam

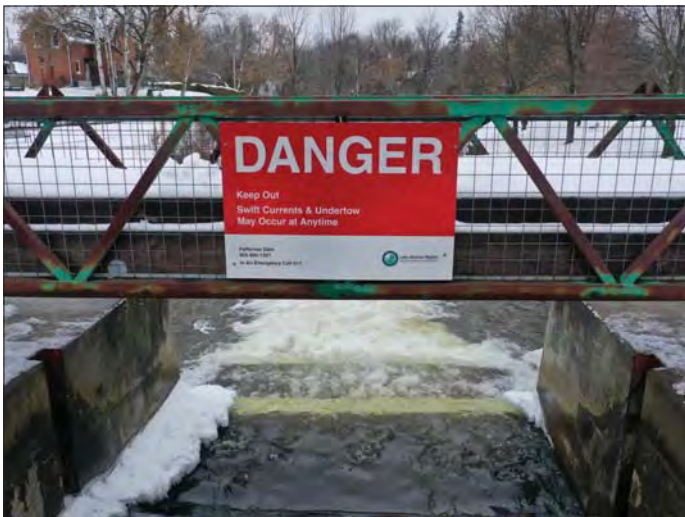
Photo 0940 - Nov. 19, 2019
Pefferlaw Dam
Public Safety Sign, Upstream Side of Dam

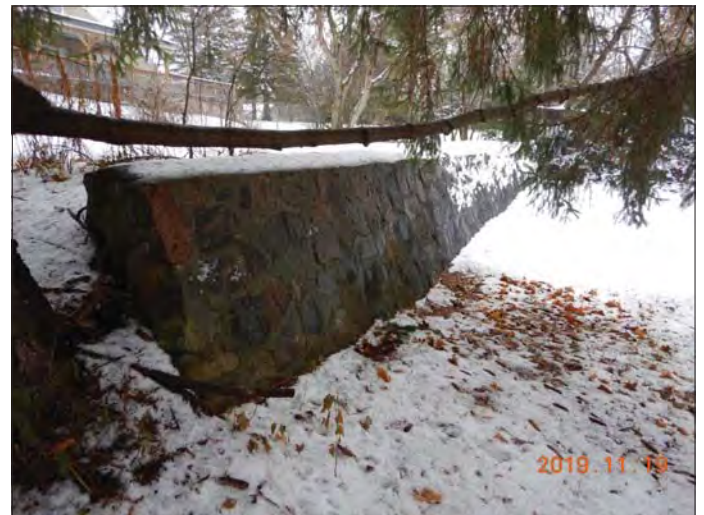
Masonry Wall from Former Mill Structure

There is a portion of the right (east) embankment that is retained by the stone foundation wall of the former mill. The stone wall generally appears to be in fair condition.

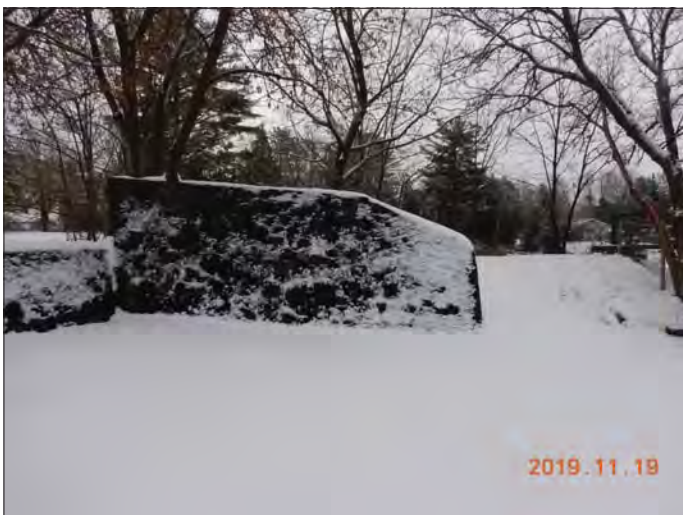
Masonry Wall from Former Mill Structure

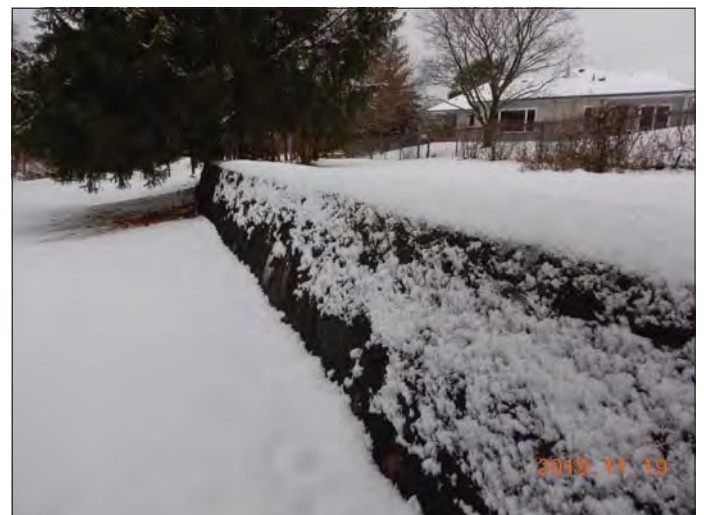
Masonry Wall from Former Mill Structure

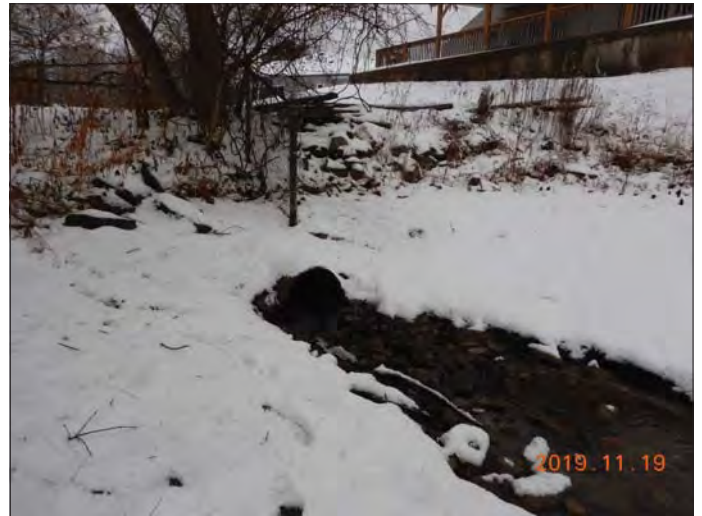
Lake Simcoe Region
conservation authority
Photo 2658 - Sept 19, 2019
Pefferlaw Dam
Masonry Wall of Former Mill Structure

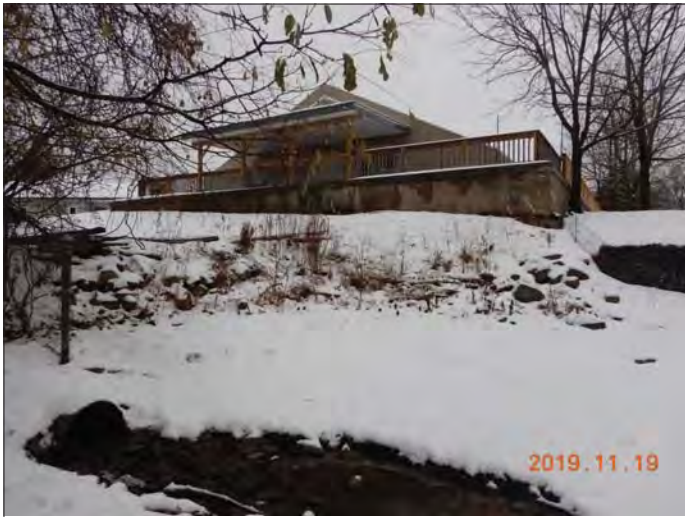
Lake Simcoe Region
conservation authority
Photo 2659 - Sept 19, 2019
Pefferlaw Dam
Culvert Inlet/Outlet East of Dam

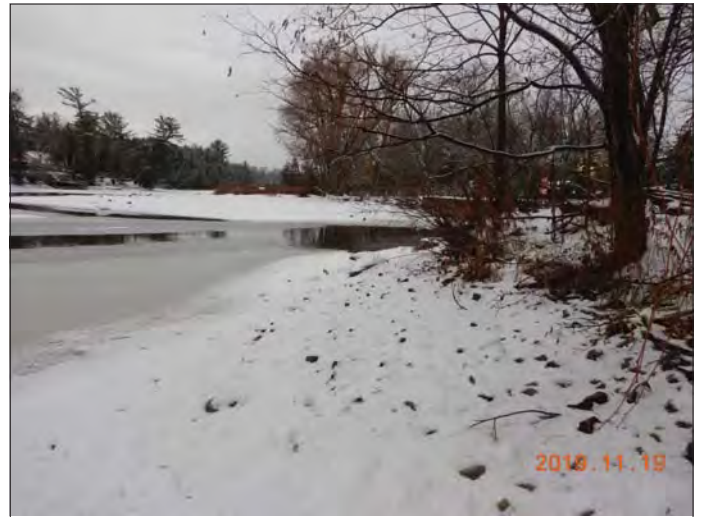
Lake Simcoe Region
conservation authority
Photo 2660 - Sept 19, 2019
Pefferlaw Dam
Expected Site of Former Mill Intake, East of Dam

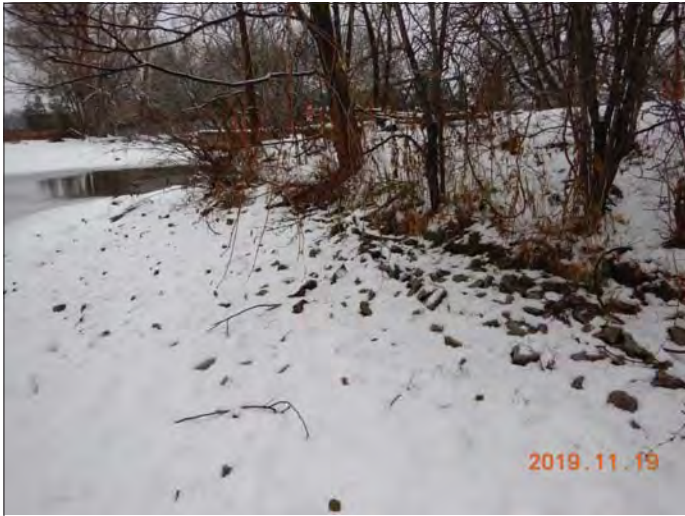
Lake Simcoe Region
conservation authority
Photo 2665 - Sept 19, 2019
Pefferlaw Dam
Upstream Right Earth Embankment

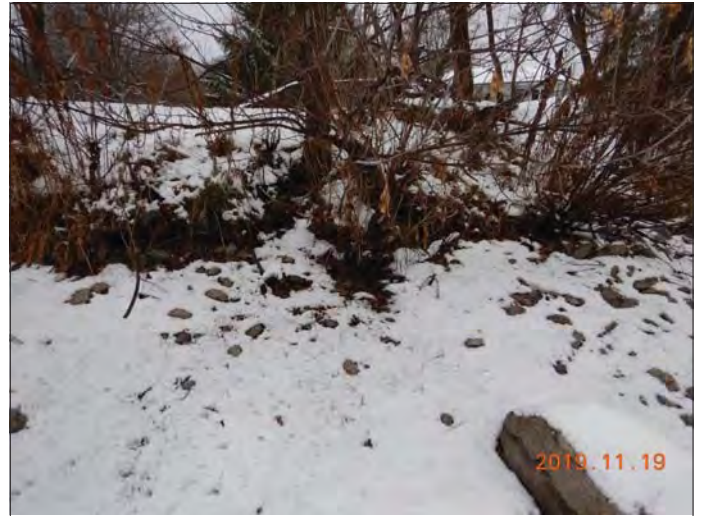
Lake Simcoe Region
conservation authority
Photo 2666 - Sept 19, 2019
Pefferlaw Dam
Upstream Right Earth Embankment

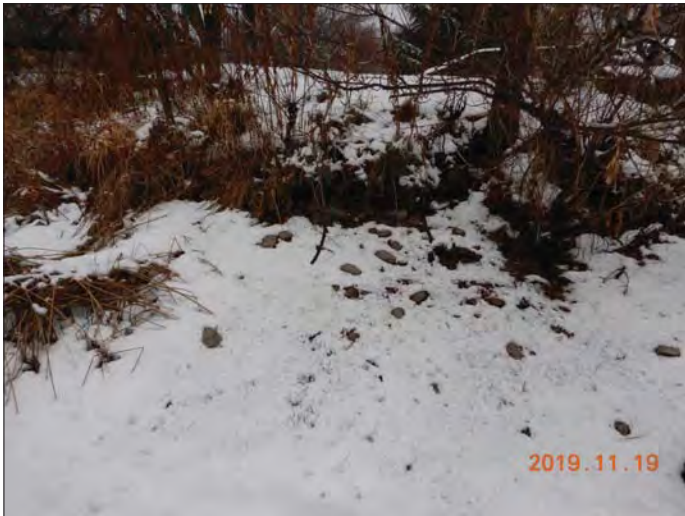
Lake Simcoe Region
conservation authority
Photo 2667 - Sept 19, 2019
Pefferlaw Dam
Upstream Right Earth Embankment

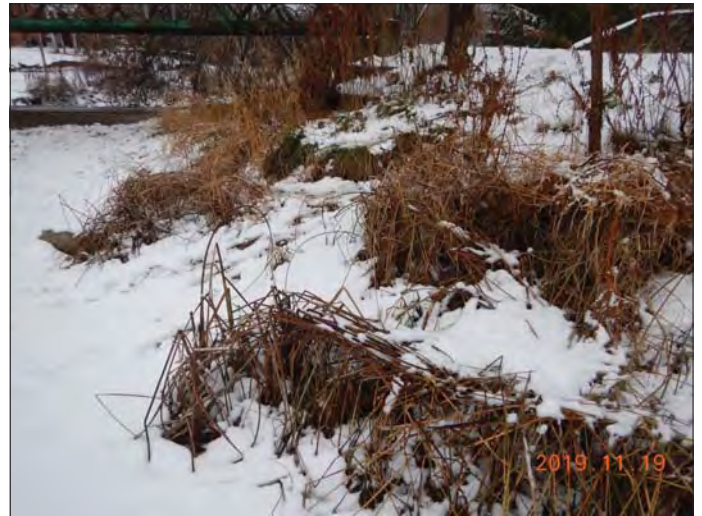
Photo 2670 - Sept 19, 2019
Pefferlaw Dam

Upstream Right Earth Embankment

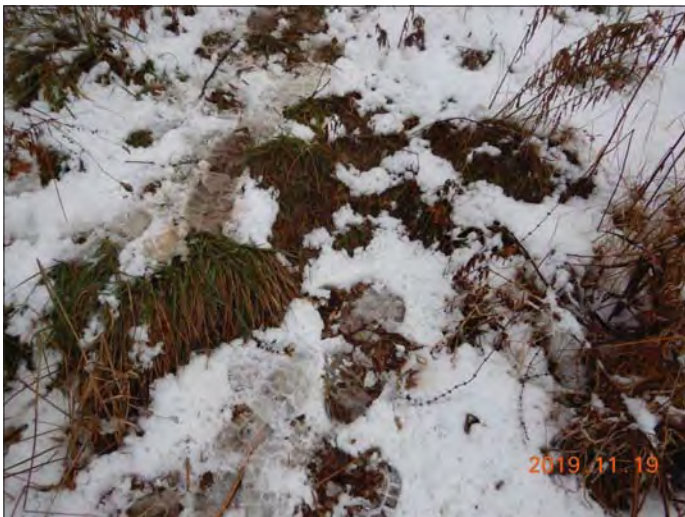
Photo 2671 - Sept 19, 2019
Pefferlaw Dam

Upstream Right Earth Embankment

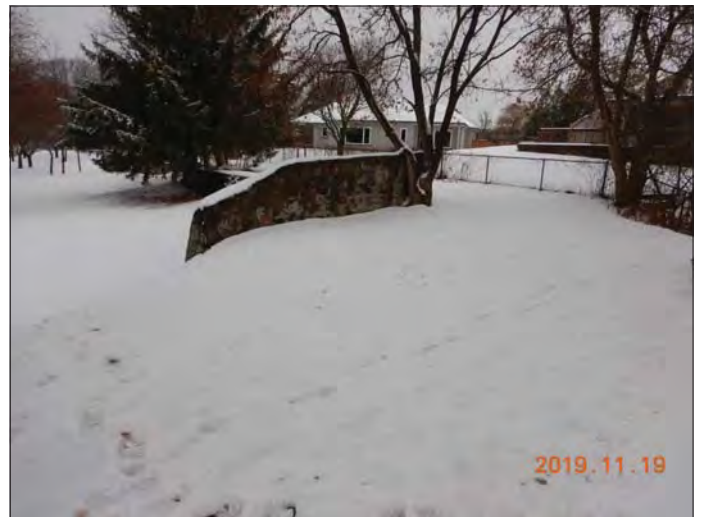
Photo 2674 - Sept 19, 2019
Pefferlaw Dam

Upstream Right Earth Embankment

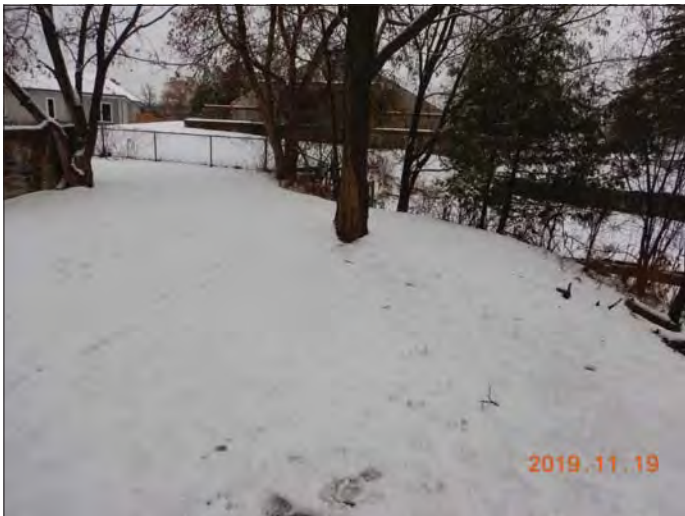
Photo 2676 - Sept 19, 2019
Pefferlaw Dam

Right Earth Embankment Crest

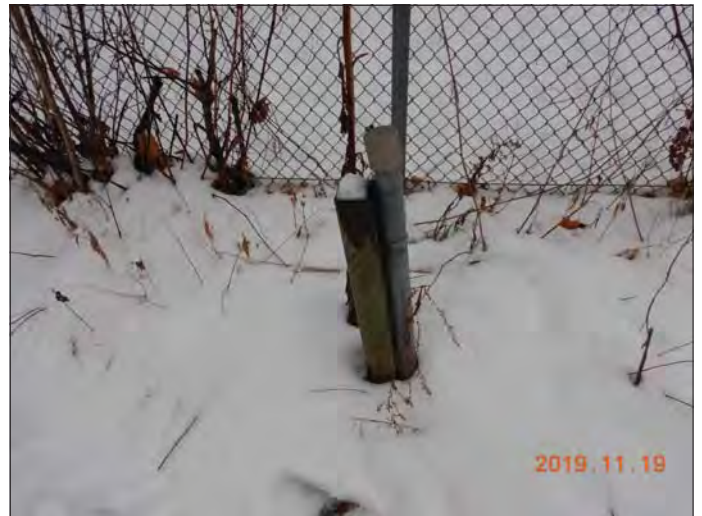
Photo 2677 - Sept 19, 2019
Pefferlaw Dam

Right Earth Embankment Crest

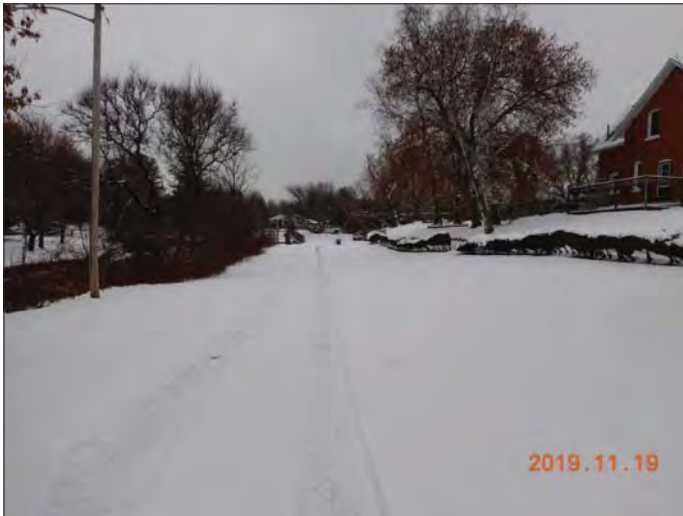
Photo 2682 - Sept 19, 2019
Pefferlaw Dam

Monitoring Well on East Side of Park

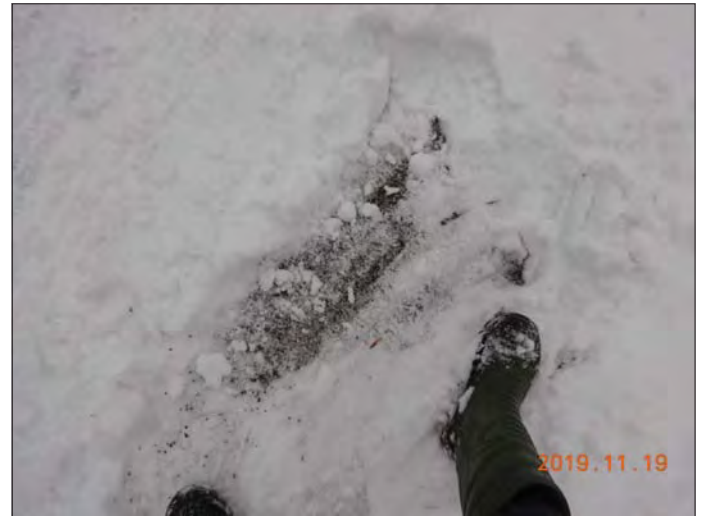
Photo 2686 - Sept 19, 2019
Pefferlaw Dam
West Access Road

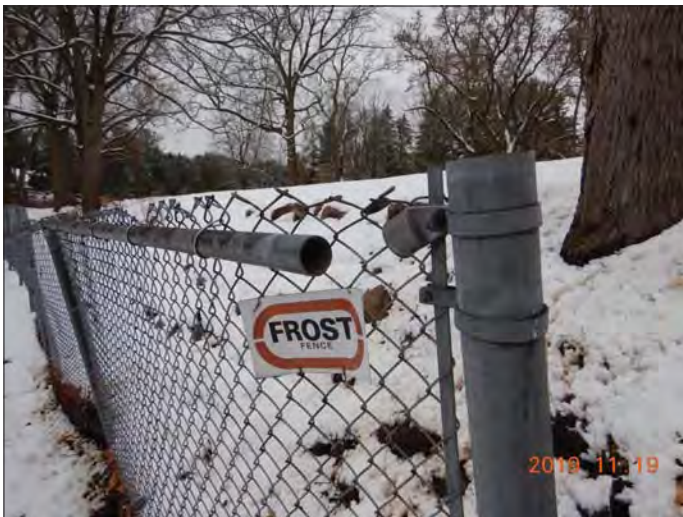
Photo 2687 - Sept 19, 2019
Pefferlaw Dam
West Access Road Gravel Surface

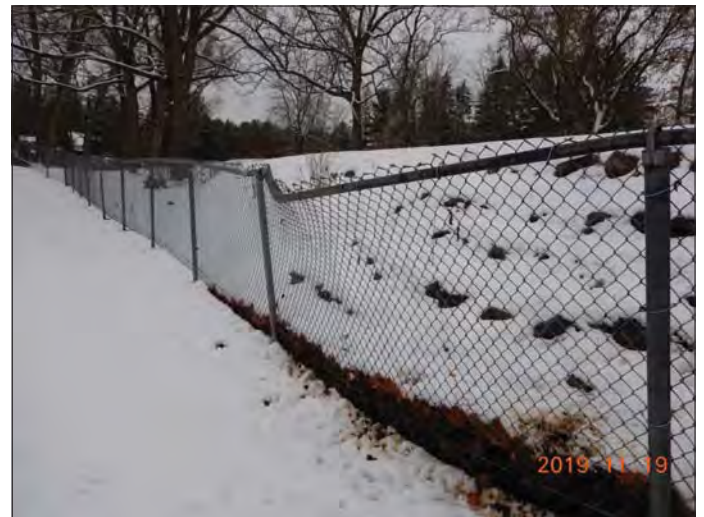
4. Repair the chain link fence along the west property line.	The chain link fence is broken.	Low	\$5,000	The cost estimate assumes that the LSRCSA would retain a contractor to complete this work. Cost savings may be realized if the LSRCA is able to complete this work using internal resources.

Photo 2693 - Sept 19, 2019
Pefferlaw Dam
Fencing on West Side of Park

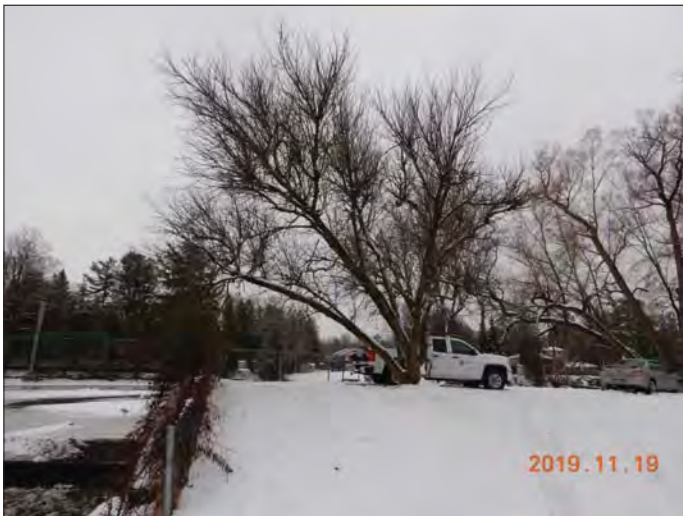
Photo 2694 - Sept 19, 2019
Pefferlaw Dam
Fencing on West Side of Park

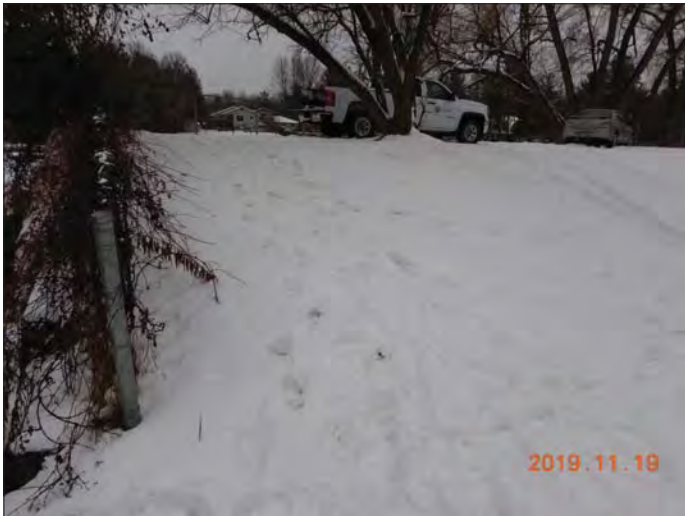
Photo 2702 - Sept 19, 2019
Pefferlaw Dam
Large Tree on Right (East) Earth Embankment

Recommendation	Description of Deficiency	Priority	Estimated Cost	Additional Comments
1. Remove the trees from the earth embankment and from adjacent to concrete or masonry structures and remediate the voids left by the root systems.	There are a significant number of large trees located on the earth embankment sections.	Medium	\$15,000	The cost estimate assumes that a contractor would be hired to remove the trees, remediate the root systems and restore the earth embankment. Cost savings may be realized if the LSRCA is able to complete this work using internal resources.

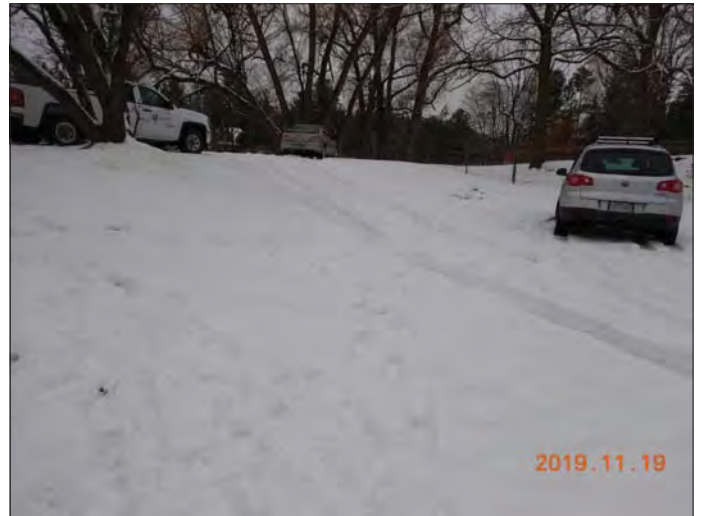
Photo 2703 - Sept 19, 2019
Pefferlaw Dam

Downstream Left (West) Earth Embankment

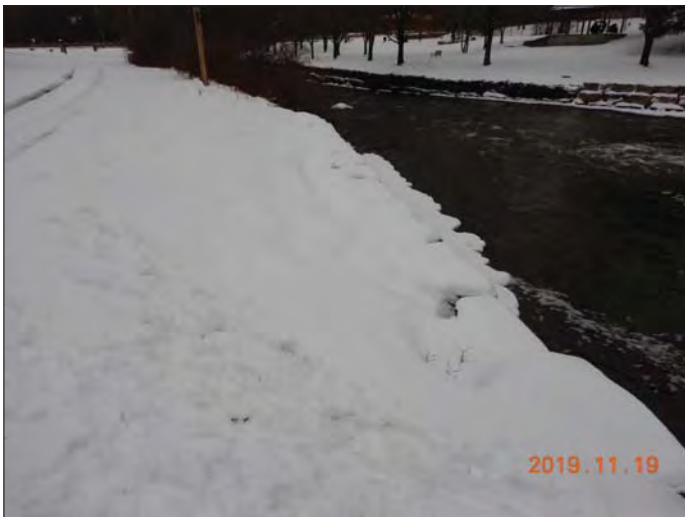
Photo 2704 - Sept 19, 2019
Pefferlaw Dam

Downstream Left (West) Earth Embankment

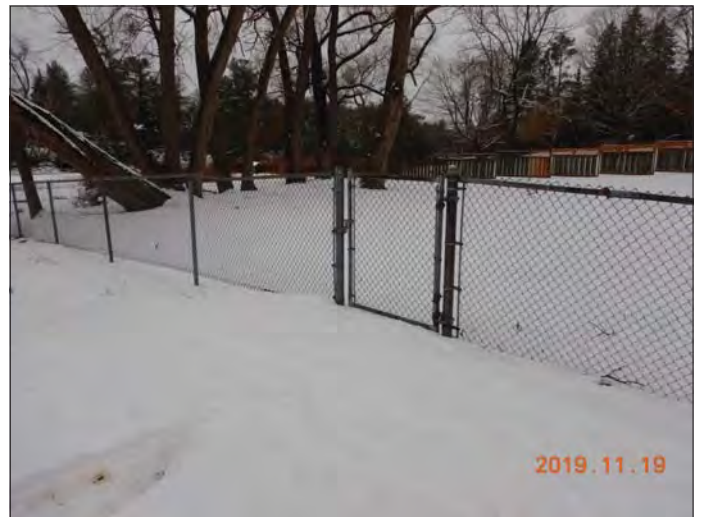
Photo 2705 - Sept 19, 2019
Pefferlaw Dam

7. Repair the erosion behind the downstream left (west) and right (east) armour stone retaining walls.	There is erosion behind the armour stone retaining walls.	High	\$25,000	The scope of the erosion repair is difficult to determine due to the presence of snow on the ground during the dam inspection. The cost estimate assumes that the LSRCA will retain a contractor to complete the work.

Downstream Left (West) Armour Stone Retaining Wall

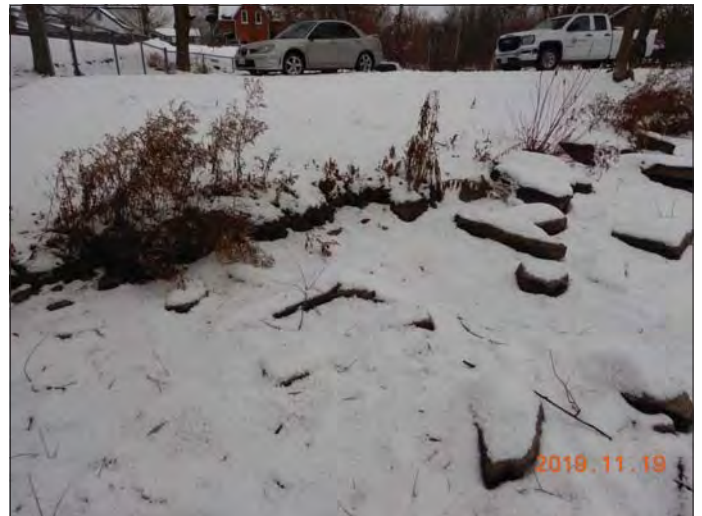
Photo 2712 - Sept 19, 2019
Pefferlaw Dam

Upstream Left (West) Earth Embankment

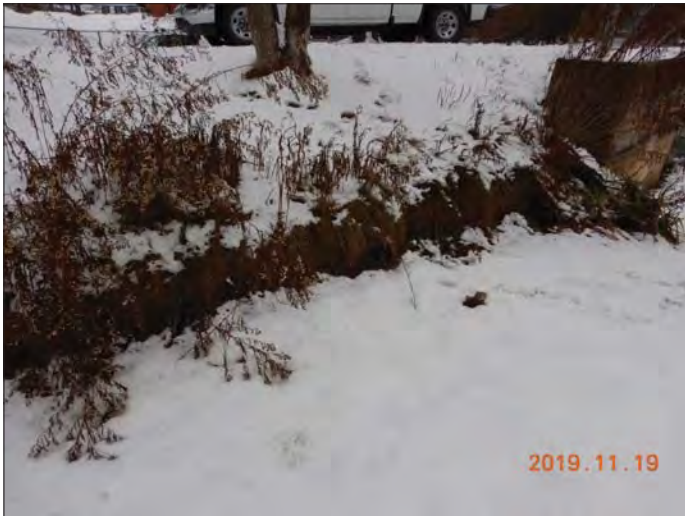
Photo 2713 - Sept 19, 2019
Pefferlaw Dam

Upstream Left (West) Earth Embankment

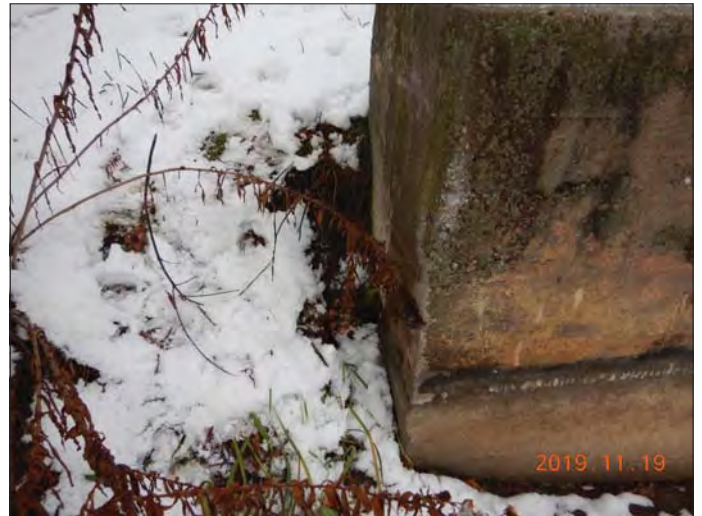
Photo 2715 - Sept 19, 2019
Pefferlaw Dam

Upstream Left (West) Earth Embankment

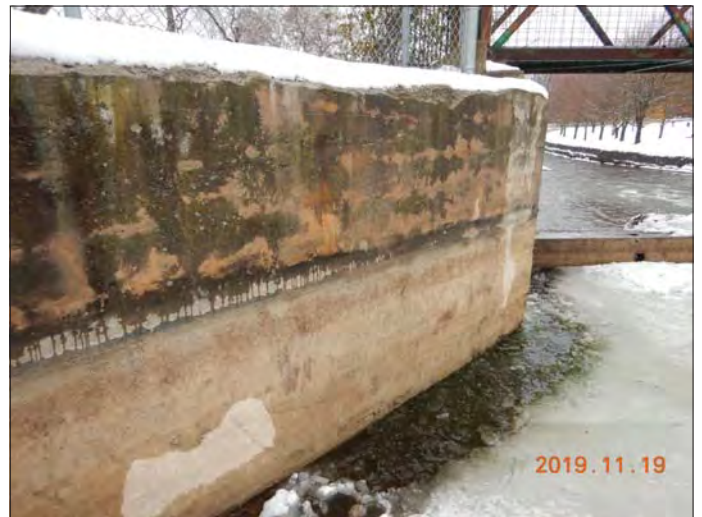
Photo 2720 - Sept 19, 2019
Pefferlaw Dam

Upstream Left (West) Retaining Wall

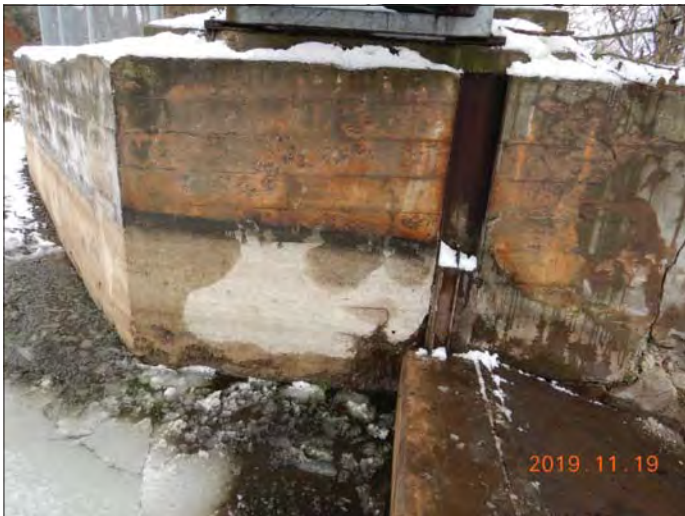
Photo 2723 - Sept 19, 2019
Pefferlaw Dam

Upstream Left (West) Retaining Wall

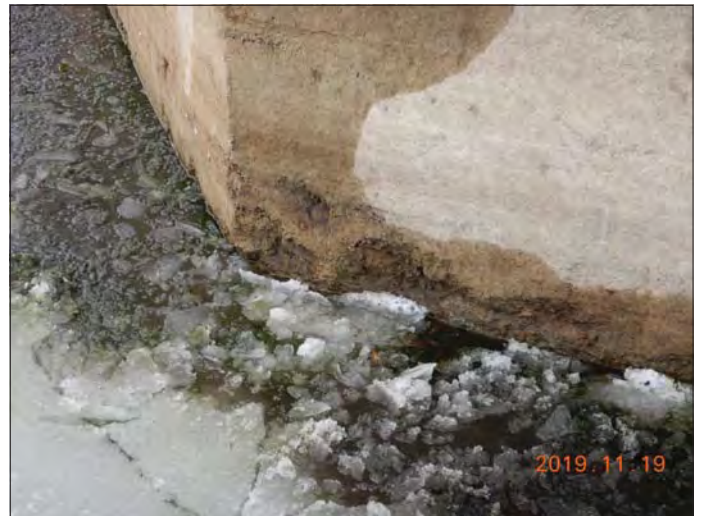
Photo 2724 - Sept 19, 2019
Pefferlaw Dam

Left (West) Dam Abutment

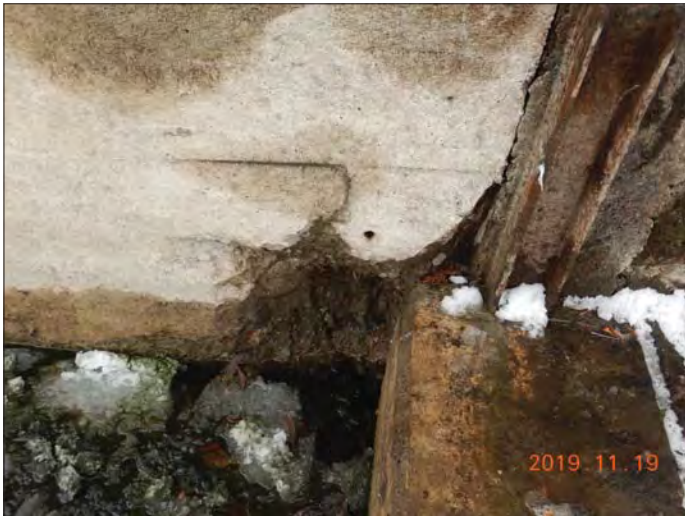
Photo 2725 - Sept 19, 2019
Pefferlaw Dam

Left (West) Dam Abutment

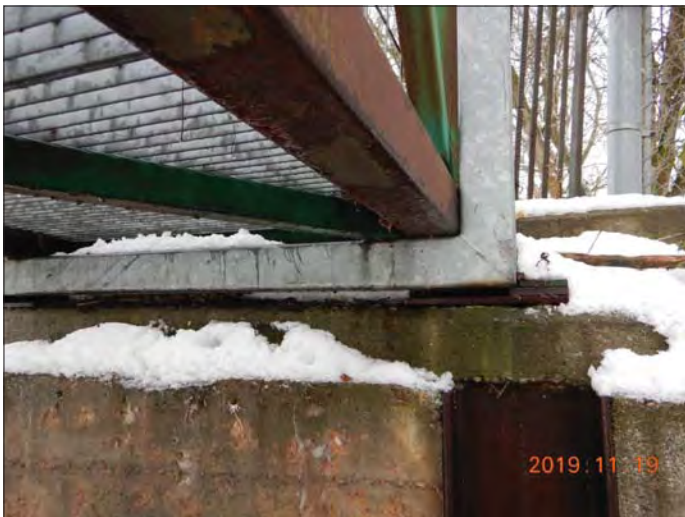
Photo 2727 - Sept 19, 2019
Pefferlaw Dam

Flashboard Gain, Left (West) Side of Left (West) Weir

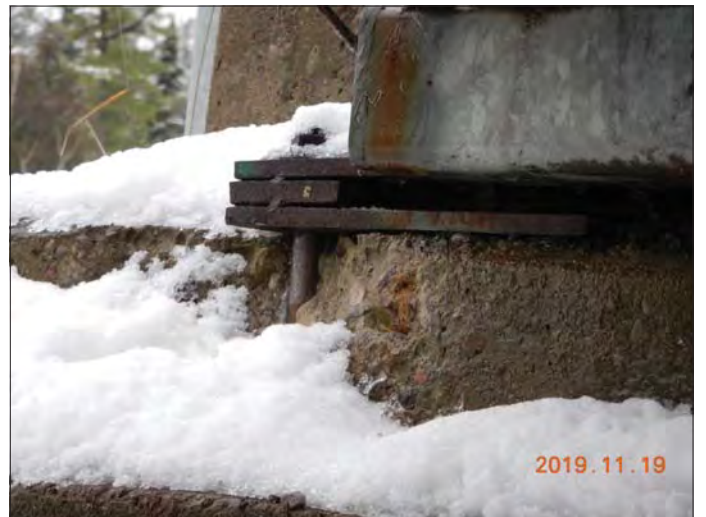
Photo 2728 - Sept 19, 2019
Pefferlaw Dam

Left (West) Bridge Abutment and Anchor, Downstream Side

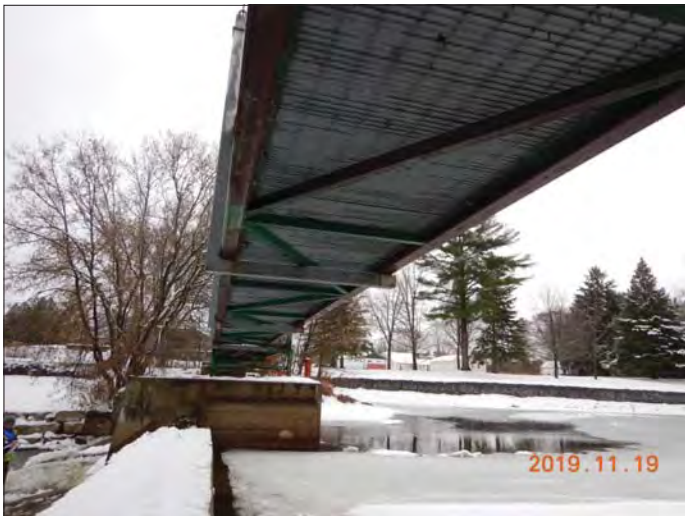
Photo 2730 - Sept 19, 2019
Pefferlaw Dam

Left (West) Bridge Abutment and Anchor, Upstream Side

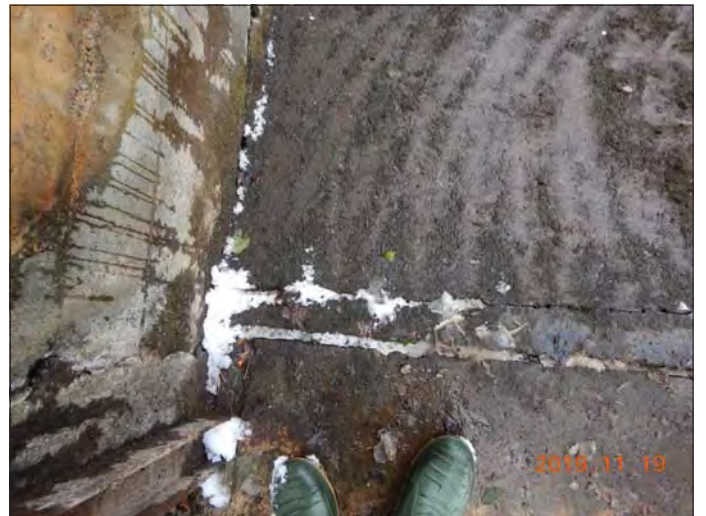
Photo 2731 - Sept 19, 2019
Pefferlaw Dam

Underside of Truss Bridge

Truss Bridge – The east and west pedestrian spans are in fair condition, with coating failure and minor corrosion throughout.

3. Undertake a structural evaluation of the truss bridge within one (1) year and develop a detailed repair or replacement design for the truss bridge and dam deck. Depending on the results of the structural evaluation, temporary repairs, the removal of the stoplogs stored on the deck or temporary suspension of dam operations may be required.	The steel truss is in poor condition with failure of the coating and cracking and bowing of the structural steel members.	Immediate	\$5,000*	<p>The cost estimate provided is the cost for the structural evaluation only. The cost for the detailed design for the repair or replacement will depend on the results of the structural evaluation and on the structure type but would likely be in the range of \$30,000 to \$60,000.</p> <p>This work should be completed by a professional consulting engineer.</p> <p>As an alternate to undertaking Recommendation 3, the LSRCA could stop operating the dam, remove the stoplogs stored on the dam and eliminate public access across the dam. However, this is only seen as a short term solution and a permanent solution, such as repair, replacement or dam decommissioning will ultimately be required in order to ensure public and operator safety.</p>

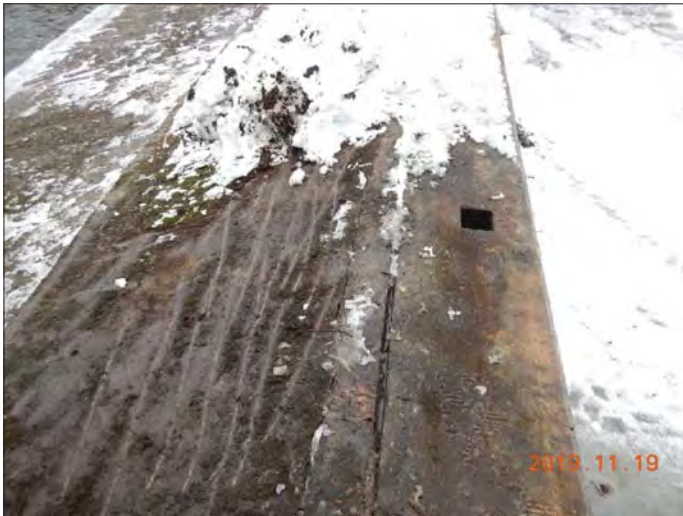
Photo 2733 - Sept 19, 2019
Pefferlaw Dam

Left (West) Weir Crest at Left (West) Dam Abutment

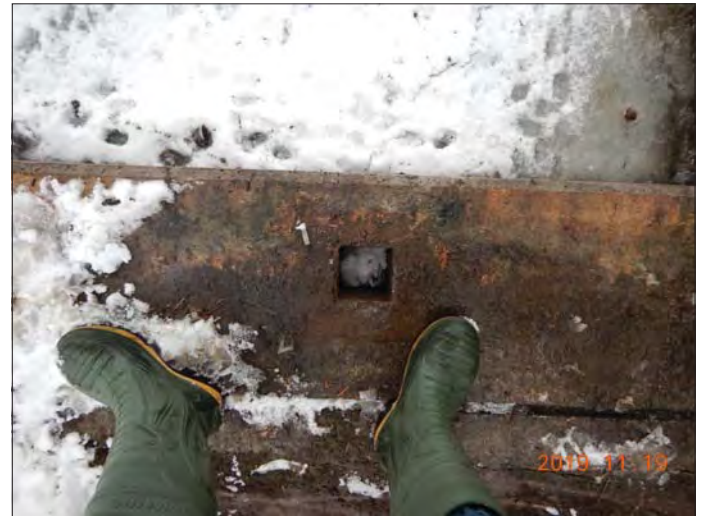
Photo 2734 - Sept 19, 2019
Pefferlaw Dam
Left (West) Weir Crest

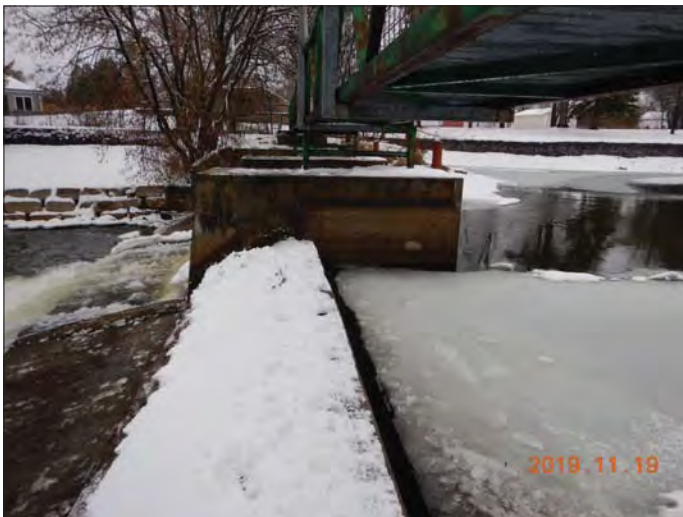
Photo 2735 - Sept 19, 2019
Pefferlaw Dam
Flashboard Post Hole (Typical)

Recommendation	Description of Deficiency	Priority	Estimated Cost	Additional Comments
5. Replace the flashboards and flashboard posts, as planned. Note: Future replacement of the stoplogs may be required.	The flashboards and flashboard posts are in poor condition and the LSRCA is already planning to replace them. The stoplogs may require replacement in 2 to 5 years.	High	\$8,000	The cost estimate assumes that the LSRCA will outsource the fabrication of the flashboard posts and will fabricate the flashboards using internal resources.

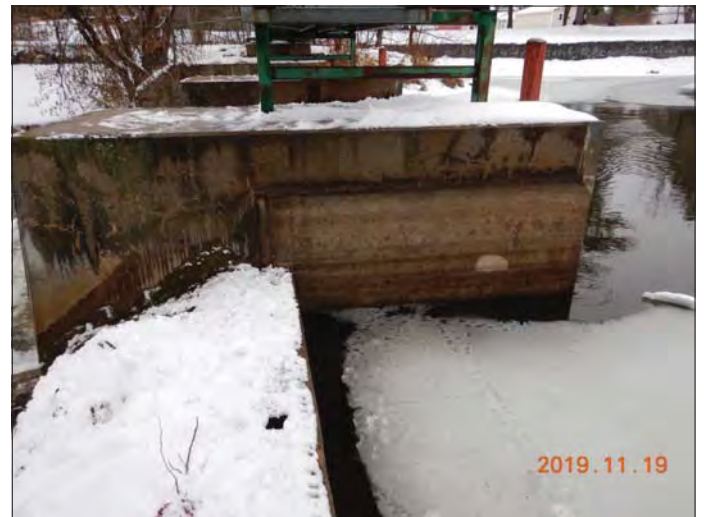
Photo 2738 - Sept 19, 2019
Pefferlaw Dam
Left (West) Weir and Left Side of Pier 1 (West Pier)

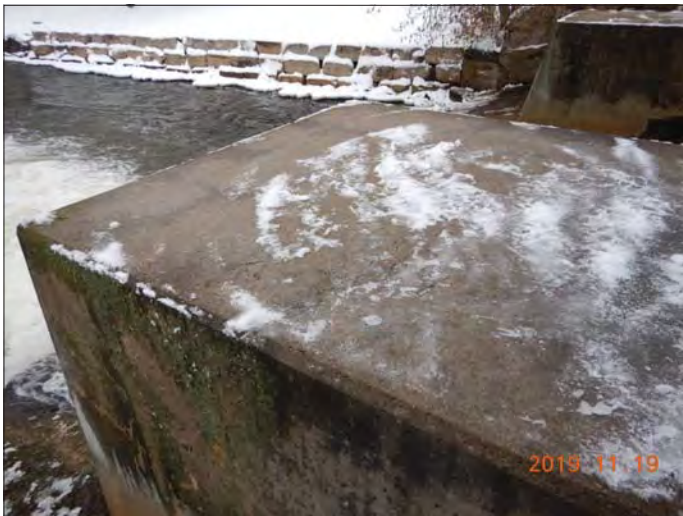
Photo 2739 - Sept 19, 2019
Pefferlaw Dam
Left Side of Pier 1 (West Pier)

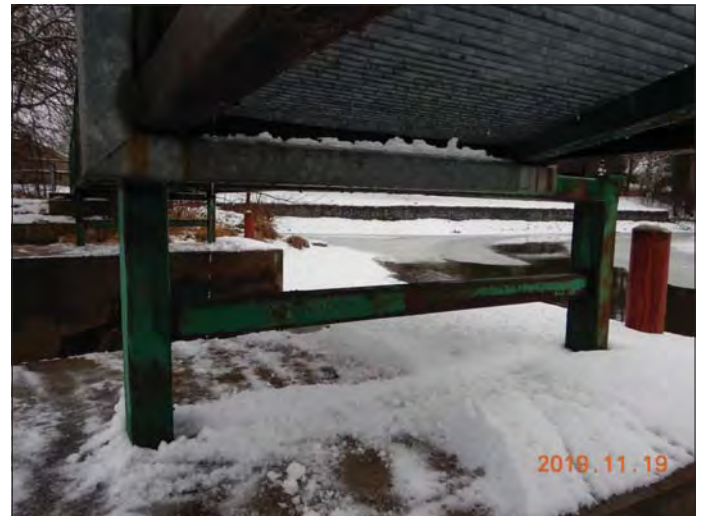
Photo 2742 - Sept 19, 2019
Pefferlaw Dam
Top of Pier 1 (West Pier)

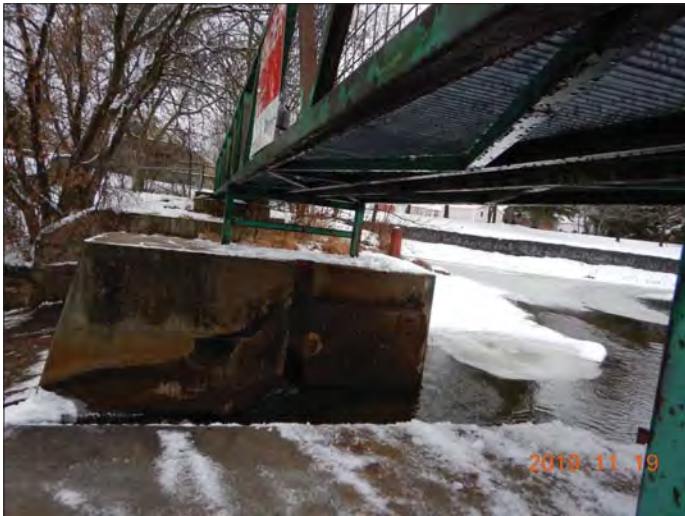
Photo 2744 - Sept 19, 2019
 Pepperlaw Dam
 Left (West) Side of Pier 2 (East Pier)

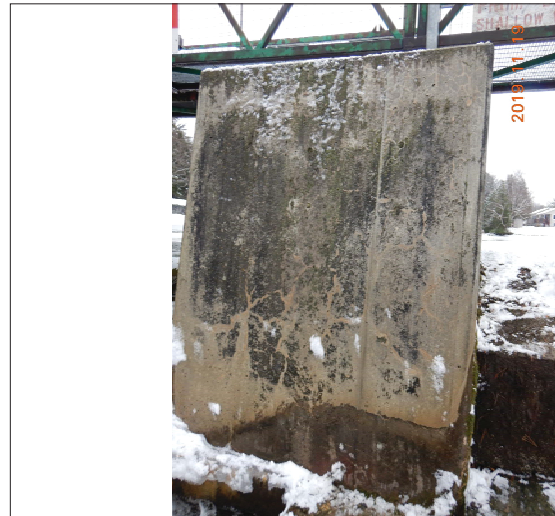
Photo 2747 - Sept 19, 2019
 Pepperlaw Dam
 Downstream Side of Pier 1 (West Pier)

Pier 1 (West Pier) – The downstream face and top surface of the pier is in good condition. The upstream, west and east faces are also in good condition with some map cracking, cracks with efflorescence and pitting above the high water mark. Video of the underwater inspection did not indicate any undermining of the pier or significant concrete deterioration below the winter water level.

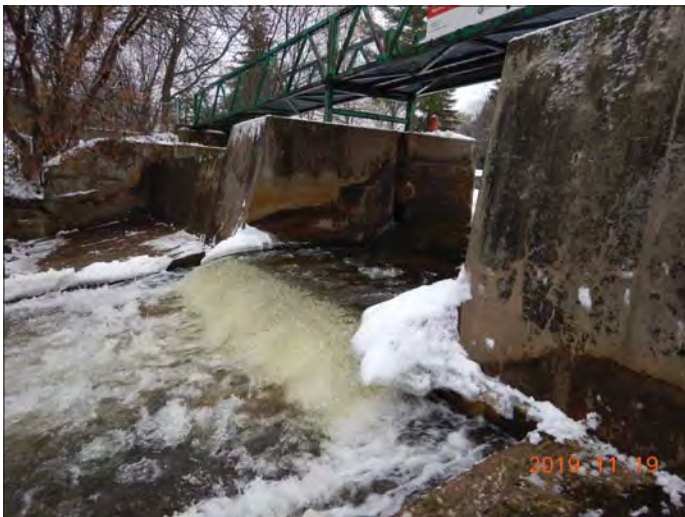
Photo 2751 - Sept 19, 2019
 Pepperlaw Dam
 Stoplog Sluiceway

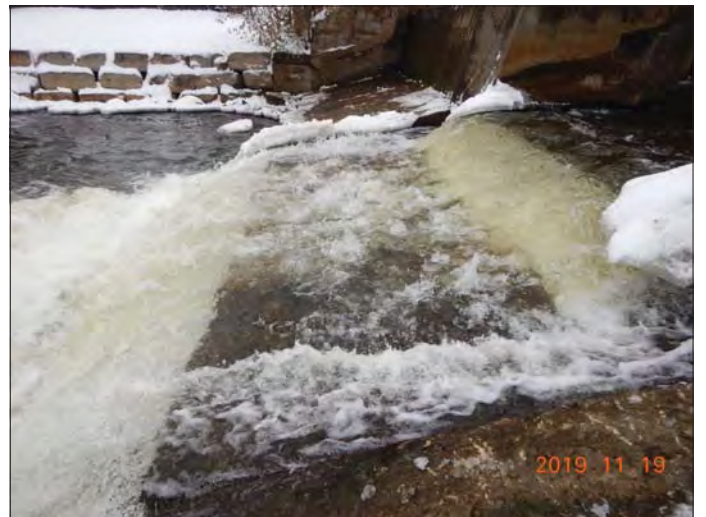
Photo 2752 - Sept 19, 2019
 Pepperlaw Dam
 Stoplog Sluiceway Apron

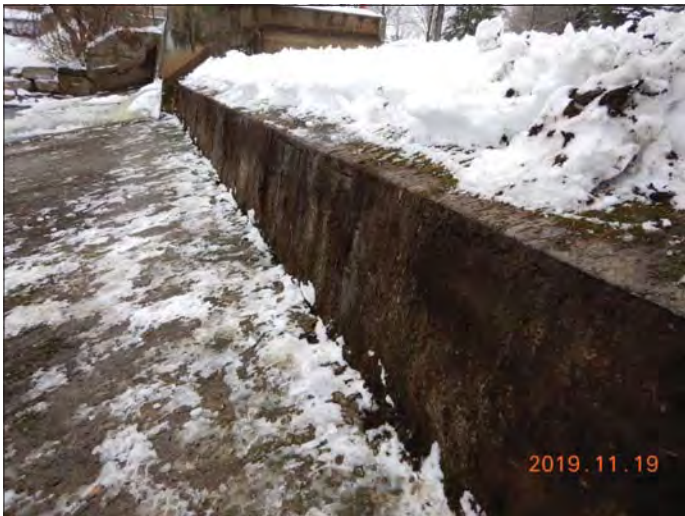
Photo 2759 - Sept 19, 2019
 Pepperlaw Dam
 Left (West) Weir and Left (West) Apron

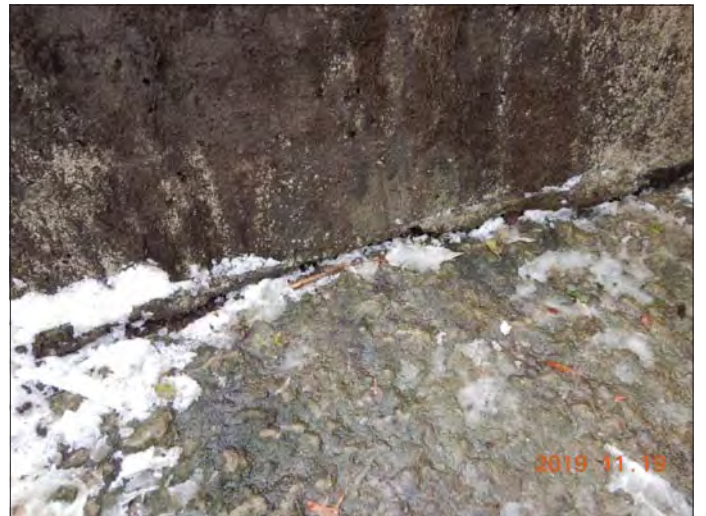
Photo 2760 - Sept 19, 2019
 Pepperlaw Dam
 Gap Between Left (West) Weir and Left (West) Apron

Left (West) Weir – Inspection of the left (west) weir was limited as it was partially snow covered during the inspection. There is a large gap (25 mm) at the construction joint where the flat section of the weir crest meets the sloping section of the weir crest. There is also a wide crack located approximately 200 mm downstream of the construction joint. There is a 600 mm wide strip along the sloping section of the weir that is delaminated in the area that was exposed by Wills' snow removal. The flat section of the weir crest contains a number of square holes for the installation of the flashboard posts. There appears to be a construction joint approximately 60 mm below the downstream weir crest on the downstream face of the weir. The downstream face of the weir is in good condition, however, there is a 30 mm gap at the interface of the weir and the apron. Video from the underwater inspection did not identify any undercutting of the upstream side of the weir.

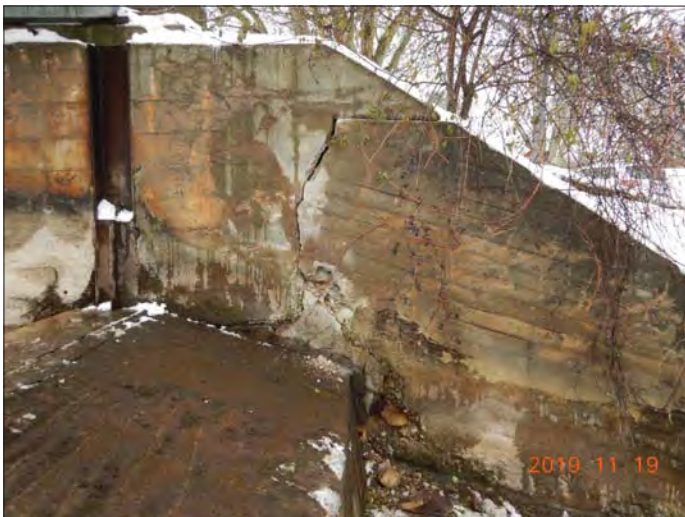
Lake Simcoe Region
conservation authority
Photo 2764 - Sept 19, 2019
Pefferlaw Dam
Left (West) Dam Abutment

Left (West) Dam Abutment – The left (west) dam abutment is generally in fair to poor condition. There is a large spall measuring approximately 500 mm by 400 mm by 200 mm deep at the interface of the upstream face of the left (west) weir and the left

There is a wide crack at a construction joint that extends across the height of the wall extending from the interface with the left (west) weir to the top of the wall. There are two large spalls above the downstream crest of the weir along the wide crack measuring approximately 400 mm by 600 mm (exposed and corroded steel reinforcing, large round aggregate) and 450 mm by 700 mm. There is another spall at the base of the abutment (where it meets the apron) that measures approximately 600 mm by 200 mm.

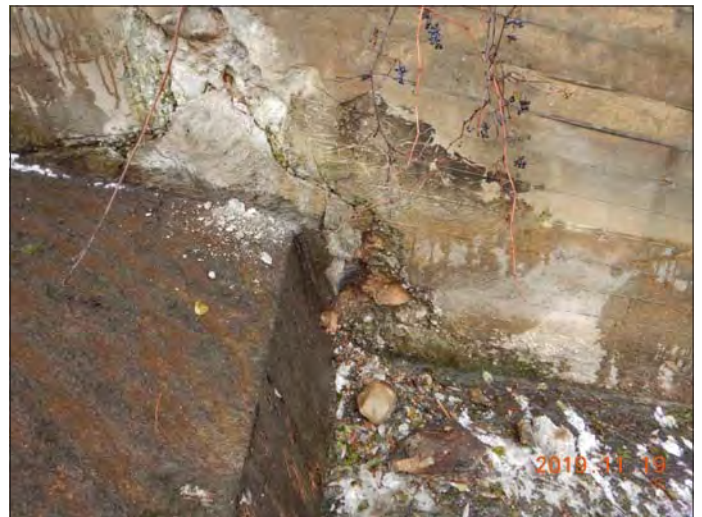
Lake Simcoe Region
conservation authority
Photo 2765 - Sept 19, 2019
Pefferlaw Dam
Left (West) Dam Abutment

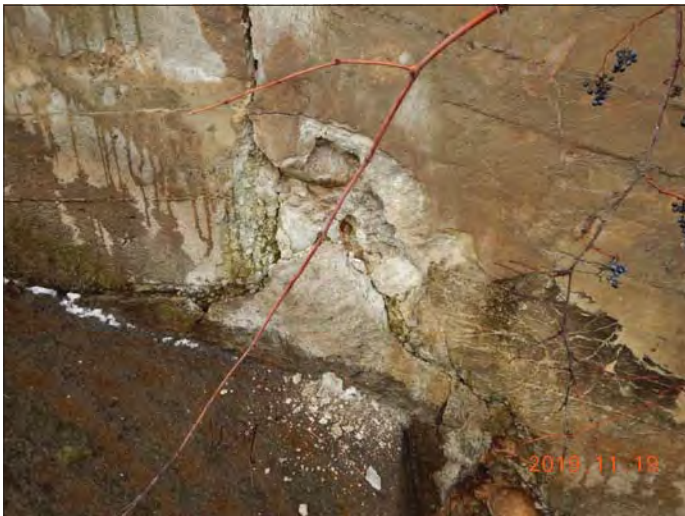
Lake Simcoe Region
conservation authority
Photo 2766 - Sept 19, 2019
Pefferlaw Dam
Left (West) Dam Abutment

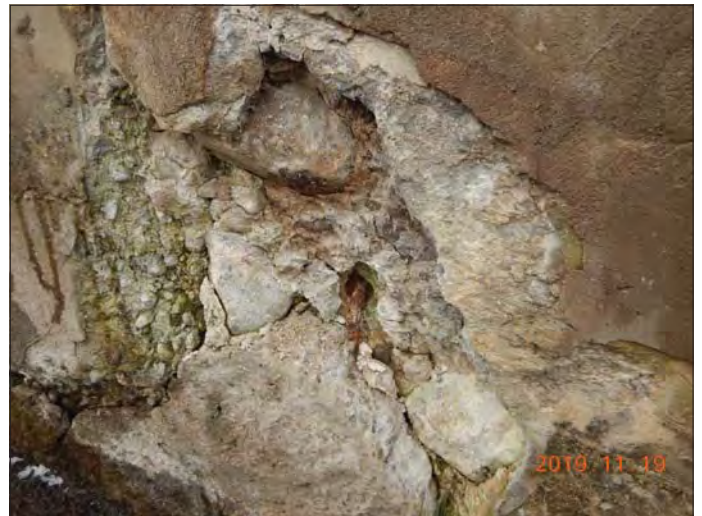
Lake Simcoe Region
conservation authority
Photo 2767 - Sept 19, 2019
Pefferlaw Dam
Left (West) Dam Abutment

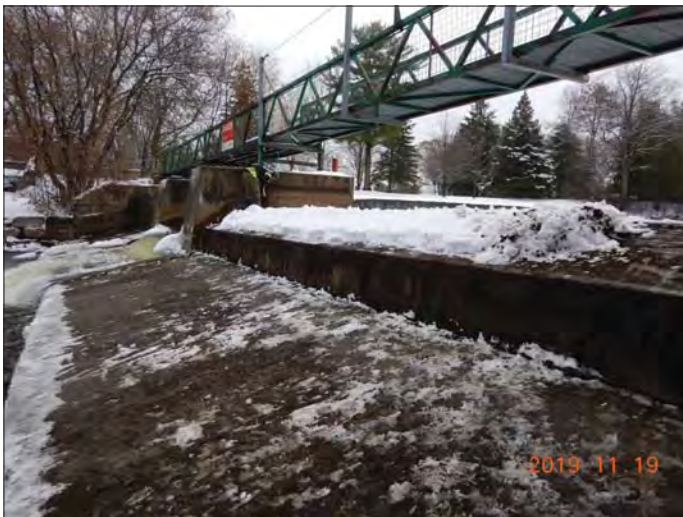
Photo 2773 - Sept 19, 2019
 Pefferlaw Dam
 Left (West) Side of Dam

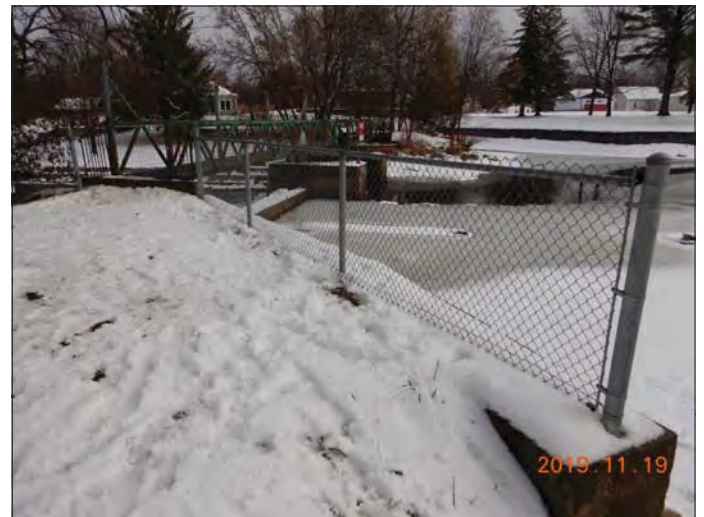
Photo 2777 - Sept 19, 2019
 Pefferlaw Dam
 Fencing on Left (West) Retaining Wall
