Dam Inspection Report

Pefferlaw Dam

Town of Georgina
Regional Municipality of York

December 2019

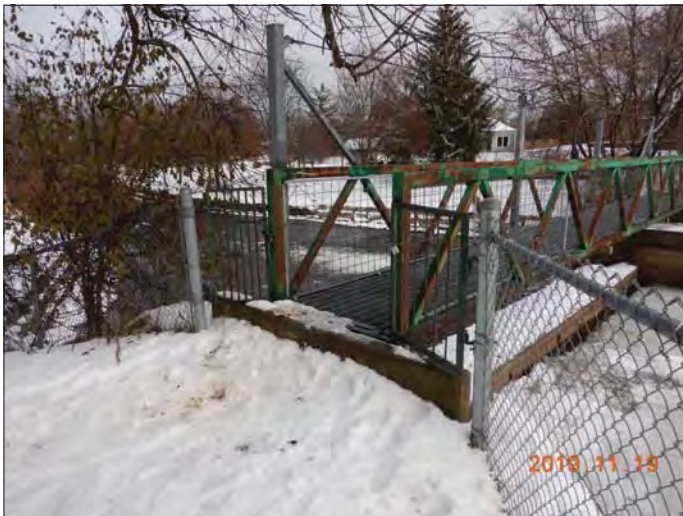
Photo 2778 - Sept 19, 2019
 Pefferlaw Dam
 Entrance to Left (West) Side of Truss Bridge

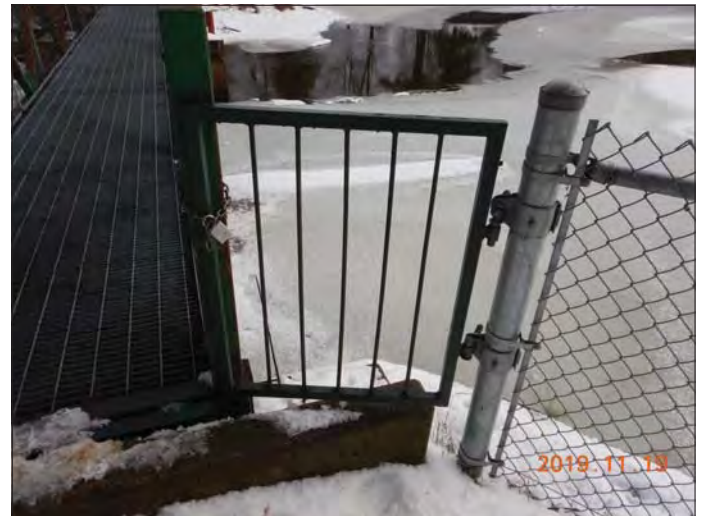
Photo 2779 - Sept 19, 2019
 Pefferlaw Dam
 Locked Gate on Upstream, Left (West) Side of Truss Bridge

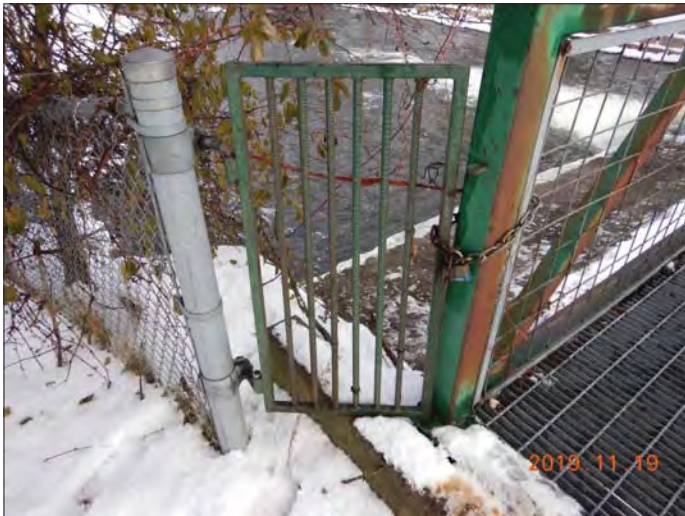
Lake Simcoe Region
conservation authority
 Photo 2780 - Sept 19, 2019
Pefferlaw Dam
 Locked Gate on Downstream, Left (West) Side of Truss Bridge

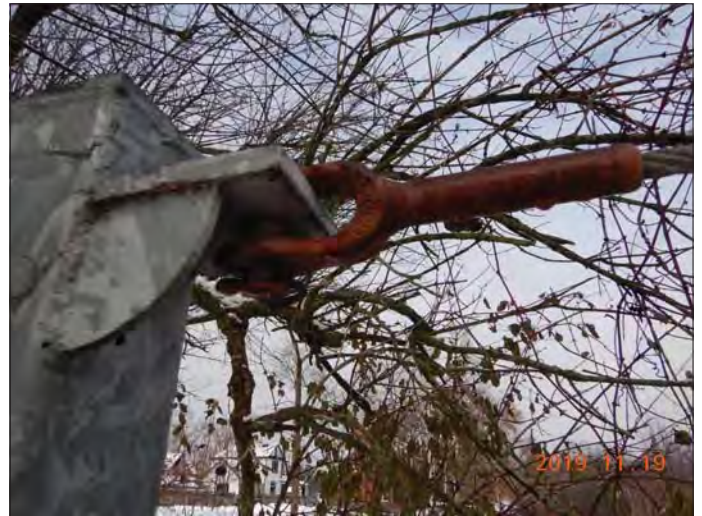
Lake Simcoe Region
conservation authority
 Photo 2781 - Sept 19, 2019
Pefferlaw Dam
 Fall Arrest Cable Connection, Left (West) Side

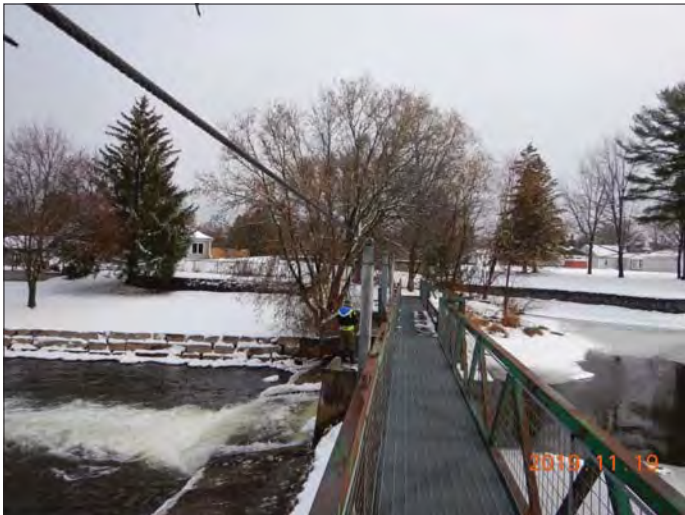
Lake Simcoe Region
conservation authority
 Photo 2782 - Sept 19, 2019
Pefferlaw Dam
 Fall Arrest Cable

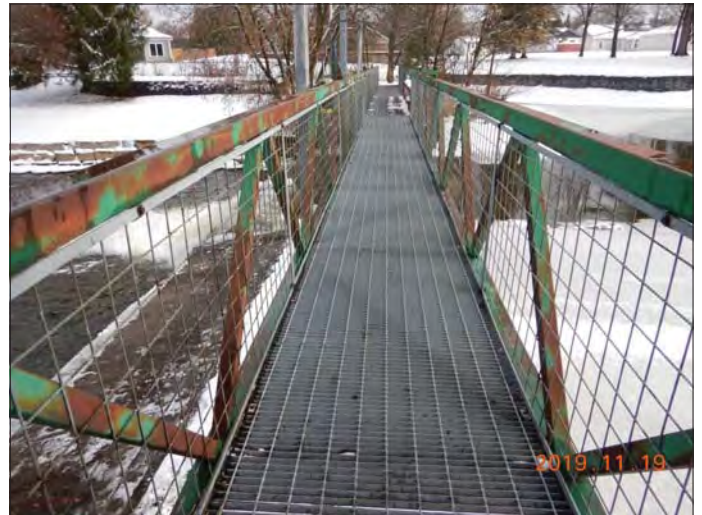
Lake Simcoe Region
conservation authority
 Photo 2783 - Sept 19, 2019
Pefferlaw Dam
 Typical Deck Grating and Railing

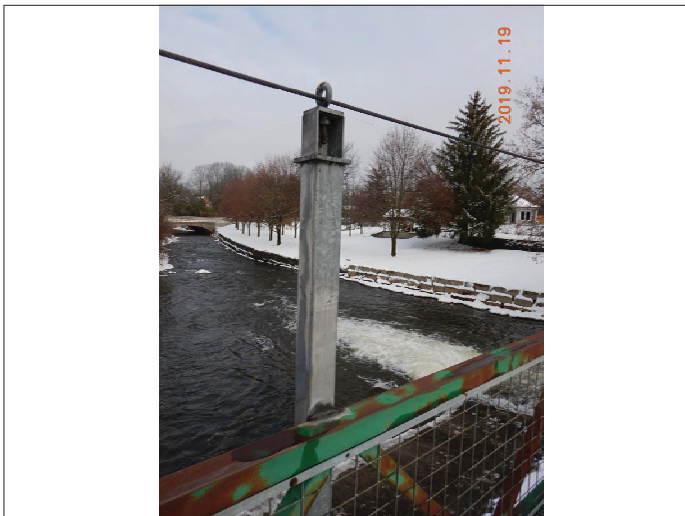
Lake Simcoe Region
conservation authority
 Photo 2786 - Sept 19, 2019
Pefferlaw Dam
 Fall Arrest Cable Mid Support

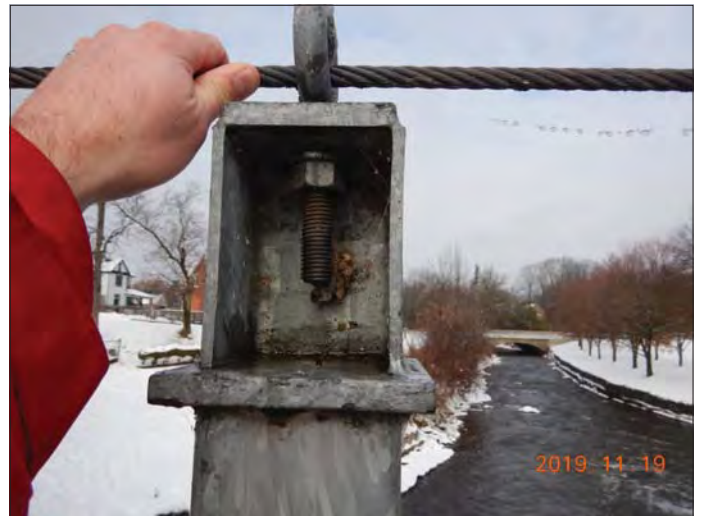
Lake Simcoe Region
conservation authority
 Photo 2787 - Sept 19, 2019
Pefferlaw Dam
 Fall Arrest Cable Mid Support Connection

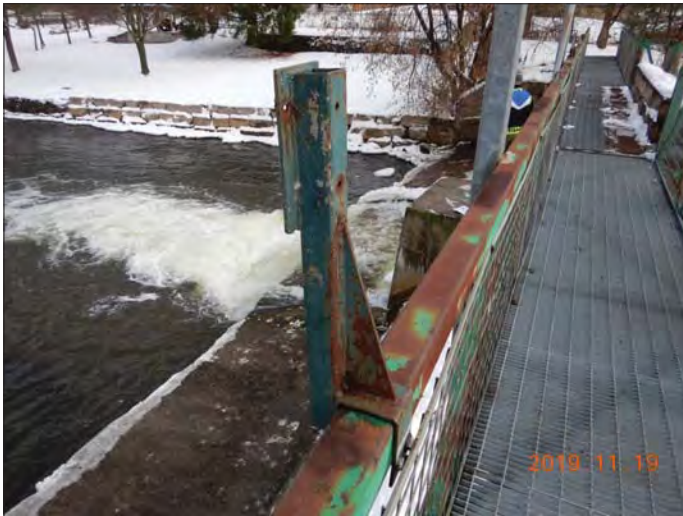
Photo 2790 - Sept 19, 2019
Pefferlaw Dam
Remnants of Fish Ladder Bracket

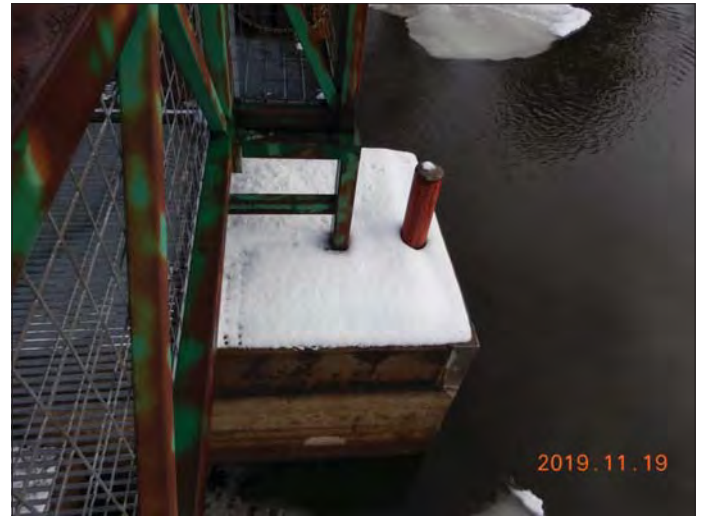
Photo 2792 - Sept 19, 2019
Pefferlaw Dam
Top of Upstream Side of Pier 1 (West Pier)

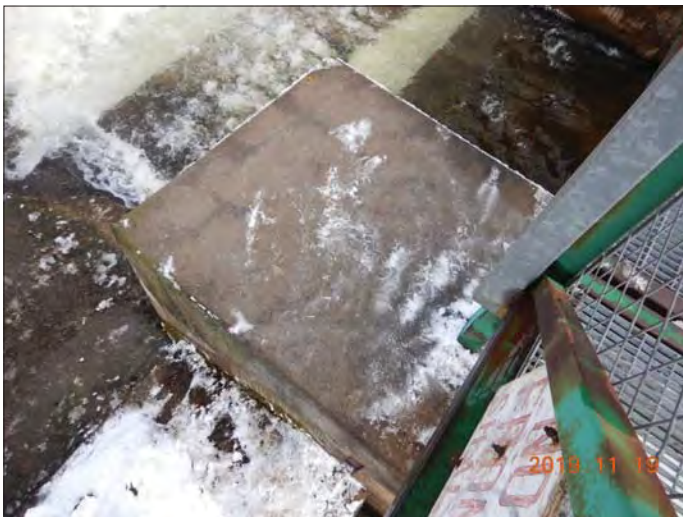
Photo 2793 - Sept 19, 2019
Pefferlaw Dam
Top of Downstream Side of Pier 1 (West Pier)

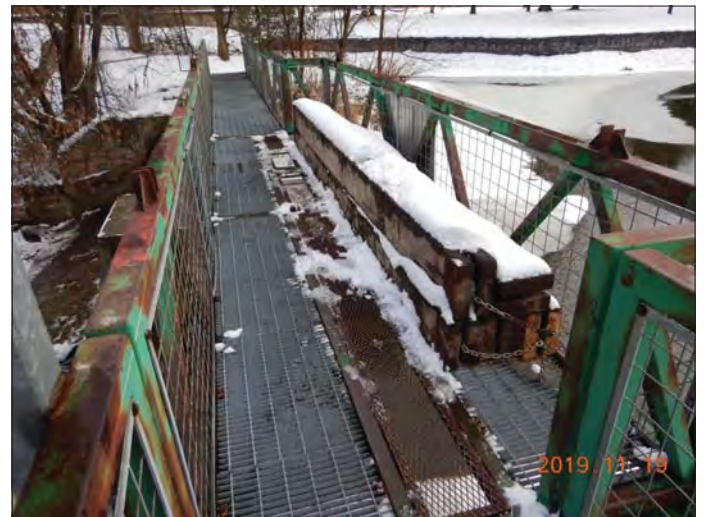
Photo 2794 - Sept 19, 2019
Pefferlaw Dam
Operating Deck and Stoplog Storage Above Sluiceway

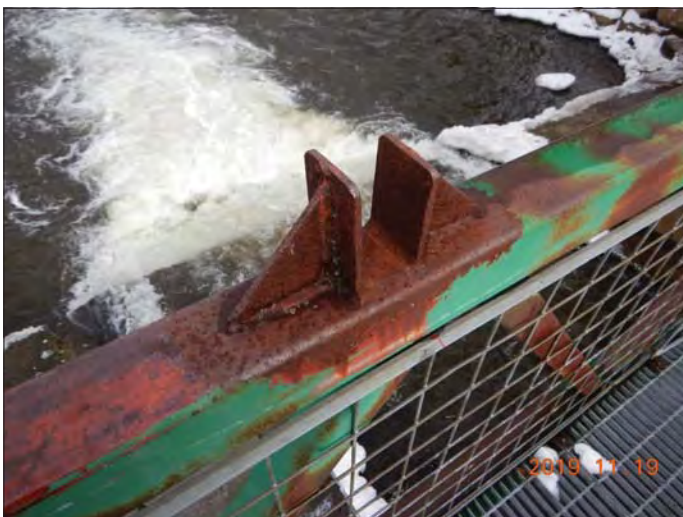
Photo 2795 - Sept 19, 2019
Pefferlaw Dam
Winch Mounting Bar Bracket, Downstream Left

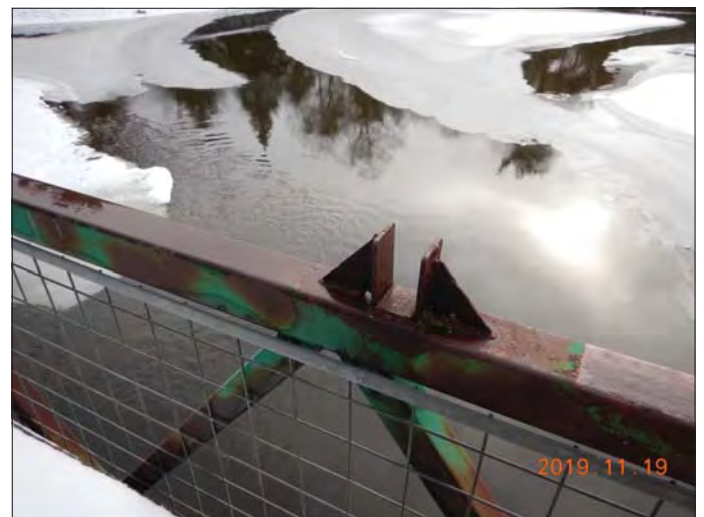
Photo 2796 - Sept 19, 2019
Pefferlaw Dam
Winch Mounting Bar Bracket, Upstream Left

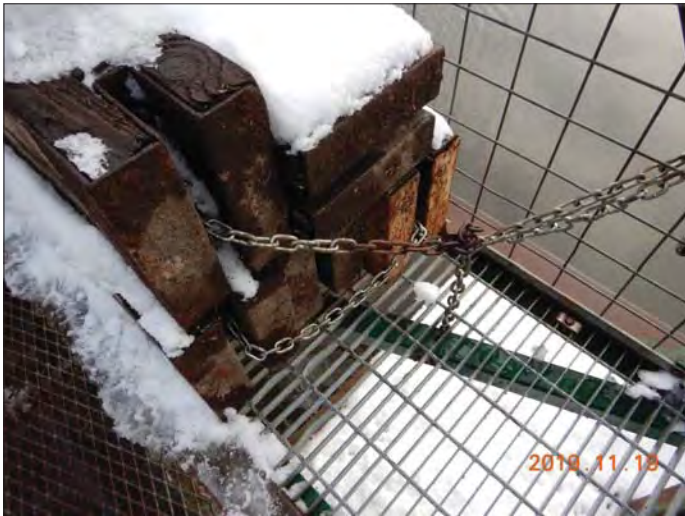
Lake Simcoe Region
conservation authority
 Photo 2797 - Sept 19, 2019
Pefferlaw Dam
 Stoplogs Chained to Truss Bridge

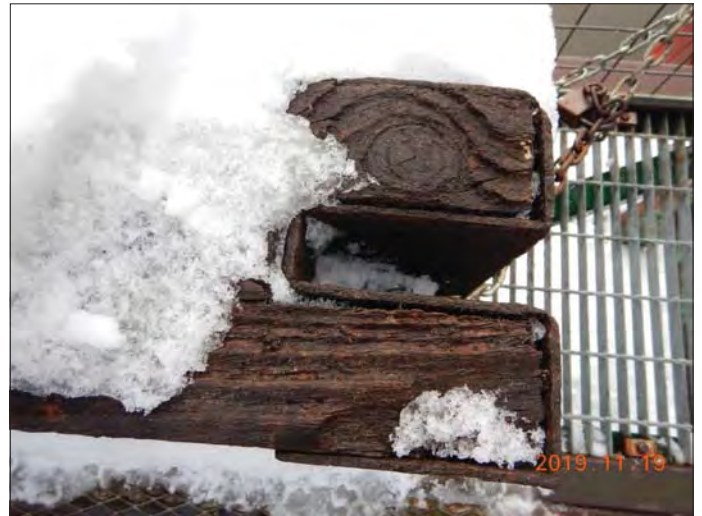
Lake Simcoe Region
conservation authority
 Photo 2798 - Sept 19, 2019
Pefferlaw Dam
 Stoplog Condition

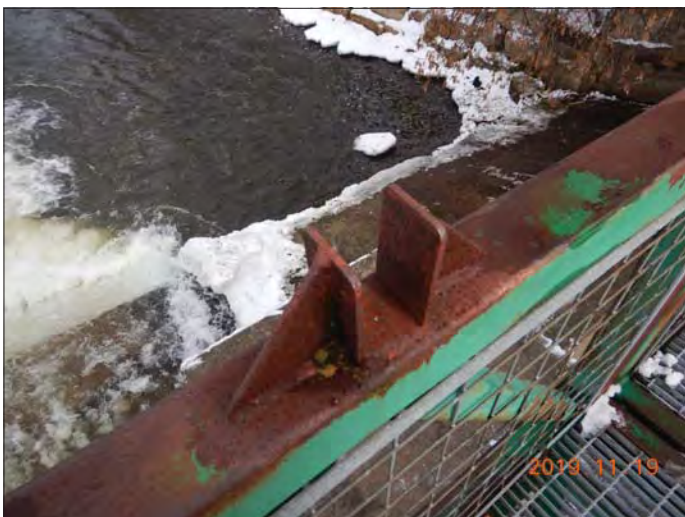
Lake Simcoe Region
conservation authority
 Photo 2803 - Sept 19, 2019
Pefferlaw Dam
 Winch Mounting Bar Bracket, Downstream Right Side

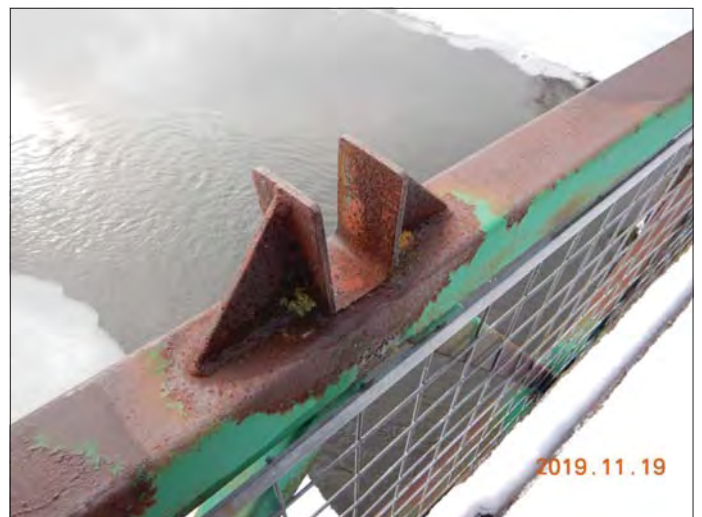
Lake Simcoe Region
conservation authority
 Photo 2804 - Sept 19, 2019
Pefferlaw Dam
 Winch Mounting Bar Bracket, Upstream Right Side

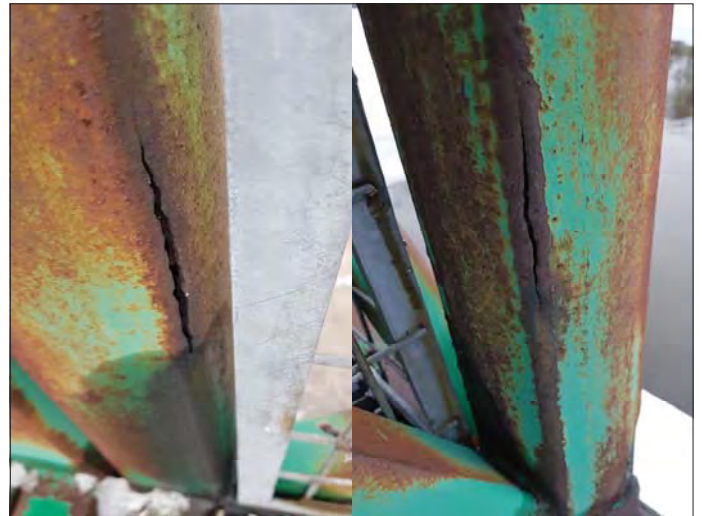
Lake Simcoe Region
conservation authority
 Photo 3916 - Sept 19, 2019
Pefferlaw Dam
 Cracks in Vertical HSS Sections of the Truss Bridge

Truss Bridge – The east and west pedestrian spans are in fair condition, with coating failure and minor corrosion throughout.

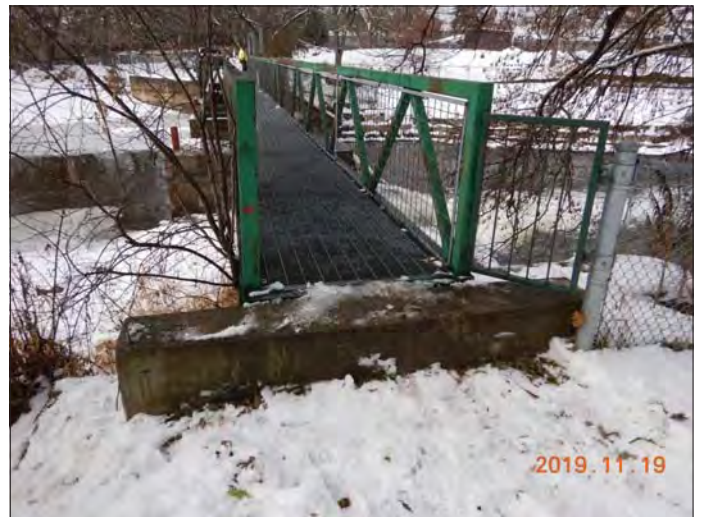
Lake Simcoe Region
conservation authority
 Photo 2814 - Sept 19, 2019
Pefferlaw Dam
 Access to Right (East) Side of Truss Bridge

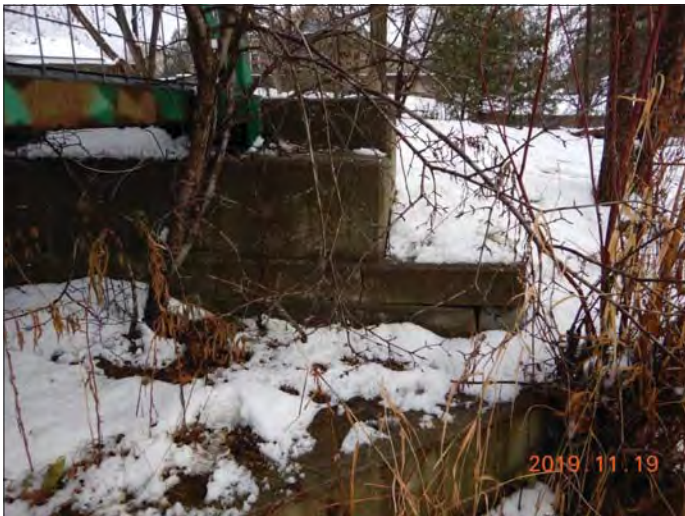
Lake Simcoe Region
conservation authority
 Photo 2817 - Sept 19, 2019
Pefferlaw Dam
 Right (East) Bridge Abutment

Right (East) Bridge Abutment – The right (east) bridge abutment is generally in fair to good condition. There is medium scaling along the face of the abutment, and there is a wide crack in the precast concrete block that is supporting the cast in place abutment.

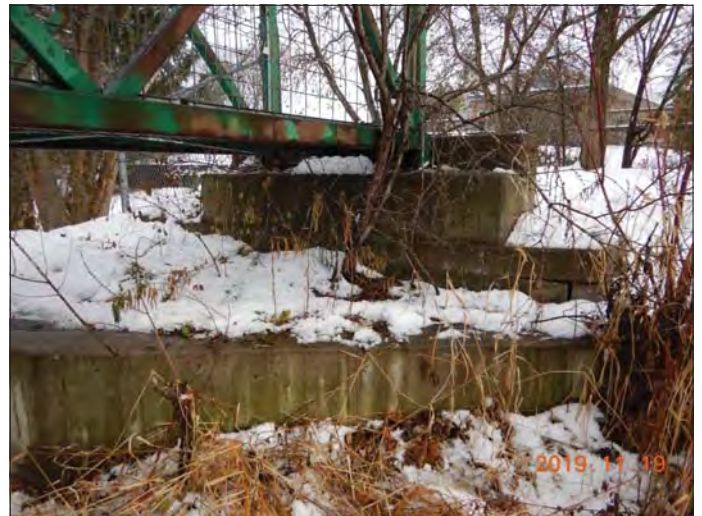
Lake Simcoe Region
conservation authority
 Photo 2818 - Sept 19, 2019
Pefferlaw Dam
 Right (East) Bridge Abutment and Retaining Wall

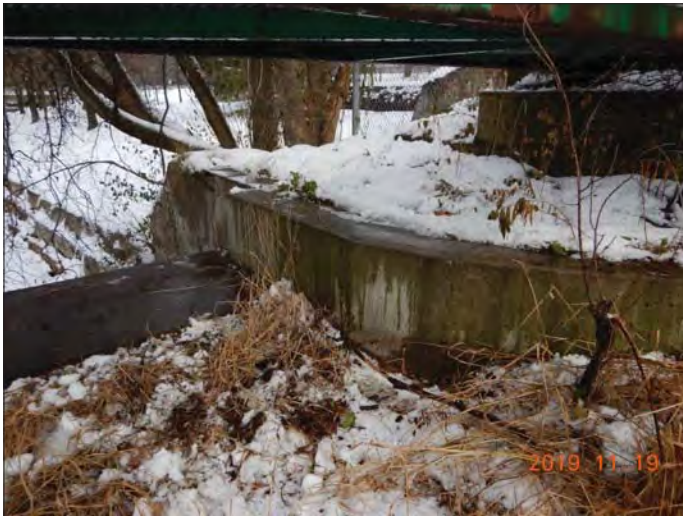
Photo 2819 - Sept 19, 2019
Pefferlaw Dam
Upstream Right (East) Retaining Wall and Dam Abutment

Upstream Right (East) Retaining Wall – Limited inspection, snow and vegetation prevented clear access. The upstream right (east) retaining wall generally appears to be in good condition.

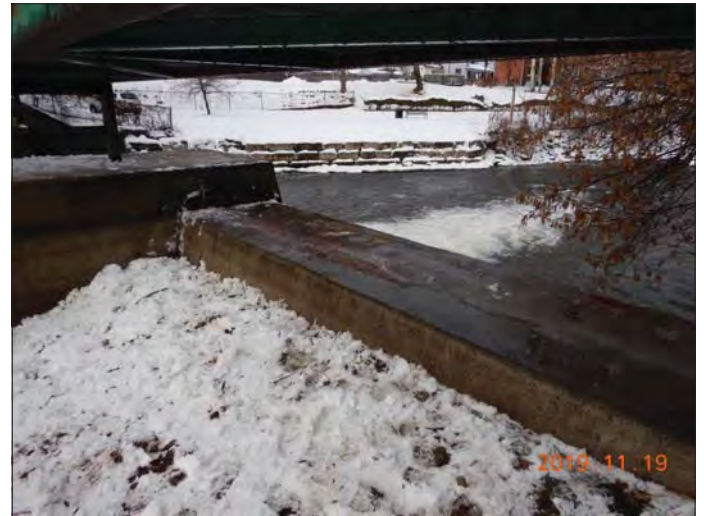
Photo 2820 - Sept 19, 2019
Pefferlaw Dam
Right (East) Weir Crest

Right (East) Weir – The upstream face of the weir is generally in good condition with some bug holes. The weir crest is in good condition. The downstream face of the weir is in fair to good condition with honeycombing noted near the interface with the abutment (1.2 m²).

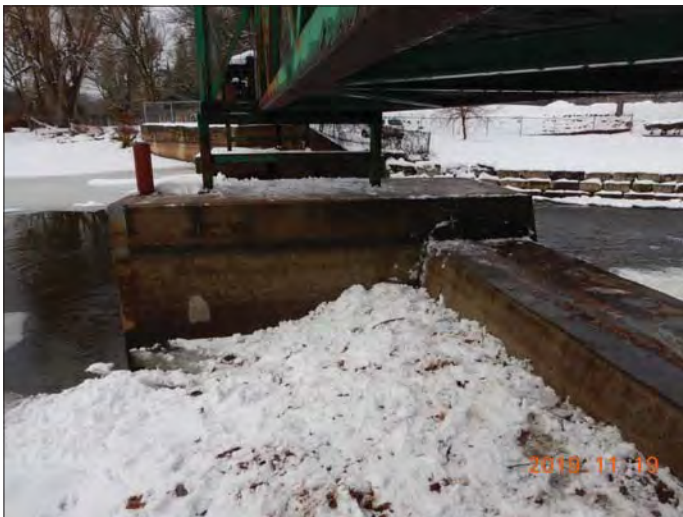
Photo 2821 - Sept 19, 2019
Pefferlaw Dam
Pier 2 (East Pier) Right (East) Side

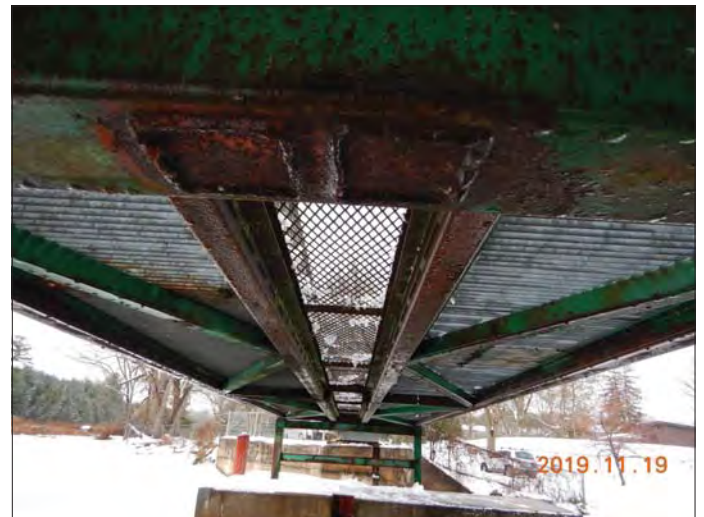
Photo 2823 - Sept 19, 2019
Pefferlaw Dam
Stoplog Gate Cover and Opening from Below

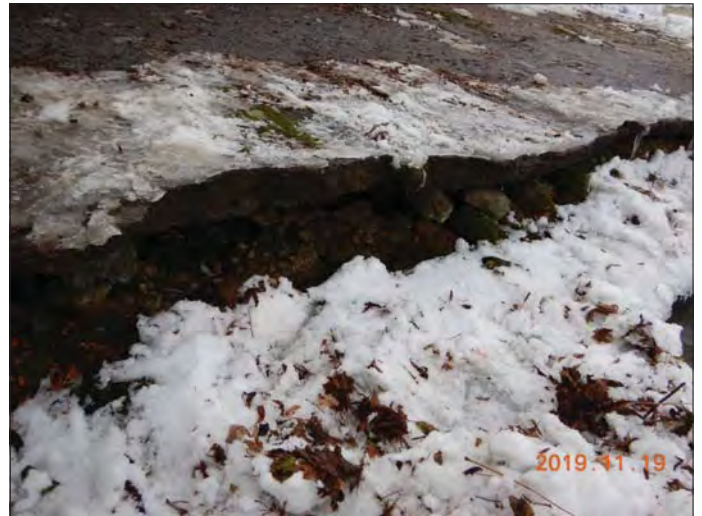
Photo 2829 - Sept 19, 2019
Pefferlaw Dam

Downstream Side of Dam from Right (East) Side

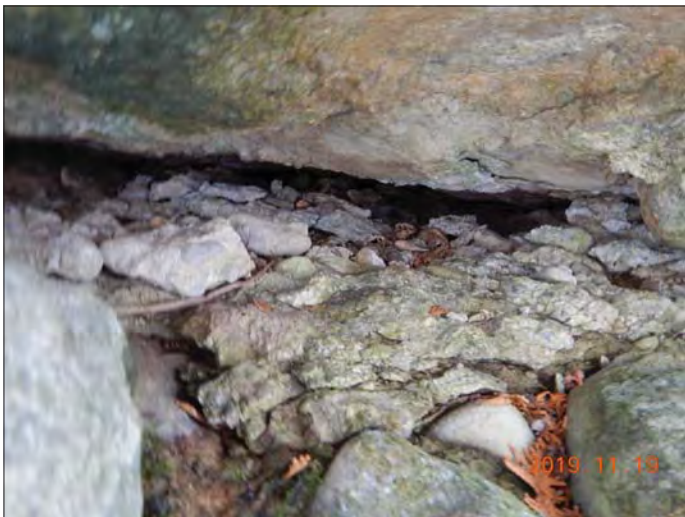
Photo 2832 - Sept 19, 2019
Pefferlaw Dam

Right (East) Apron

Right (East) Apron – There are some medium width cracks along the apron surface. The apron is undermined by approximately 1500 mm and it would appear as though the end of the apron has spalled off. Video from the underwater inspection appears to indicate that the undermining is restricted to the right side of the apron and does not extend to the sluiceway. The top of the apron is approximately 700 mm off the river bottom.

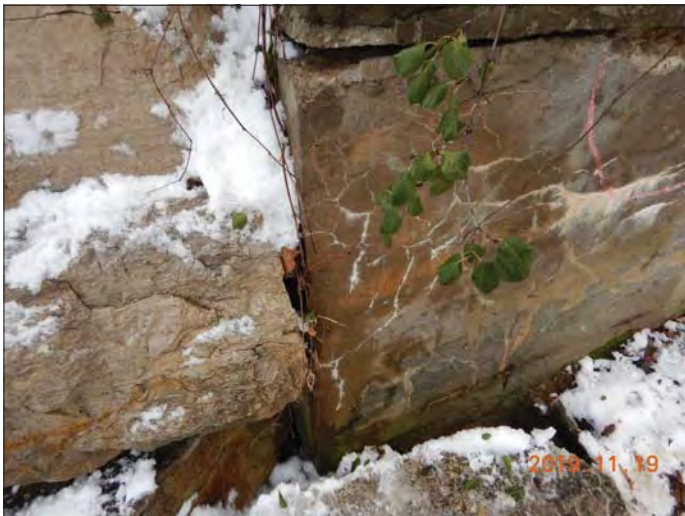
Photo 2833 - Sept 19, 2019
Pefferlaw Dam

Right (East) Apron

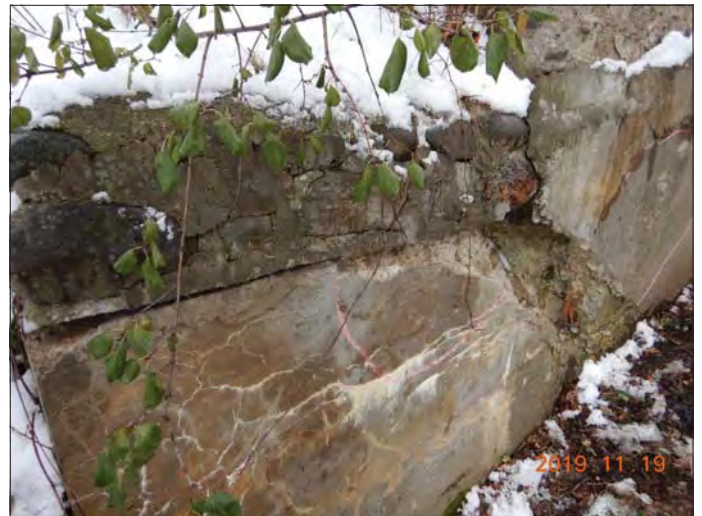
Photo 2834 - Sept 19, 2019
Pefferlaw Dam

Right (East) Dam Abutment

Right (East) Dam Abutment – The right (east) abutment is in poor to very poor condition. There is evidence of patch repairs at this wall area. The majority of the wall surface is delaminated and there are several large spalls. There is some map cracking with efflorescence at the far downstream end of the wall, with a 300 mm by 1000 mm by 300 mm deep void. There is a masonry wall perched on the downstream edge of the right (east) abutment that is in very poor condition.

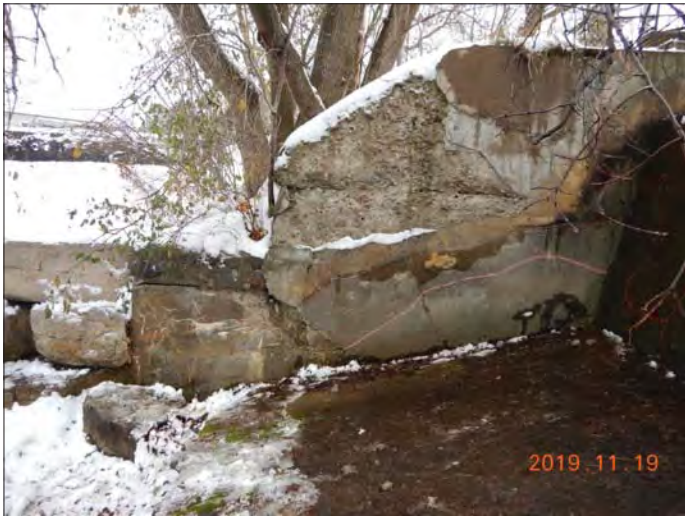
Photo 2835 - Sept 19, 2019
Pefferlaw Dam

Right (East) Dam Abutment

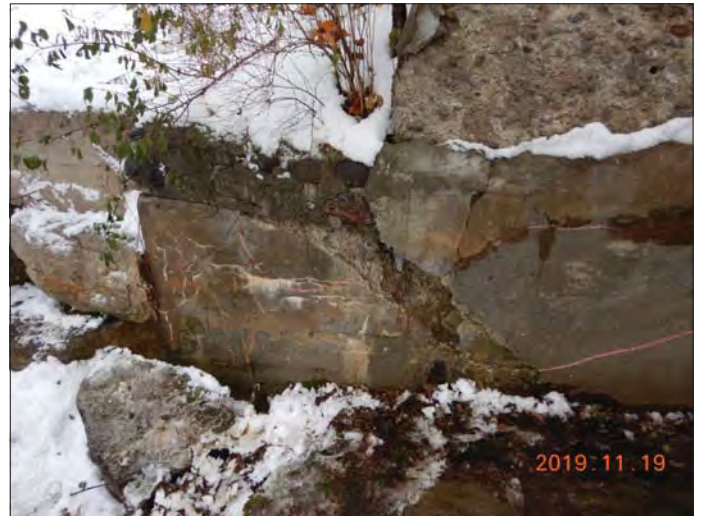
Photo 2836 - Sept 19, 2019
Pefferlaw Dam
Right (East) Dam Abutment

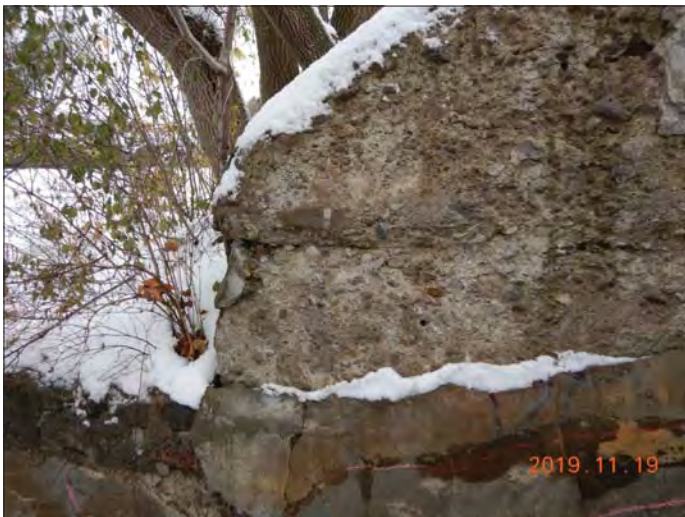
Photo 2838 - Sept 19, 2019
Pefferlaw Dam
Right (East) Dam Abutment

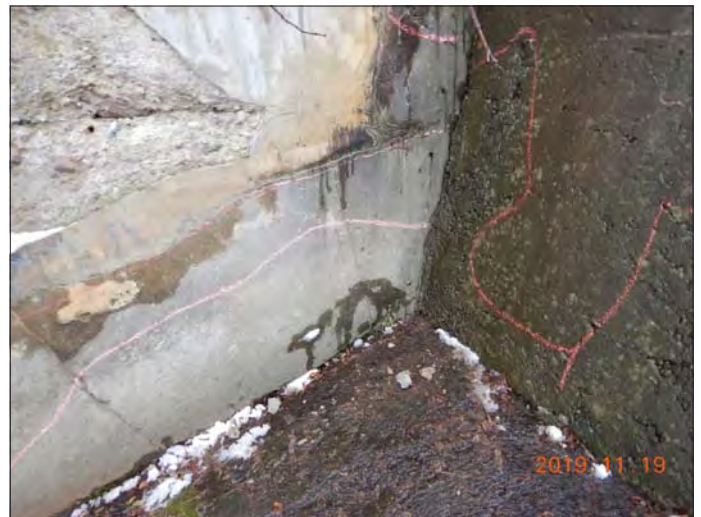
Photo 2839 - Sept 19, 2019
Pefferlaw Dam
Right (East) Dam Abutment

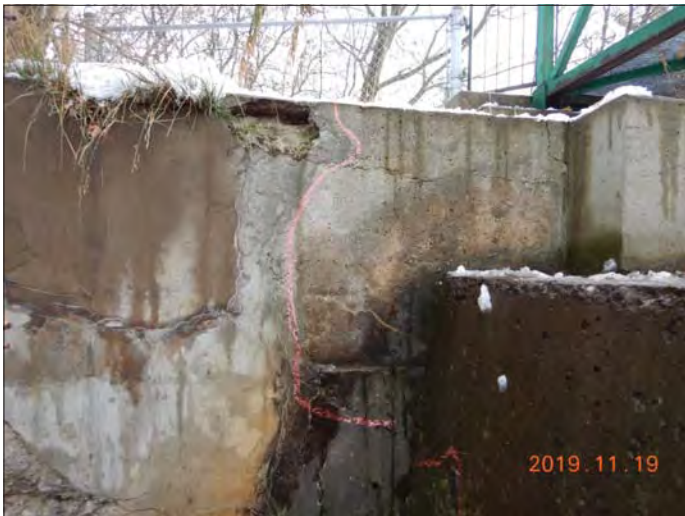
Photo 2840 - Sept 19, 2019
Pefferlaw Dam
Right (East) Dam Abutment

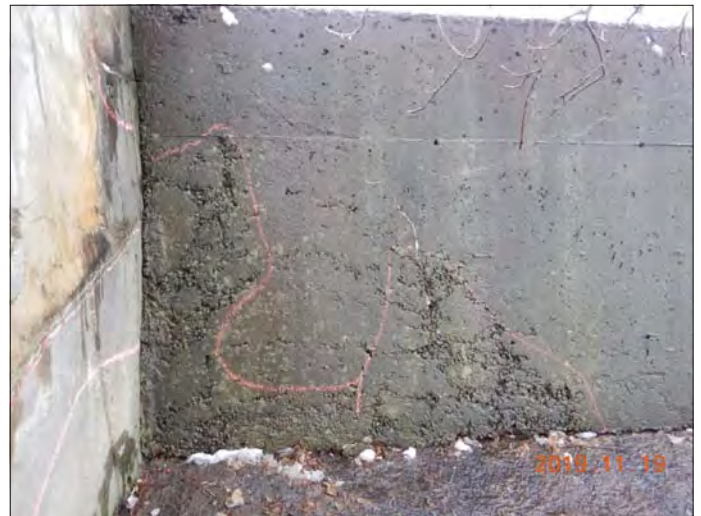
Photo 2841 - Sept 19, 2019
Pefferlaw Dam
Right (East) Dam Abutment

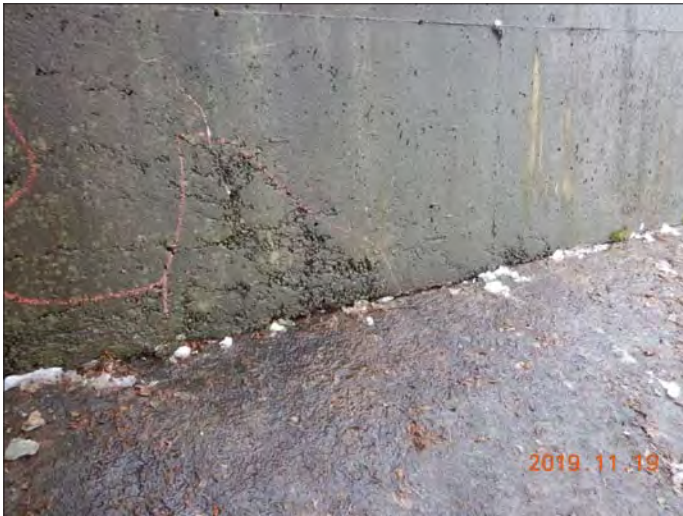
Photo 2842 - Sept 19, 2019
Pefferlaw Dam
Downstream Side of Right (East) Weir

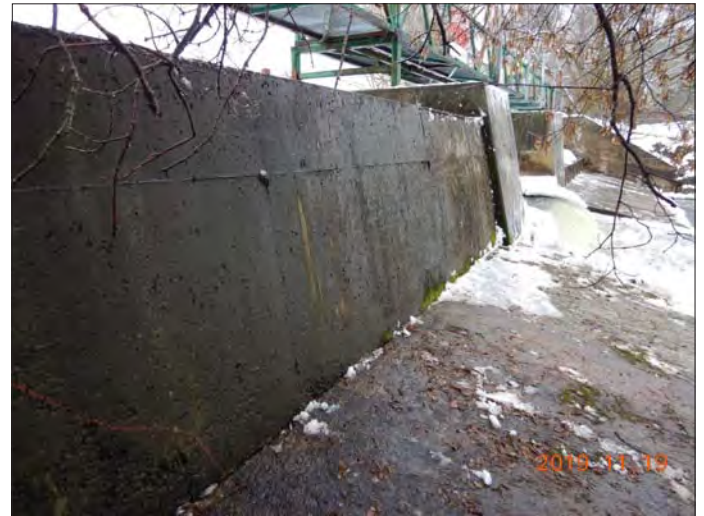
Lake Simcoe Region
conservation authority
Photo 2843 - Sept 19, 2019
Pefferlaw Dam
Downstream Side of Right (East) Weir

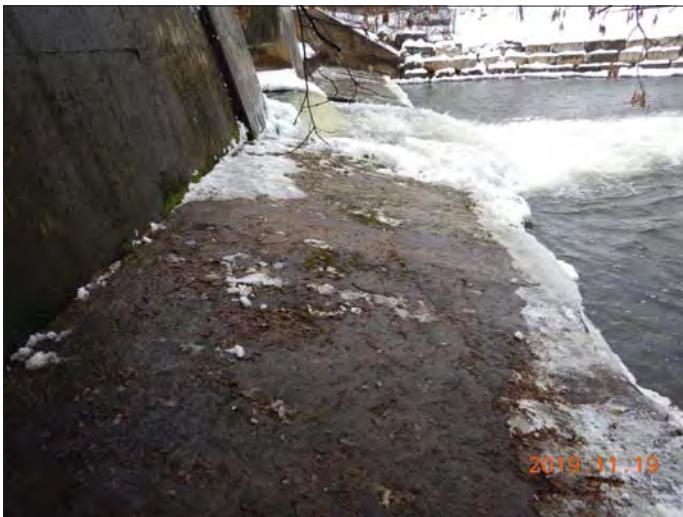
Lake Simcoe Region
conservation authority
Photo 2844 - Sept 19, 2019
Pefferlaw Dam
Downstream Side of Right (East) Weir

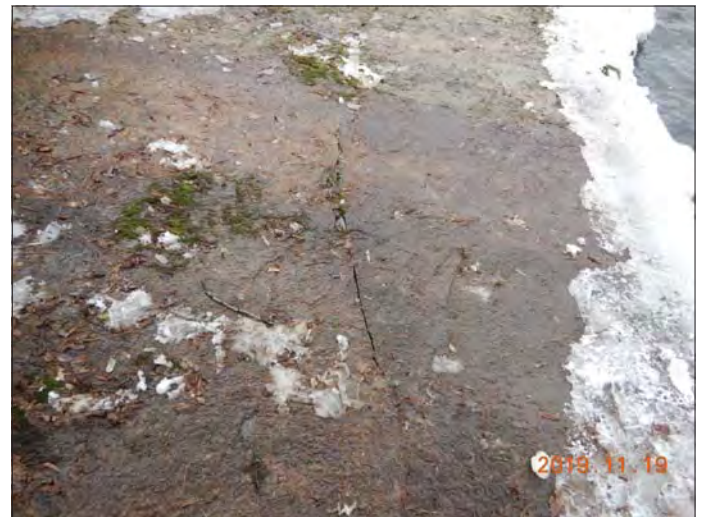
Lake Simcoe Region
conservation authority
Photo 2845 - Sept 19, 2019
Pefferlaw Dam
Right (East) Apron

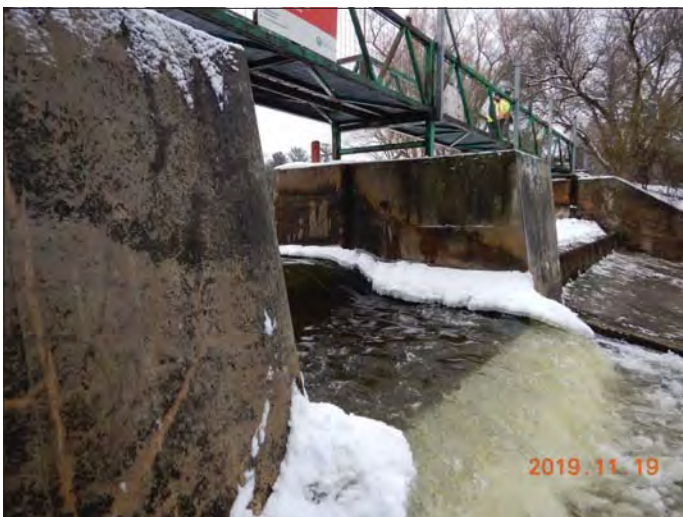
Lake Simcoe Region
conservation authority
Photo 2846 - Sept 19, 2019
Pefferlaw Dam
Right (East) Apron
