## **Structural Design Memorandum**

### **Pefferlaw Dam**

**Town of Georgina  
Regional Municipality of York**

**D.M. Wills Project Number 19-5381**

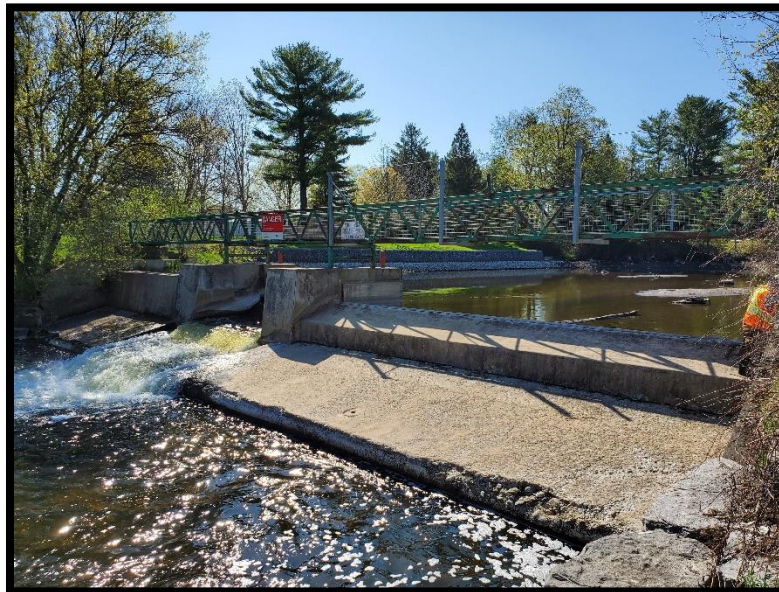
**Photo 1 – Downstream Elevation, Looking South**

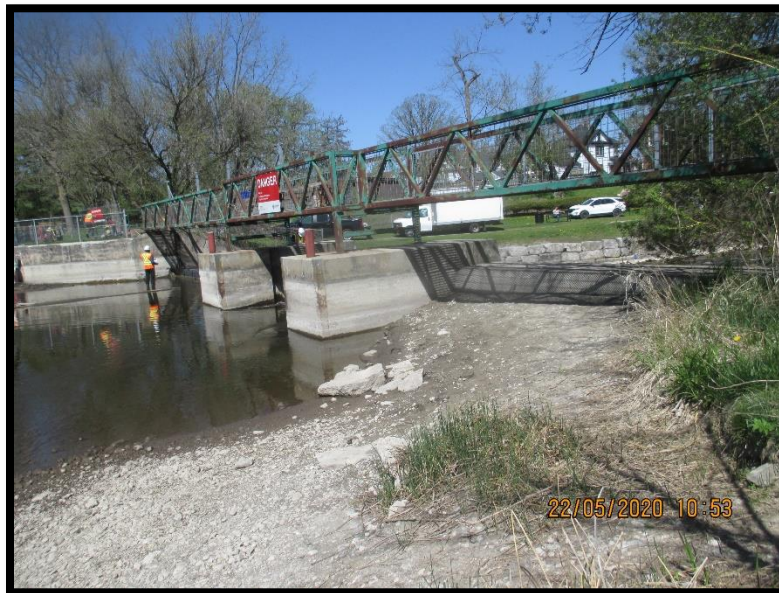
**Photo 2 – Upstream Elevation, Looking Northwest**

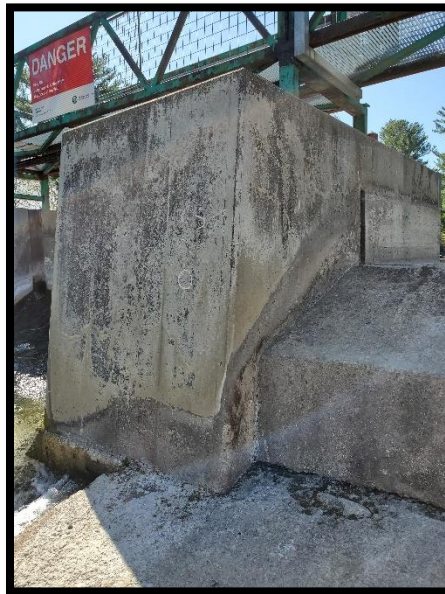
**Photo 9 – West Pier, Downstream Face**

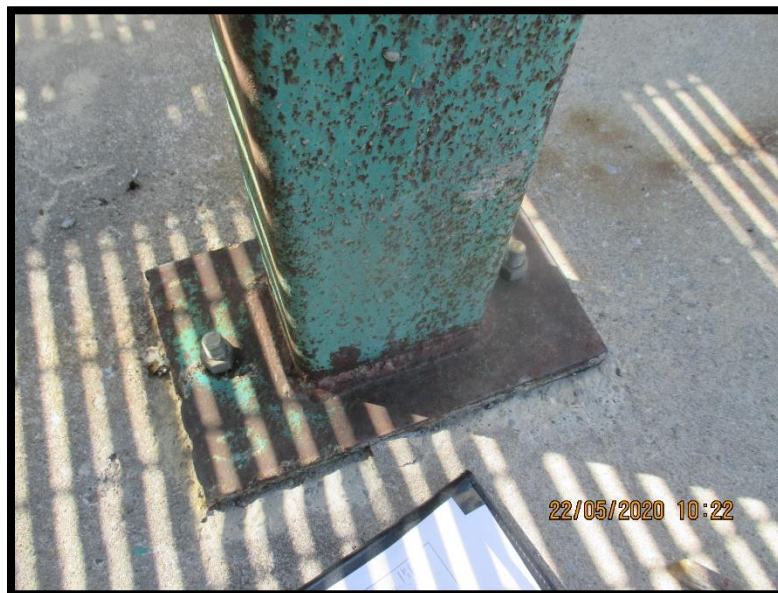
**Photo 12 – Bearing Anchorage of HSS Support (Typ.)**

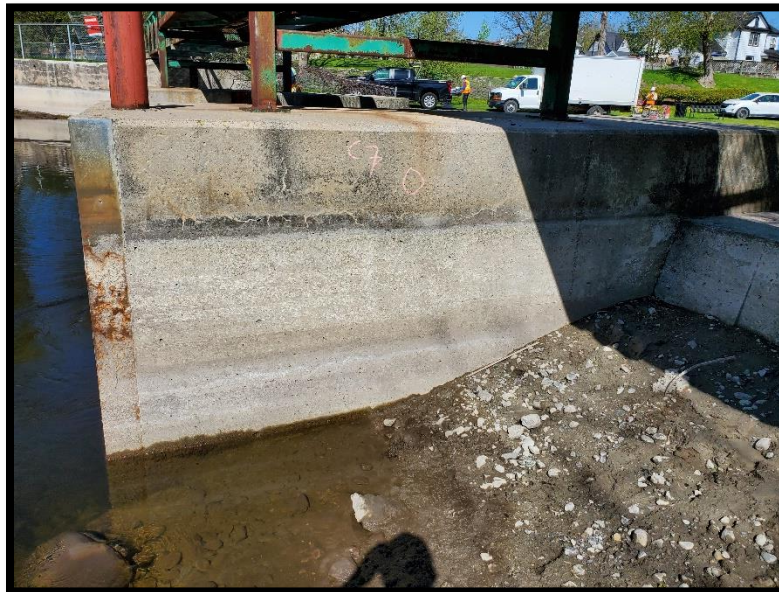
**Photo 15 – East Pier, East Face**

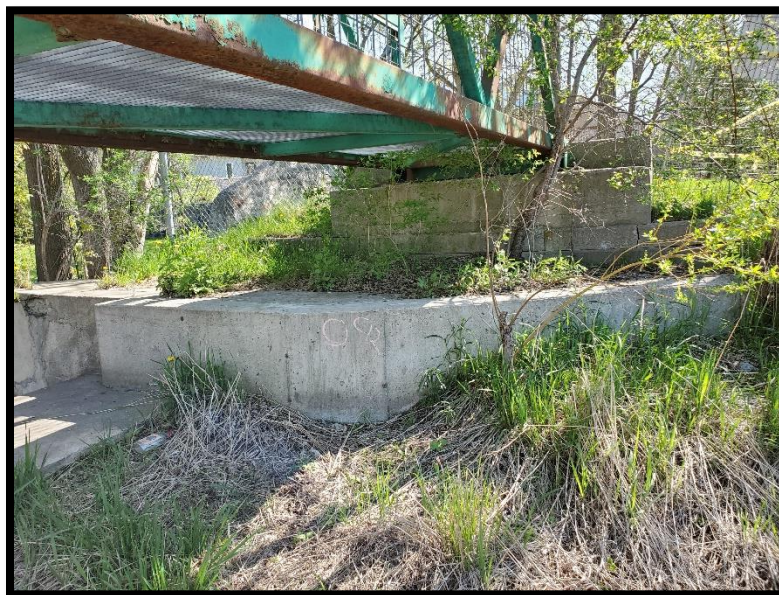
- East Abutment / Retaining Wall in poor condition.
- West Abutment / Retaining Wall in fair to poor condition.
- East Weir in fair condition.
- East Apron in poor condition.
- West Weir in fair to poor condition.
- West Apron in poor condition.
- East Pier in fair condition.
- West Pier in fair to good condition.

**Photo 16 – East Abutment and Upstream Retaining Wall**

face, partial or complete refacing of the concrete element should be considered. Complete replacement of the east abutment retaining wall is recommended, and partial replacement or grouting below the east apron slab will be required.

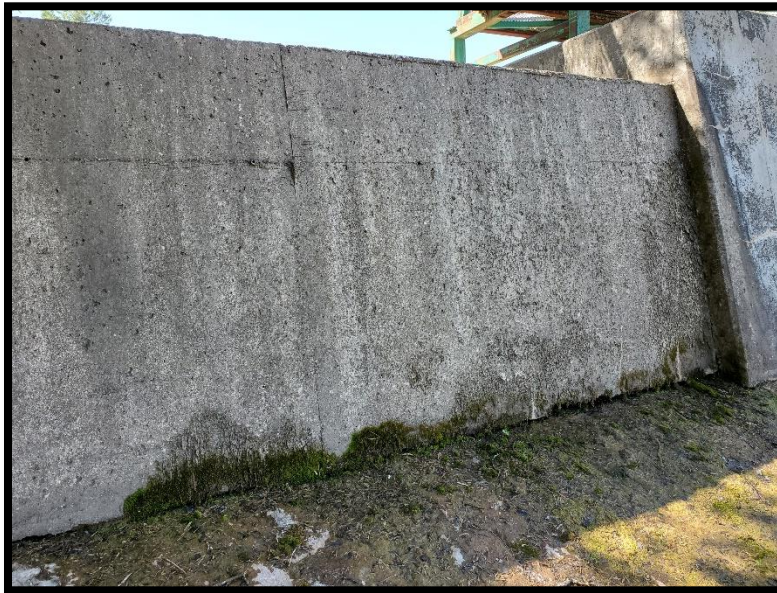
**Photo 18 – East Overflow Weir, Downstream Face**

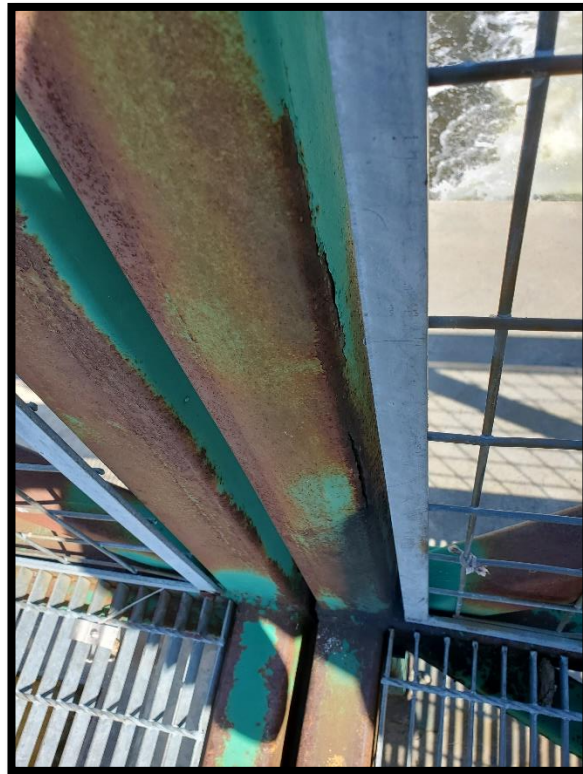
The 2019 Dam Inspection reported that the east and west spans are in fair condition, with coating failure and minor corrosion throughout. In addition, the inspection report indicated that the operational span is in poor condition with wide cracks in some corners of the square HSS. A bearing seat failure in the form of a spall was found at the southwest bearing of the west abutment. As a result of the 2019 Dam Inspection, an evaluation of the operational span has been completed.

**Photo 23 – Vertical HSS at Operational Span, Wide Cracks in Steel (1)**

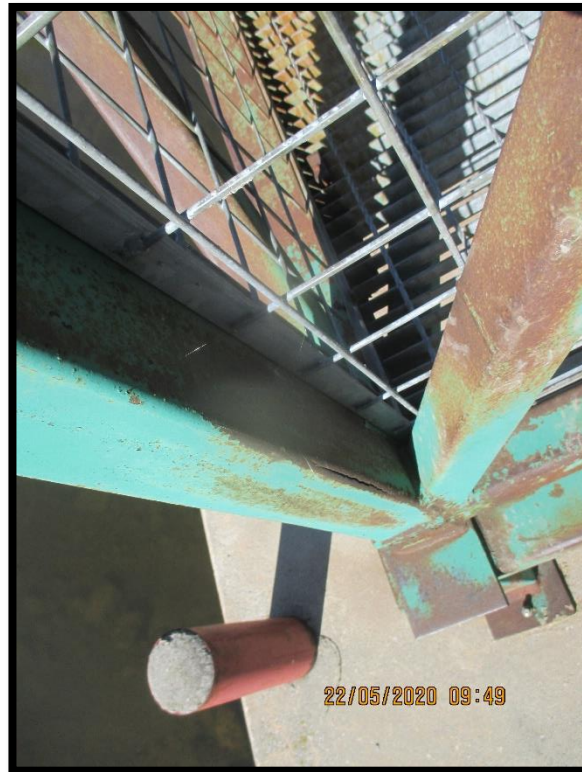
**Photo 25 – Vertical HSS at Operational Span, Wide Cracks in Steel (3)**

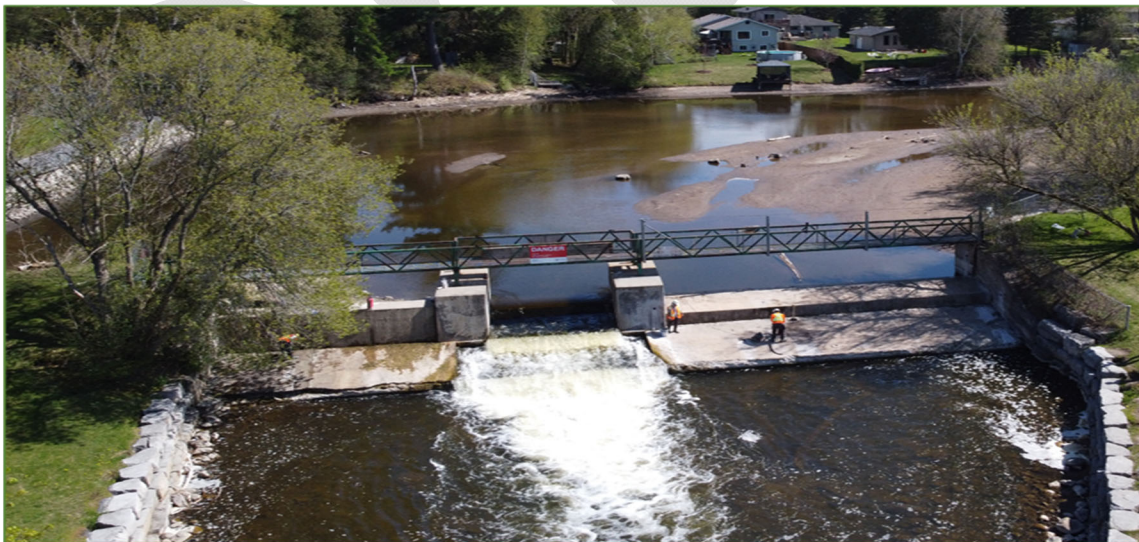
**North Elevation of Pefferlaw Dam, Pefferlaw Brook Watershed**

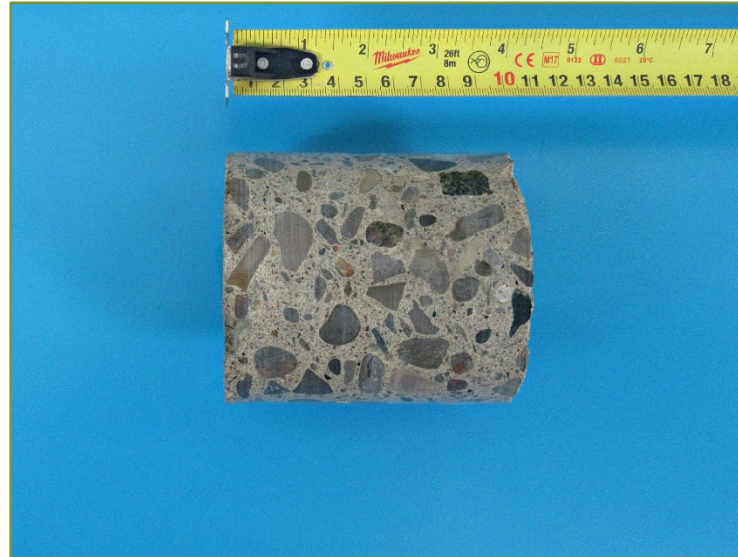
**Core C12**

| Core No. | | C10 | | C11 | | C12 | |
|--|---|---|---|---|---|---|---|
| REMARKS<br>- orientation of rebars and cover<br>- presence of overlay, patch and thickness<br>- other observed defects | | Delamination plane @ 175-180mm. | | | | Rebar imprint @ 110mm (Horizontal). | |

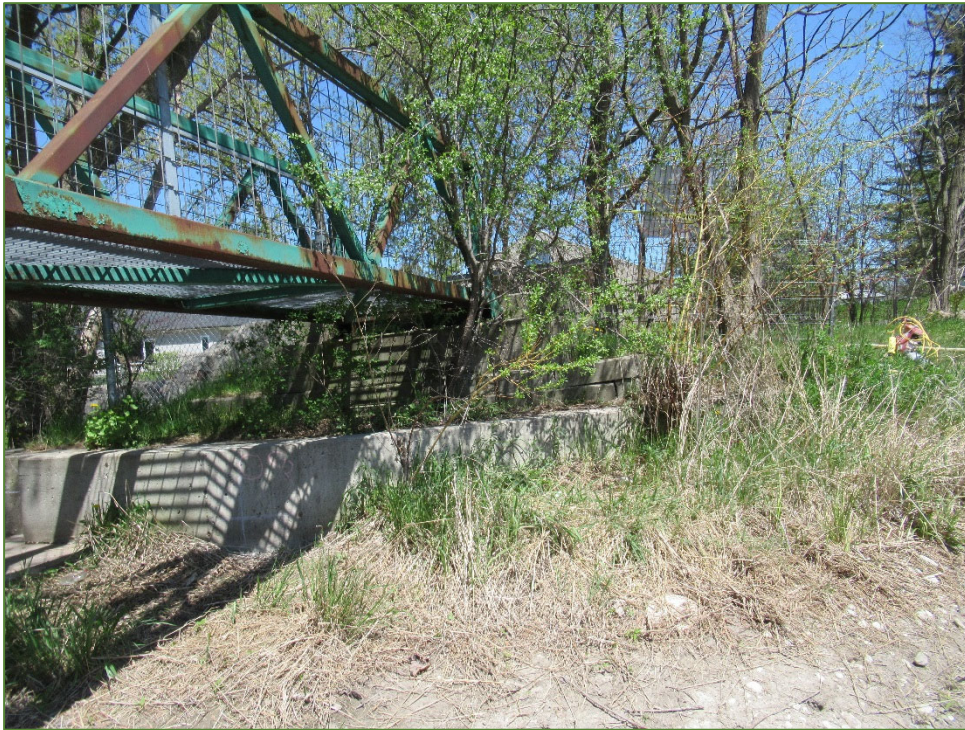
**Photo P5 East Abutment and Retaining Wall** (fair to poor condition – cracks, spall, delamination and light to severe scaling)

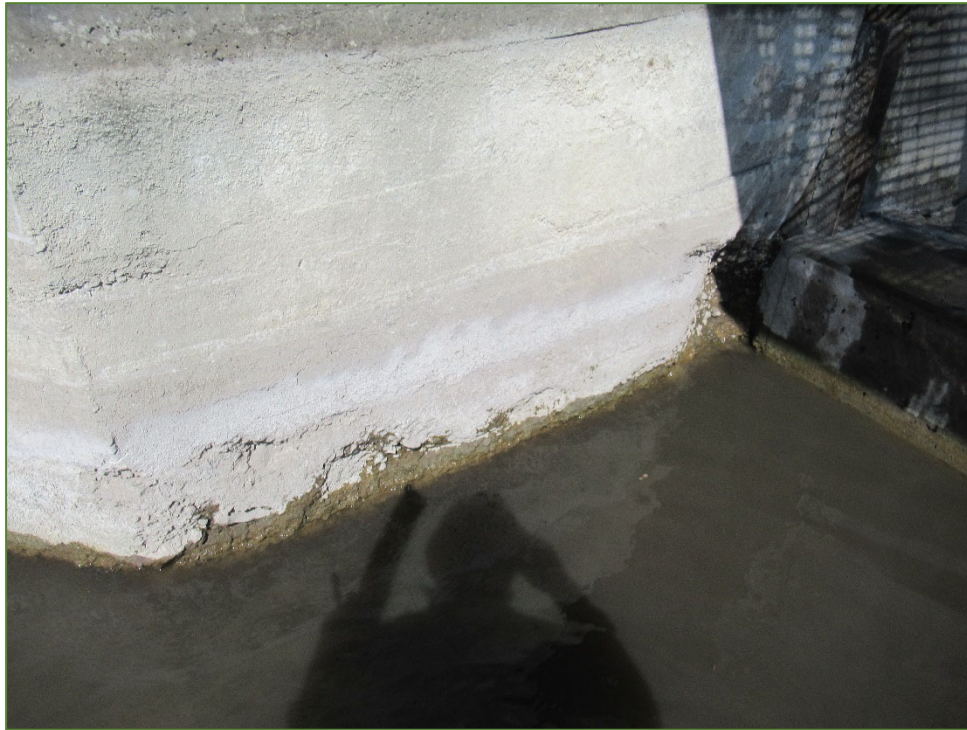
**Photo P11 West Abutment and Retaining Wall** (severe scaling) note undermining
